CITY OF SHASTA LAKE

2016-2026 WATER MASTER PLAN

FINAL • OCTOBER 2016

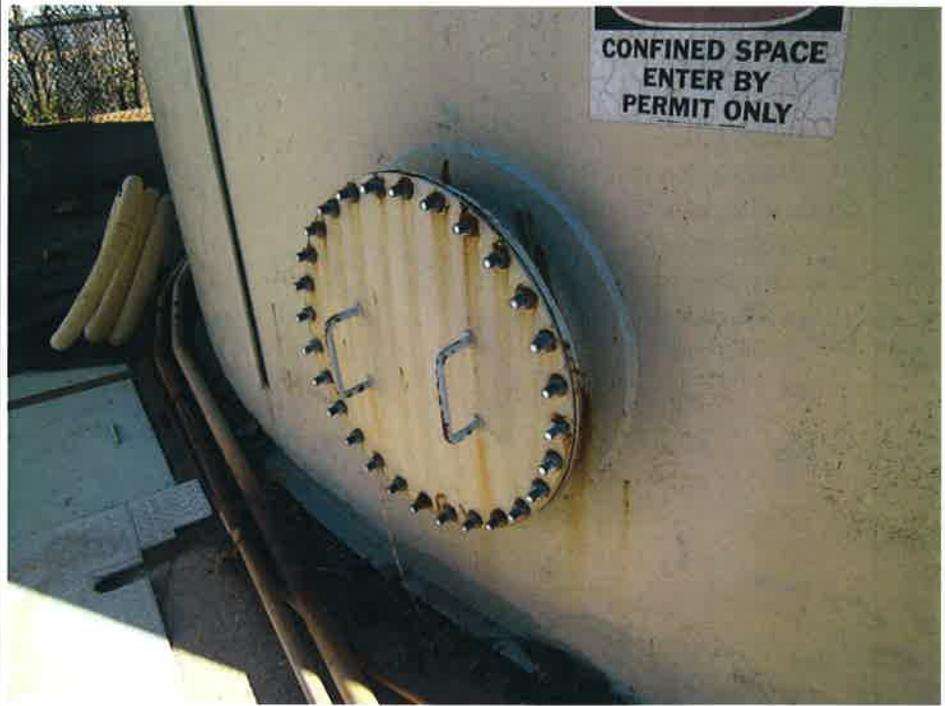
Image #8

Description:
24" Man Way appeared to be in fair condition with a minor amount of corrosion.

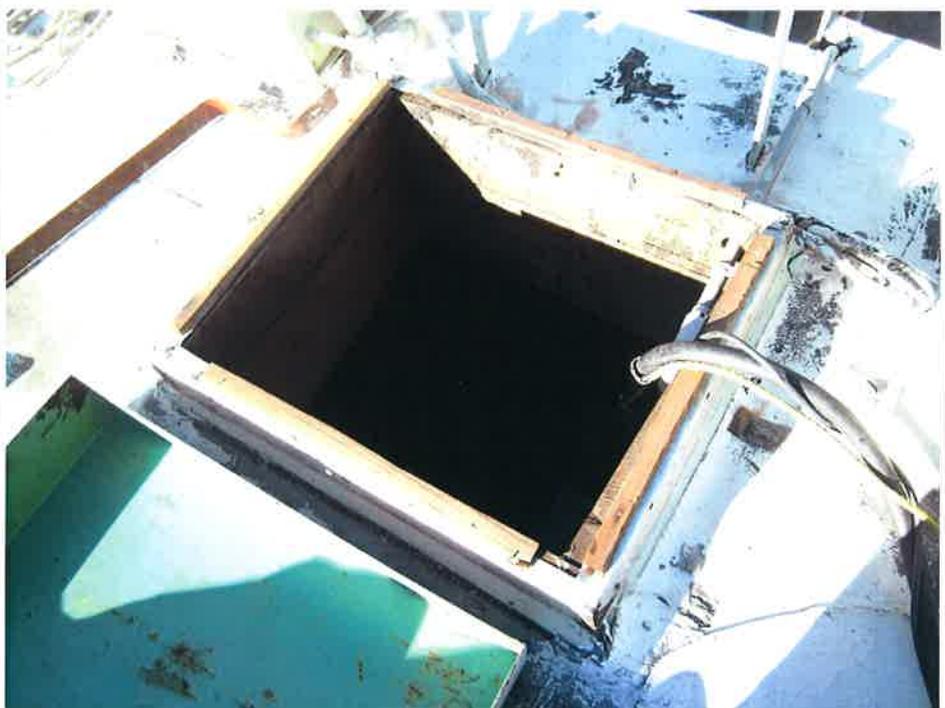
Finished 1 Tank

Description:
24" x 24" Wooden Entry Hatch appeared to be in good condition with a minor amount of deterioration observed.

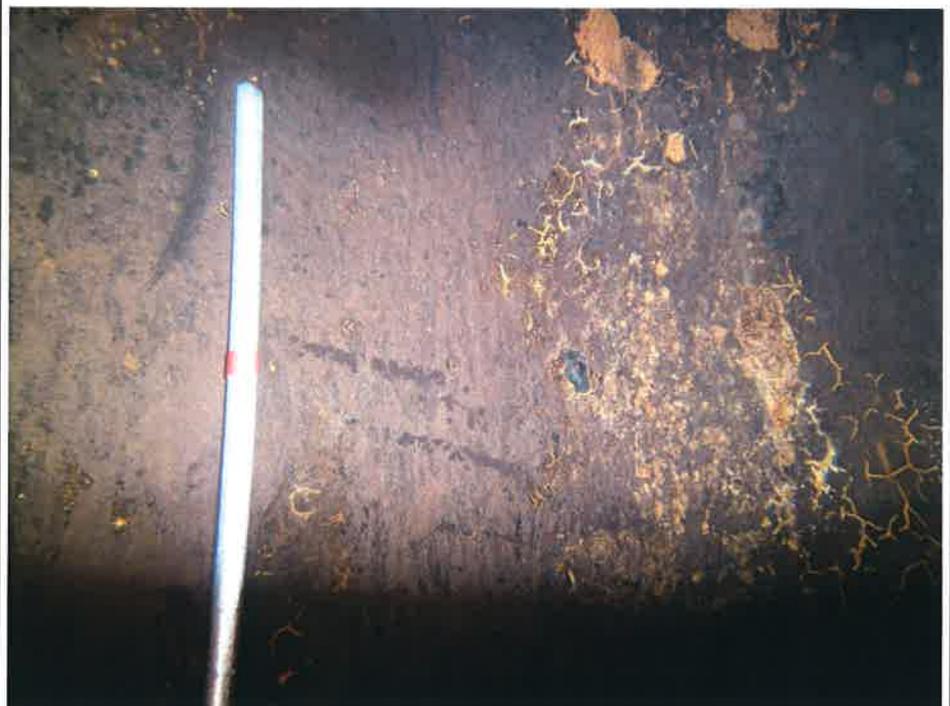
Finished 1 Tank

Description:
Coal tar coated Wall appeared to be in poor condition with a moderate amount of cracking of the coating and corrosion observed.

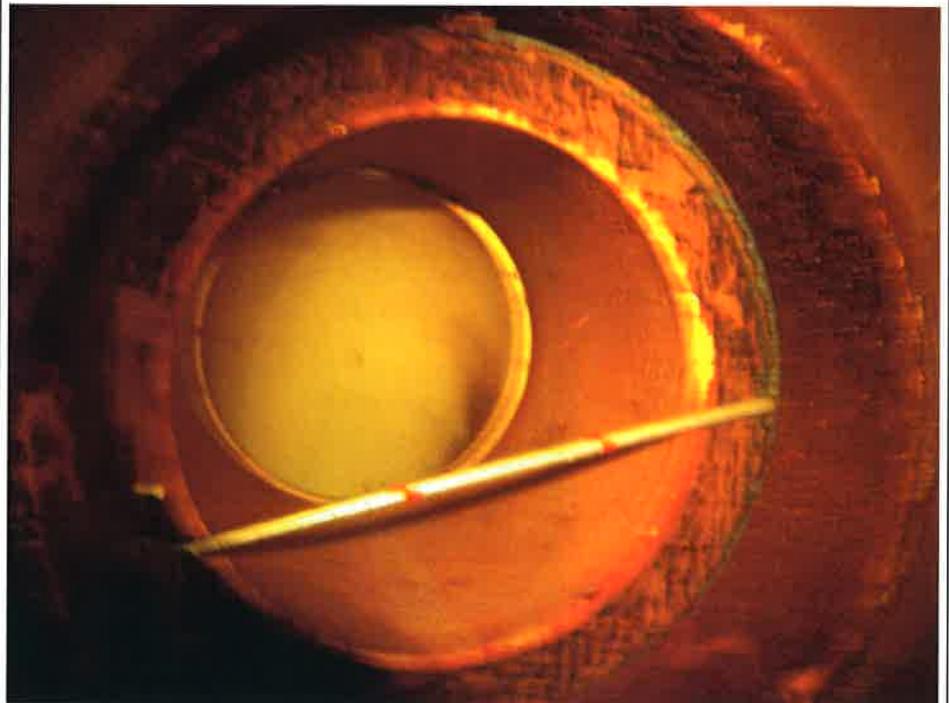
Finished 2 Tank

Description:
16" Inlet appeared to be in fair condition with a minor amount of corrosion.

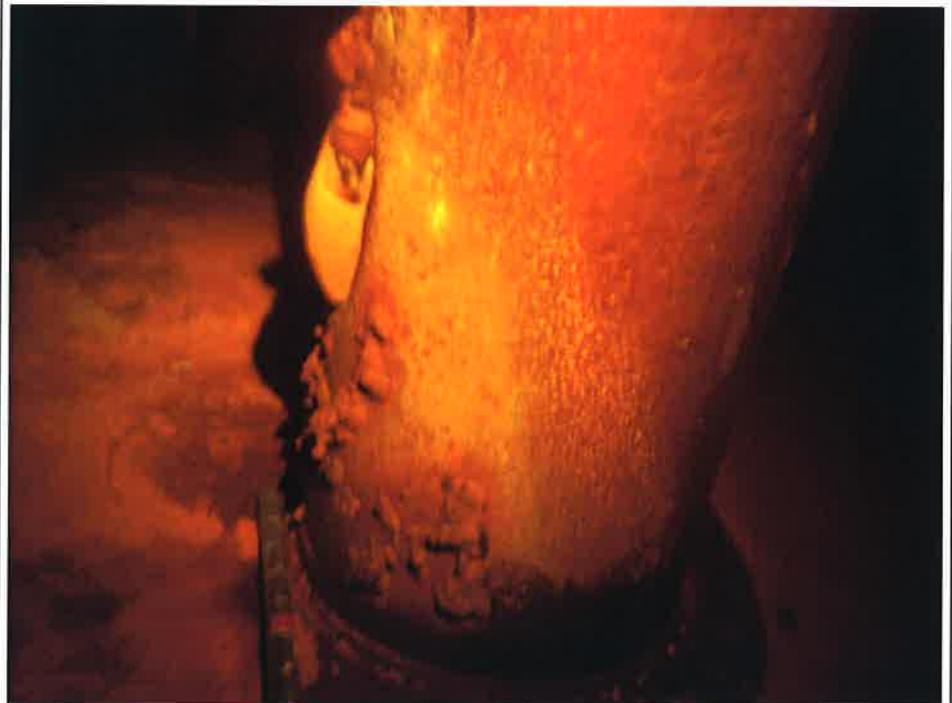
Finished 2 Tank

Description:
8" Overflow appeared to be in fair condition with a moderate amount of corrosion.

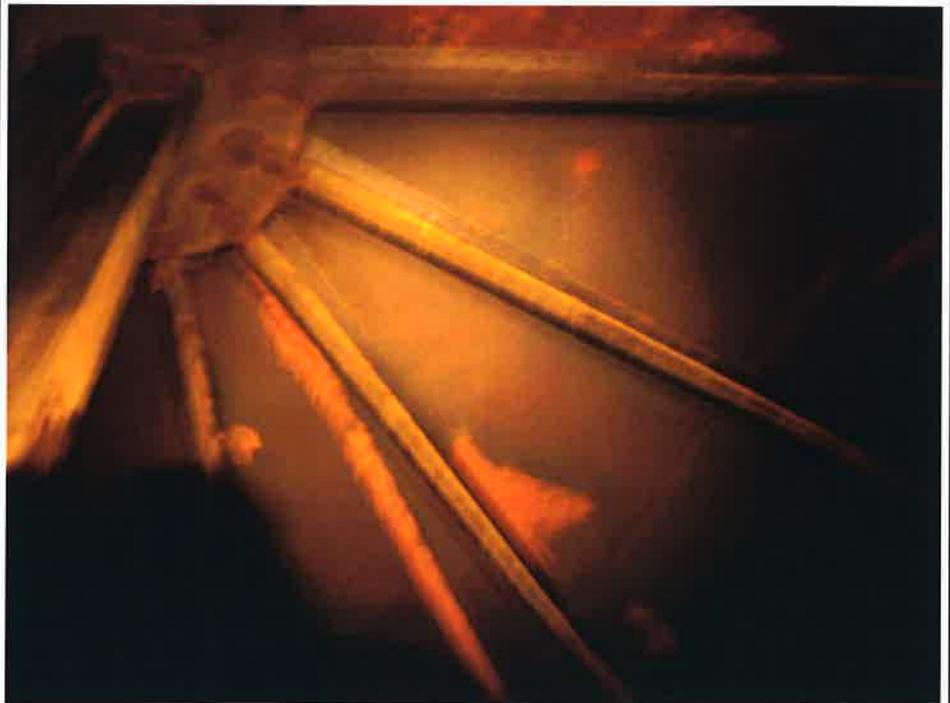
Finished 2 Tank

Description:
Ceiling appeared to be in poor condition with a heavy amount of corrosion.

- *Finished Water Tank 2*: This tank is in need of a new interior coating, as well as a few other additional items (replacement of the liquid level indicator float, and patching a hole in the ceiling). This tank is recommended to be demolished as part of the recommended storage capacity improvement alternative. Therefore, no costs were included in the City's CIP to coat this tank.

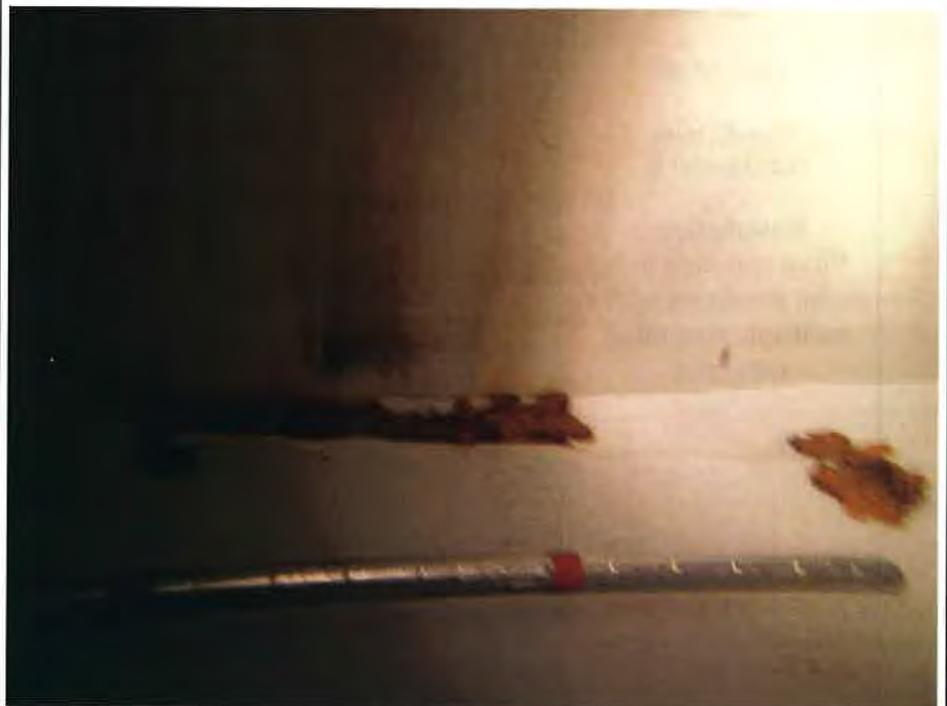
Montana B Tank

Description:
Floor appeared to be in fair condition with a moderate amount of corrosion.

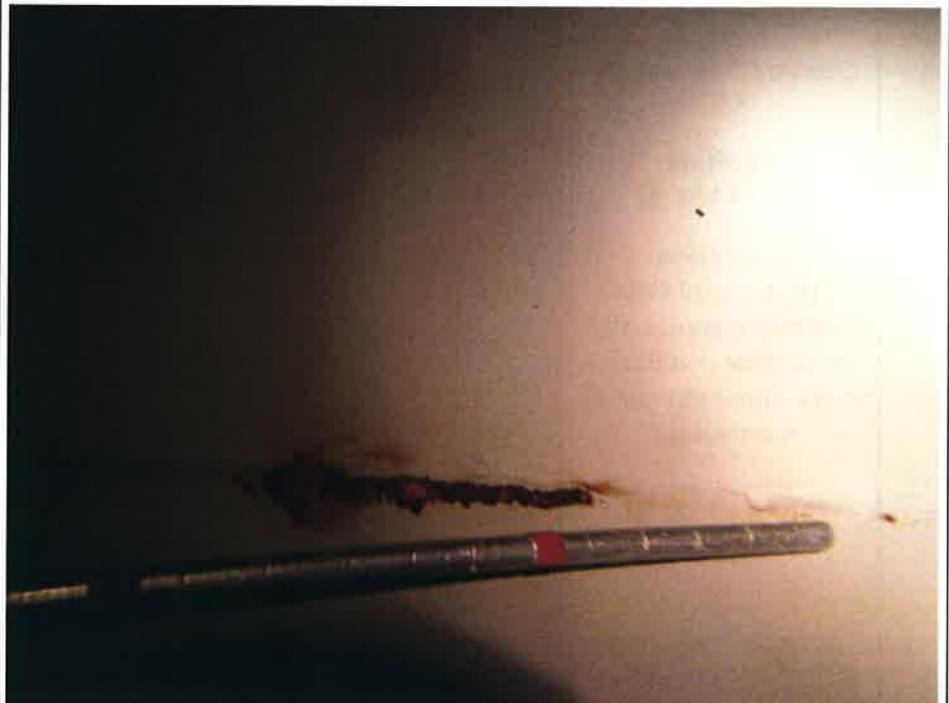
Montana B Tank

Description:
Floor appeared to be in fair condition with a moderate amount of corrosion.

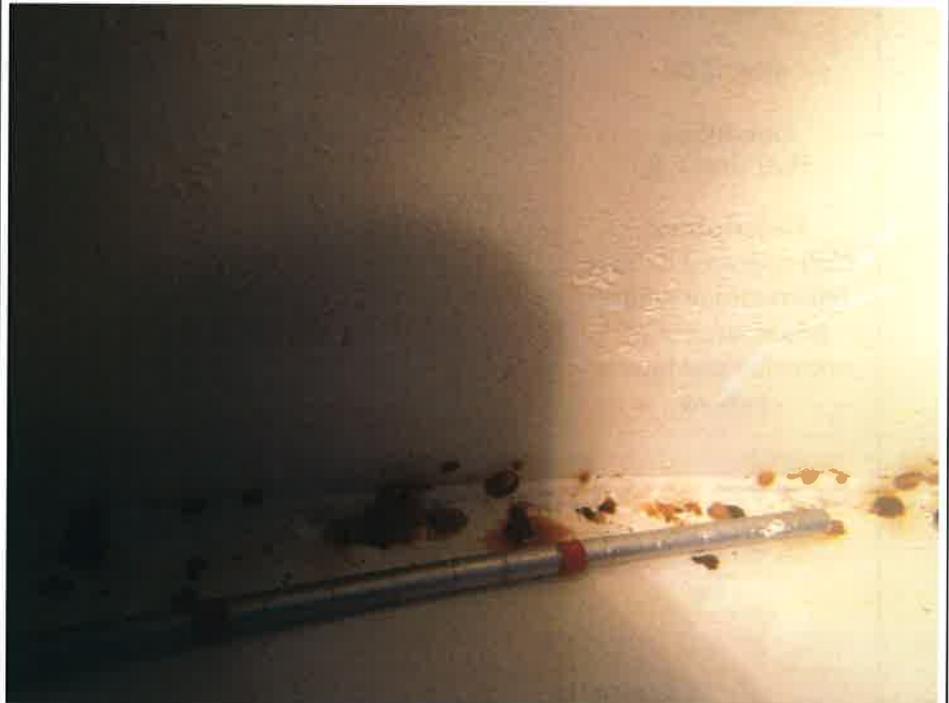
Picard Tank

Description:
Floor appeared to be in fair condition with a minor amount of corrosion and heavy chalking.

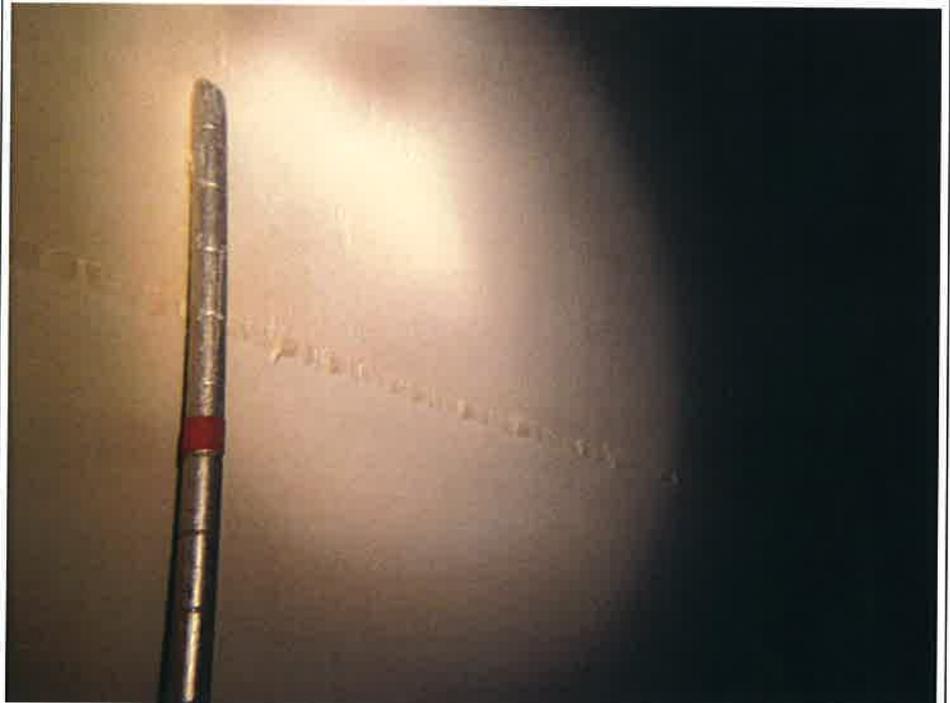
Picard Tank

Description:
Wall appeared to be in fair condition with a minor amount of corrosion and heavy chalking.

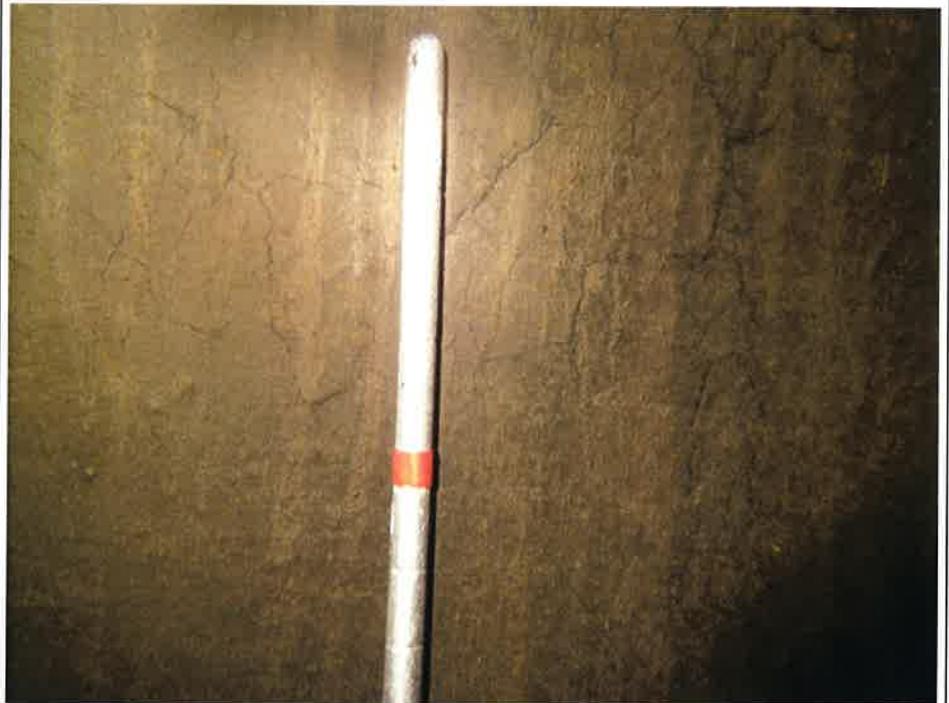
Shasta Way B Tank

Description:
Unable to evaluate the condition of the Wall due to cold tar coating with some minor cracking.

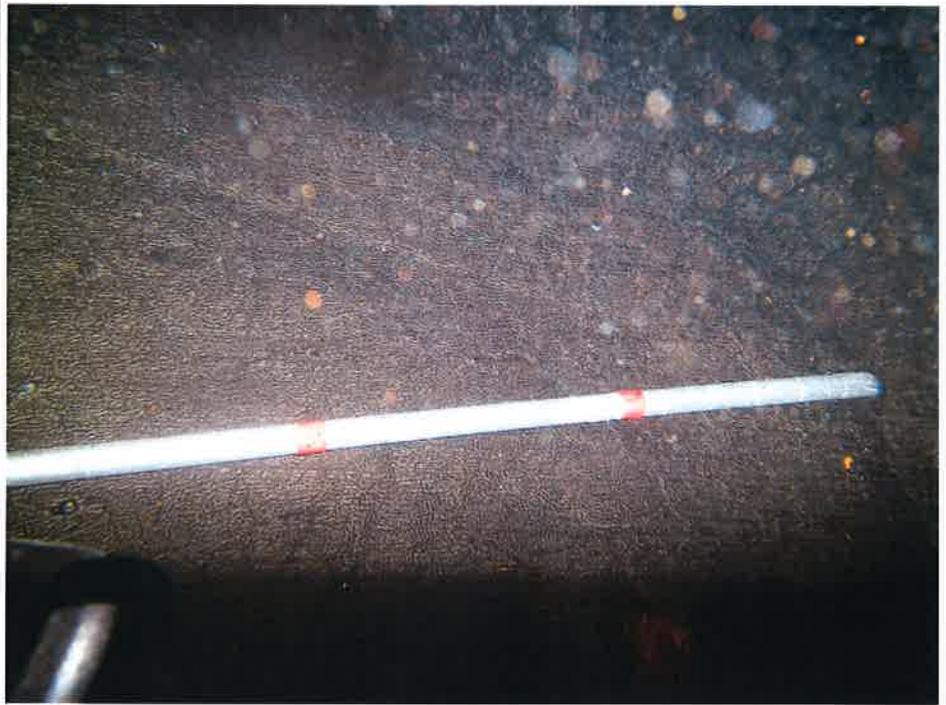
Image #40

Description:
Unable to evaluate the condition of the Floor due to cold tar coating with moderate corrosion spots.

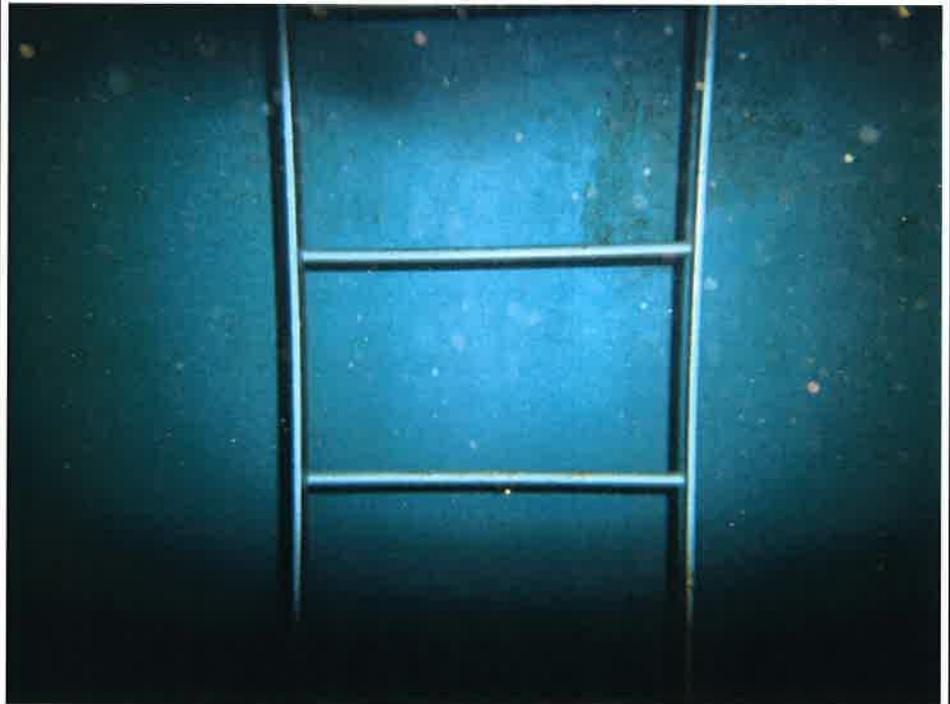
Toyon 5 Tank

Description:
Interior Ladder appeared to be in fair condition with a moderate amount of corrosion.

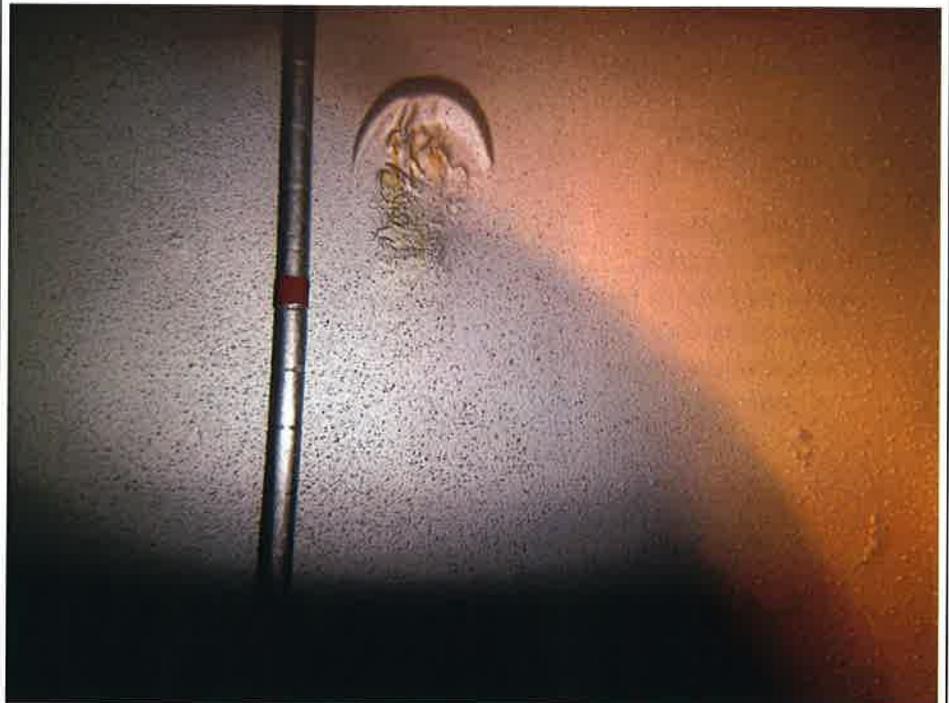
Toyon 5 Tank

Description:
Wall appeared to be in fair condition with a minor amount of corrosion and minor blistering observed.

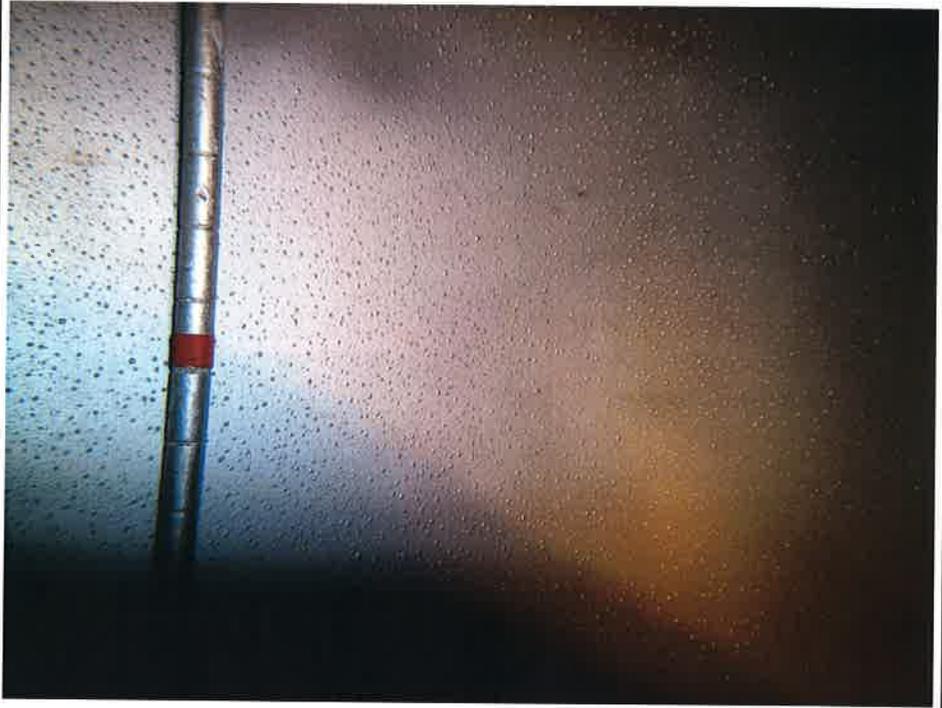
Image #24

Description:
Wall appeared to be in fair condition with a minor amount of corrosion and blistering observed.

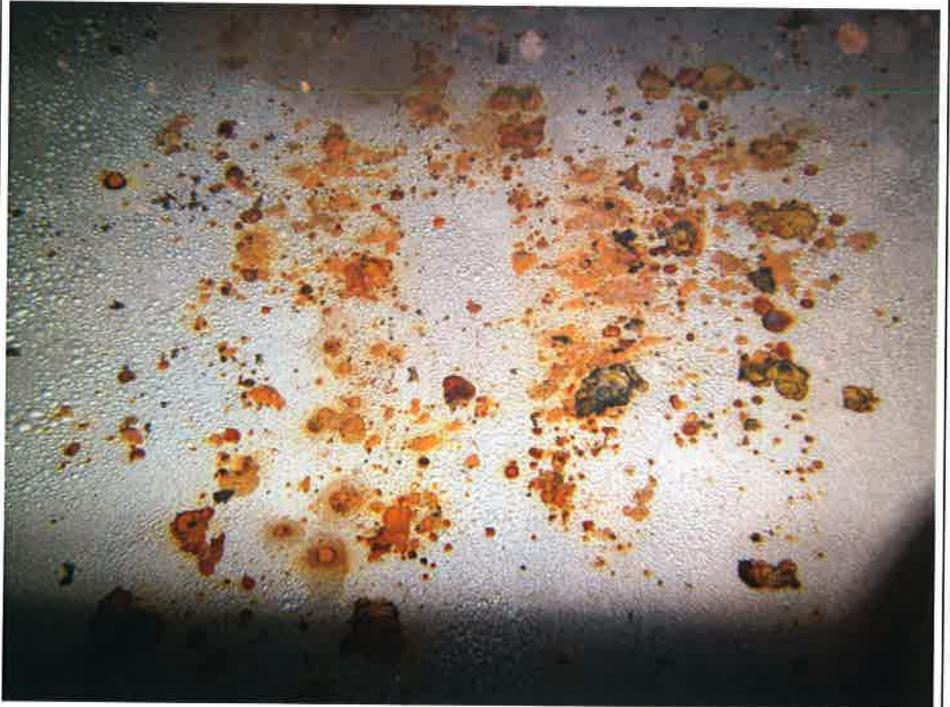
Toyon 5 Tank

Description:
Floor appeared to be in poor condition with a moderate amount of corrosion and blistering observed.

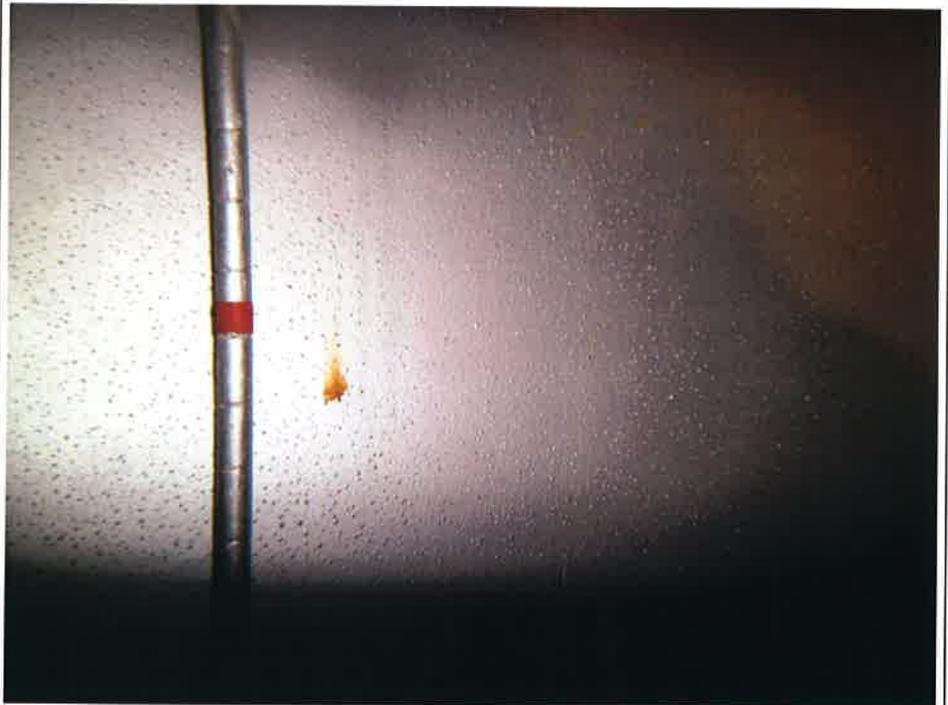
Toyon 5 Tank

Description:
Wall appeared to be in fair condition with a minor amount of corrosion and blistering observed.

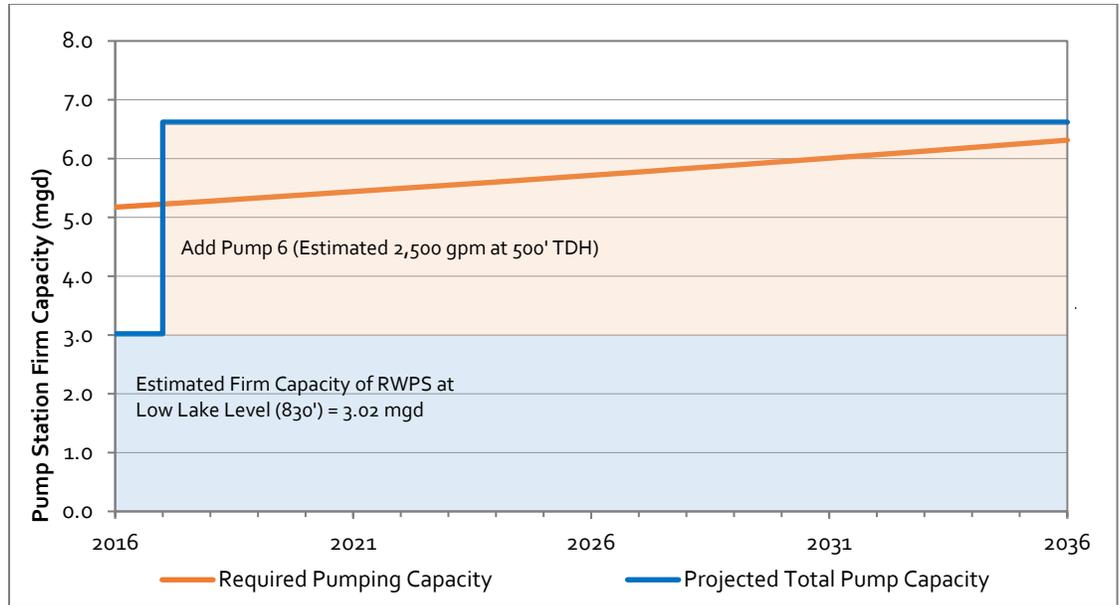
Figure 1 Raw Water Pump Station Capacity Evaluation at Low Lake Level

The RWPS capacity relies on water level of Shasta Lake. For conservative planning purposes recommended RWPS projects are designed to meet MDD at low tank level conditions. Figure 1 shows a comparison of the existing and projected MDD through year 2036, to the firm capacity of the RWPS. As shown on Figure 1, the installation of Pump 6 at the RWPS (with an estimated capacity of 2,500 gallons per minute [gpm] at 500-feet of head) would increase the City's capacity to 6.6 mgd. The addition of Pump 6 would mitigate the current pumping deficiency, and would meet the City's projected MDD through year 2036. Additional pump replacements would be required to replace the aging Pumps 1 through 4, which are 35 to 68 years old, and have reached the end of their useful lives.
