CITY OF SHASTA LAKE

2016-2026 WATER MASTER PLAN

FINAL • OCTOBER 2016

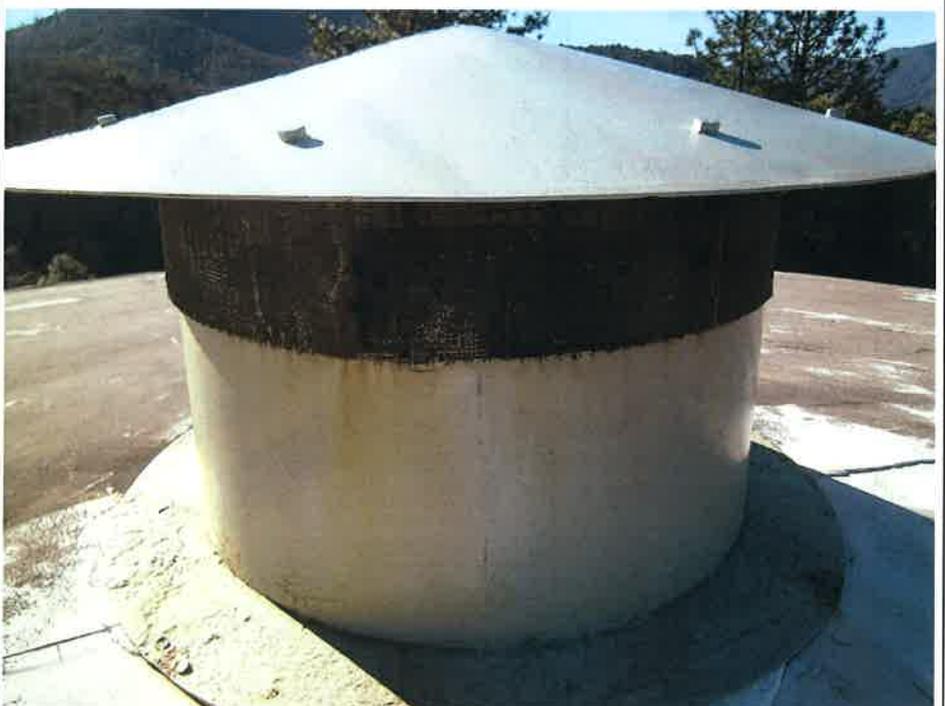
Image #11

Condition:
Rust Grade¹ 5.

Description:
Fine Mesh Vent Screen appeared to be in poor condition with several large holes observed and minor corrosion observed. Medium mesh screen appeared to be in fair condition with minor corrosion observed.

Recommendation	Estimated Time - Hrs.
Repair and/or install fine mesh screens on exterior vents to limit the risk of bugs and other matter from entering the storage tank.	1.0
Install weather stripping on entry hatch to limit the risk of bugs and other matter from entering the storage tank.	1.0
Remove the existing interior coating and apply a new NSF approved epoxy type coating. The existing interior coating was in such disrepair that it would not be cost effective to attempt to patch all of the problem areas.	Please contact our sales office for an estimate.
Perform a regular cleaning, inspection and repair cycle every 2-3 years in order to ensure superior water quality and proper maintenance of coating condition and appurtenances is performed.	Please contact our sales office for an estimate.
Total Estimated Hours

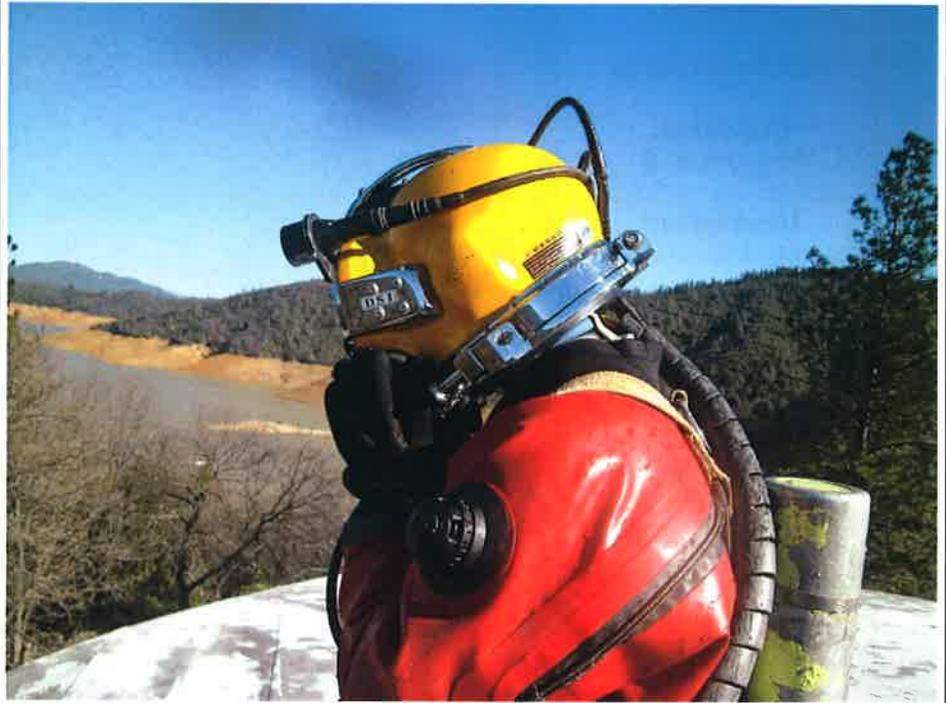
Image #14

Sediment

Description:
1/32" of sediment was
removed from
reservoir floor.

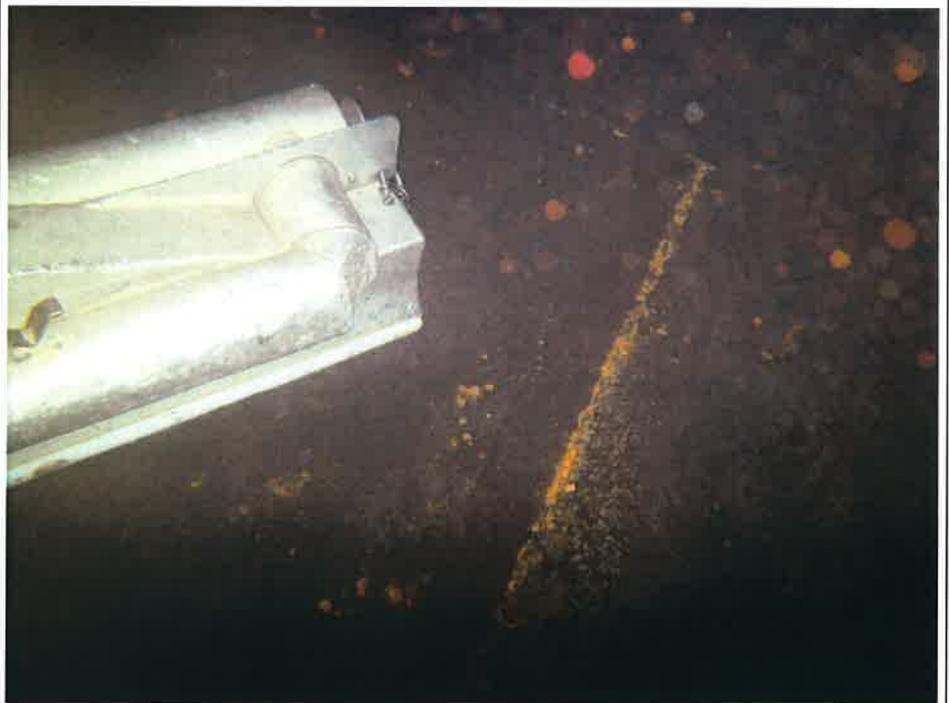
Image #15

Condition:
Rust Grade¹ 4.

Description:
Coal tar coated floor appeared to be in fair condition with moderate corrosion observed.

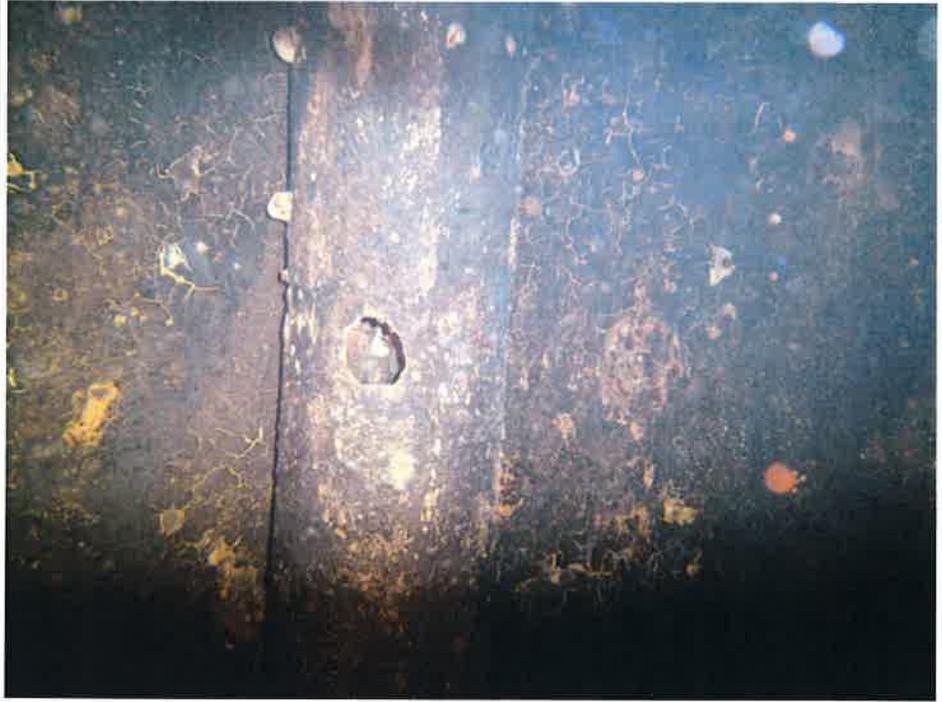
Image #18

Floor 3:00

Condition:
Rust Grade¹ 4

Description:
Coal tar coated floor
appeared to be in fair
condition with
moderate corrosion
observed.

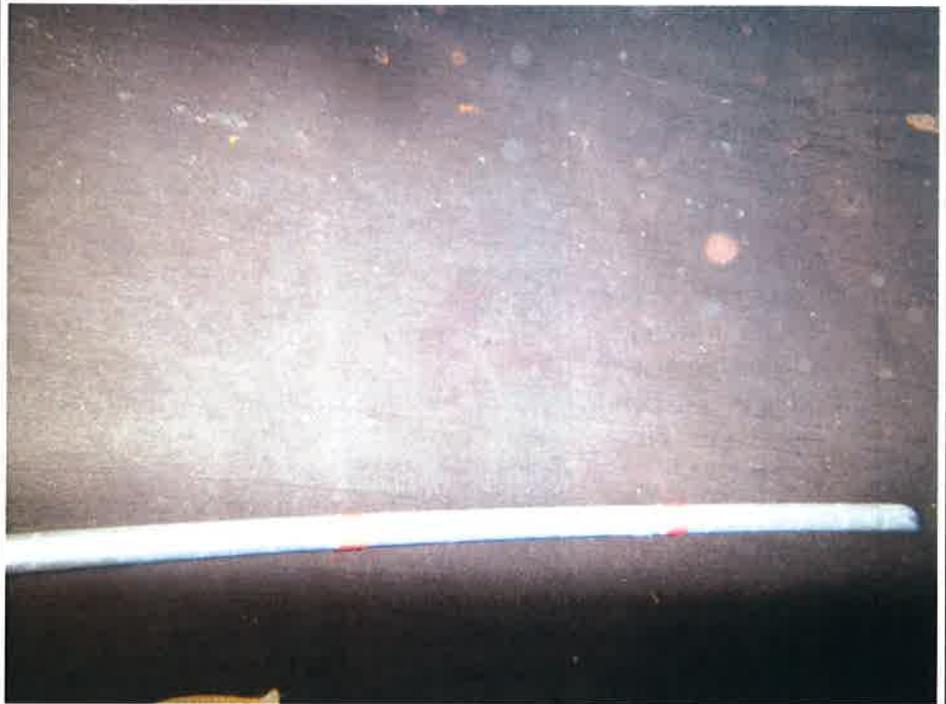
Image #19

Condition:
Rust Grade¹ 3.

Description:
Coal Tar coated Wall appeared to be in poor condition with a moderate amount of cracking of the coating and corrosion observed.

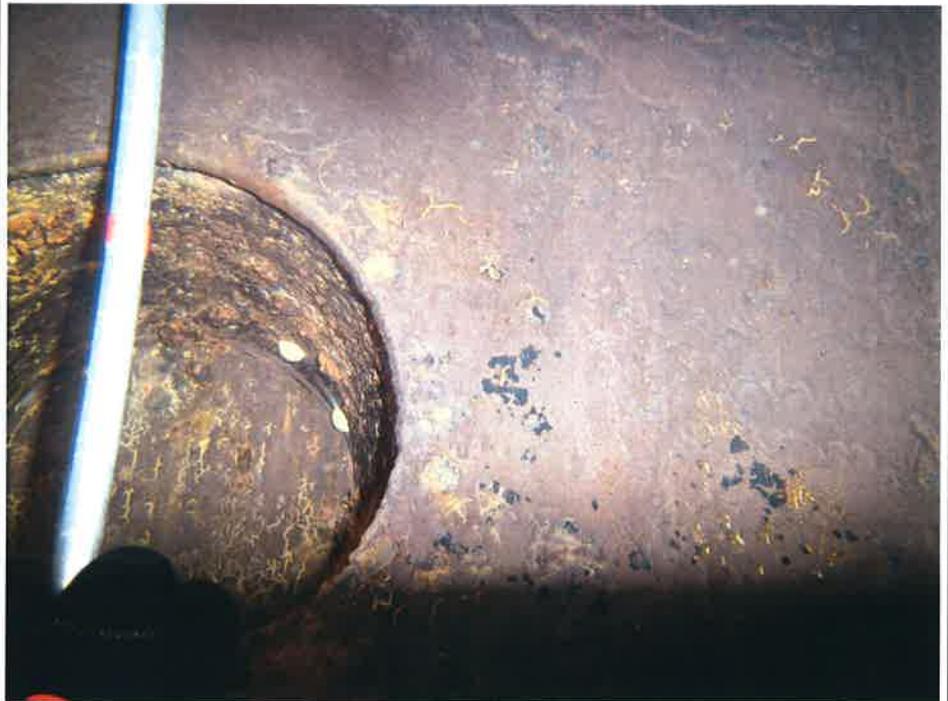
Image #21

Condition:
Rust Grade¹ 8.

Description:
Inlet appeared to be in good condition with a minor amount of corrosion.

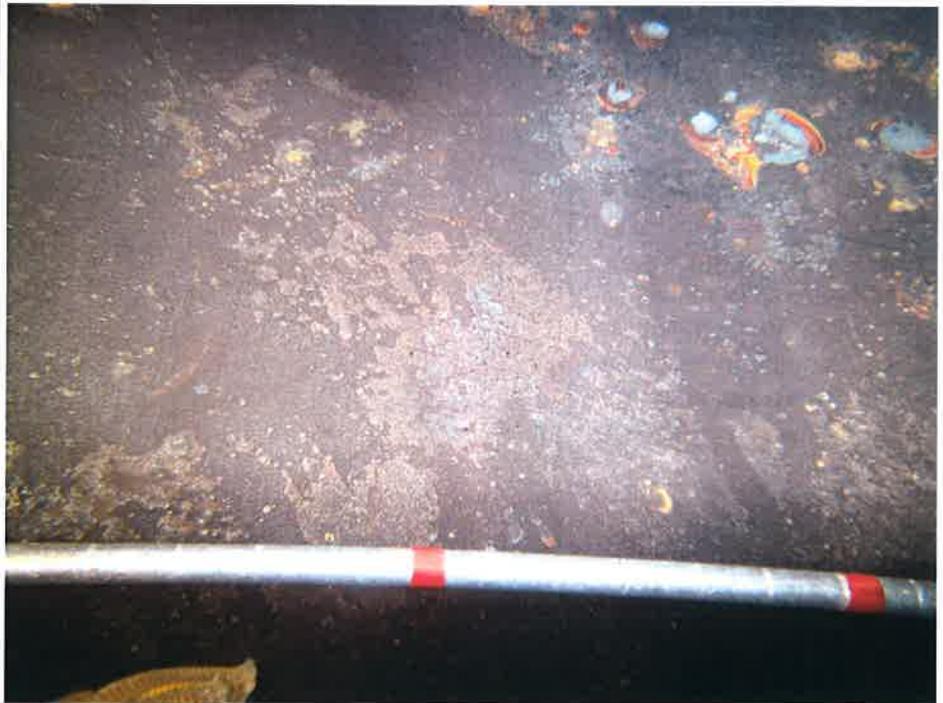
Image #23

Condition:
Rust Grade¹ 3.

Description:
Coal tar coated Wall appeared to be in fair condition with a moderate amount of cracking of the coating and corrosion observed.

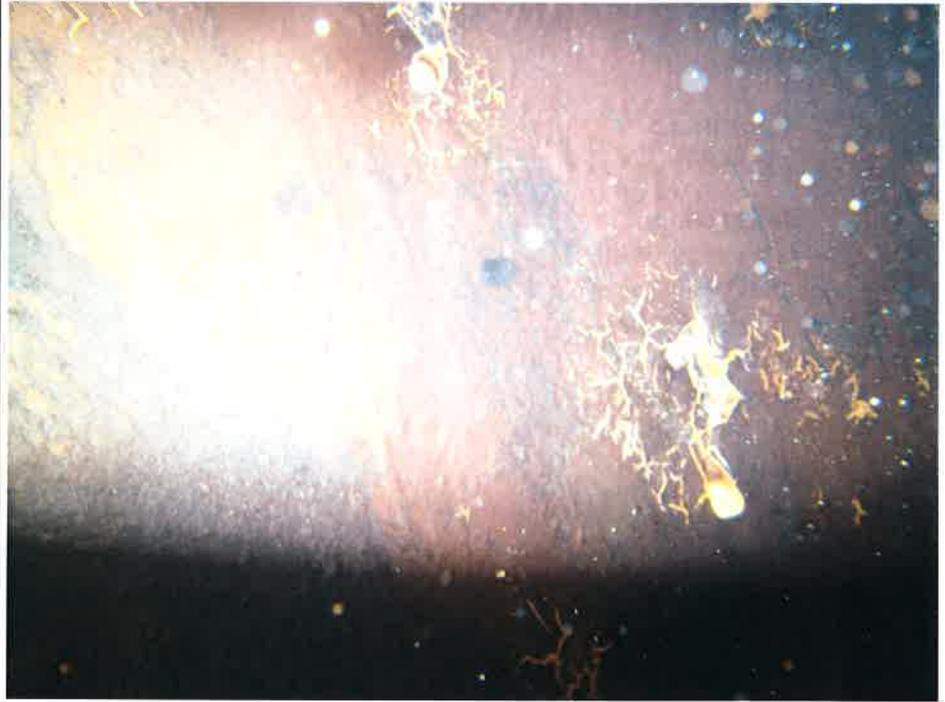
Condition:
Rust Grade 6.

Description:
8" Overflow appeared to be in fair condition with a moderate amount of corrosion.

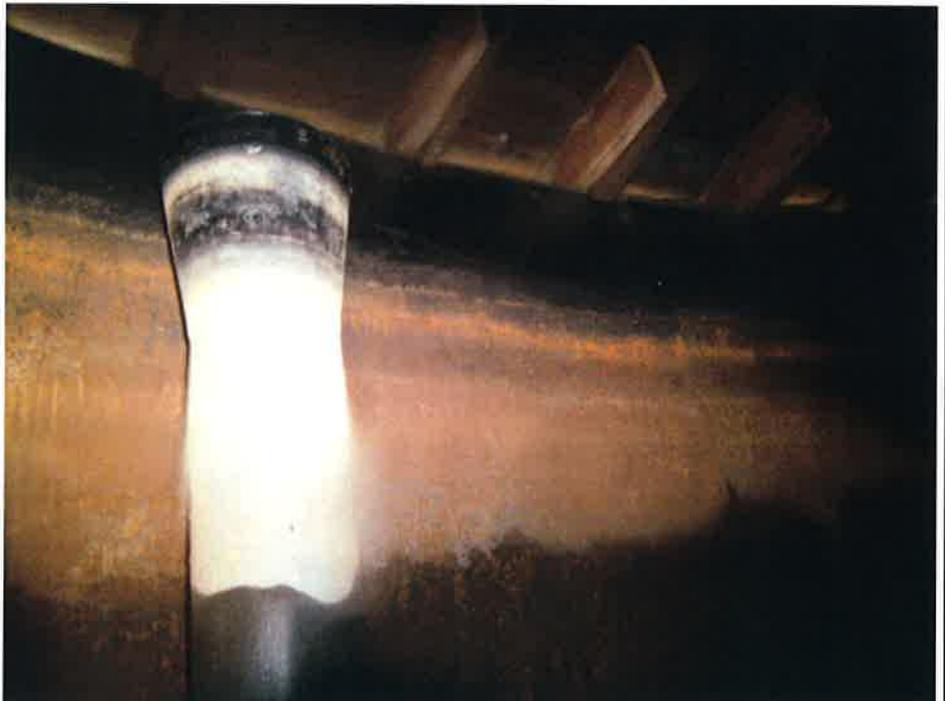
Image #26

Overflow Bell 8:10

Condition:
Rust Grade 7.

Description:
12" Overflow Bell appeared to be in good condition with a minor amount of corrosion.

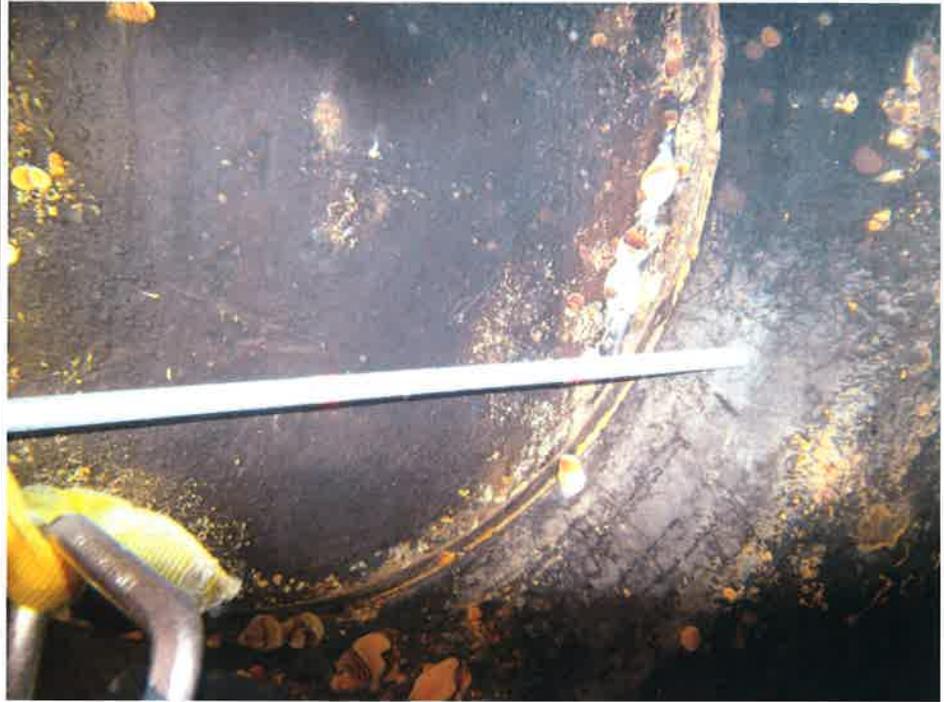
Image #27

Condition:
Rust Grade¹ 6.

Description:
24" Man Way appeared to be in fair condition with a moderate amount of corrosion.

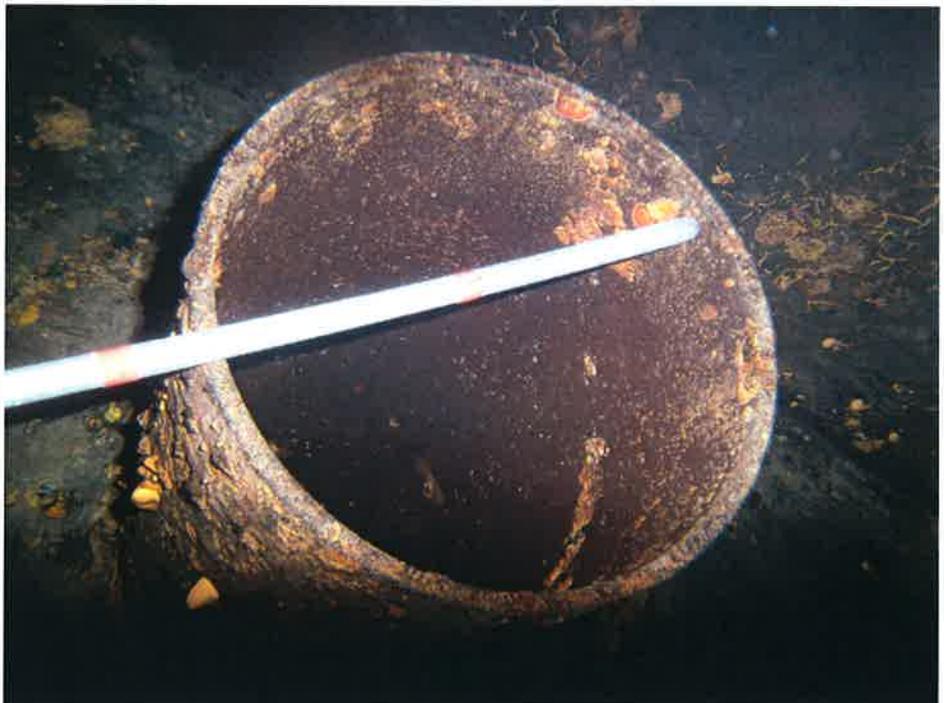
Image #28

Outlet 10:15

Condition:
Rust Grade¹ 4.

Description:
10" Outlet appeared to be in fair condition with a moderate amount of corrosion.

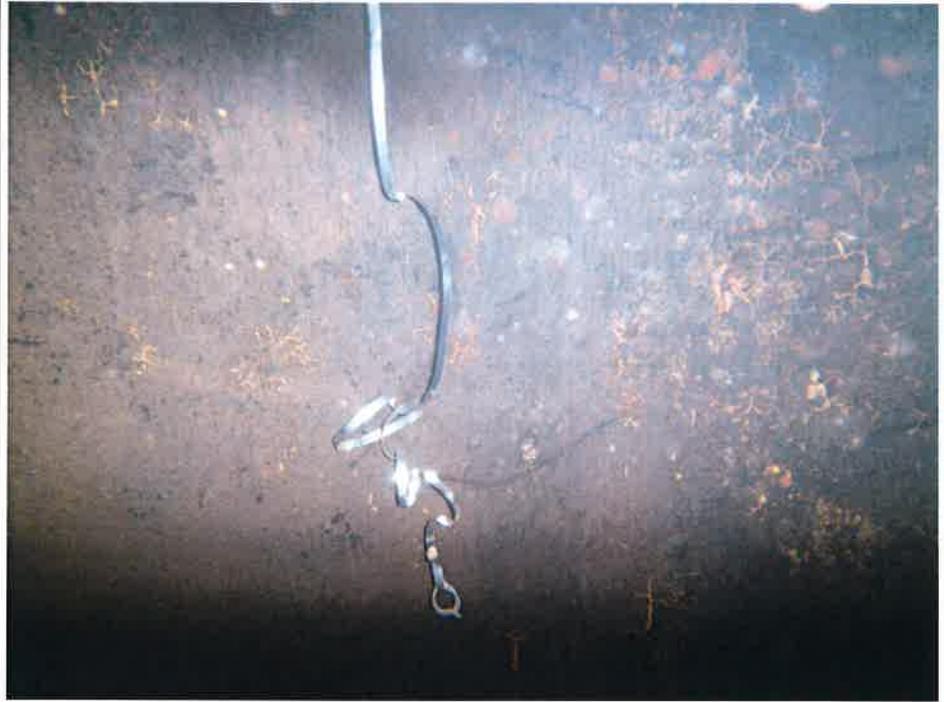
Image #29

Abandoned Telemetry
10:30

Description:
Abandoned Telemetry appeared to be in poor condition with a heavy amount of corrosion.

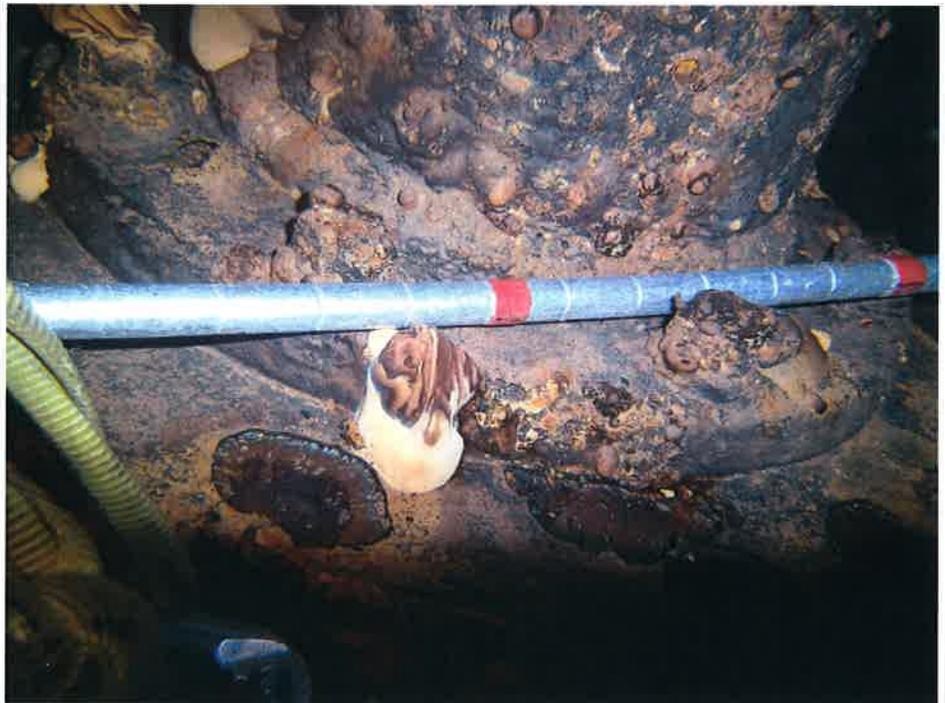
Image #30

Column Center

Condition:
Rust Grade 3.

Description:
10" Column appeared to be in fair condition with a heavy amount of corrosion.

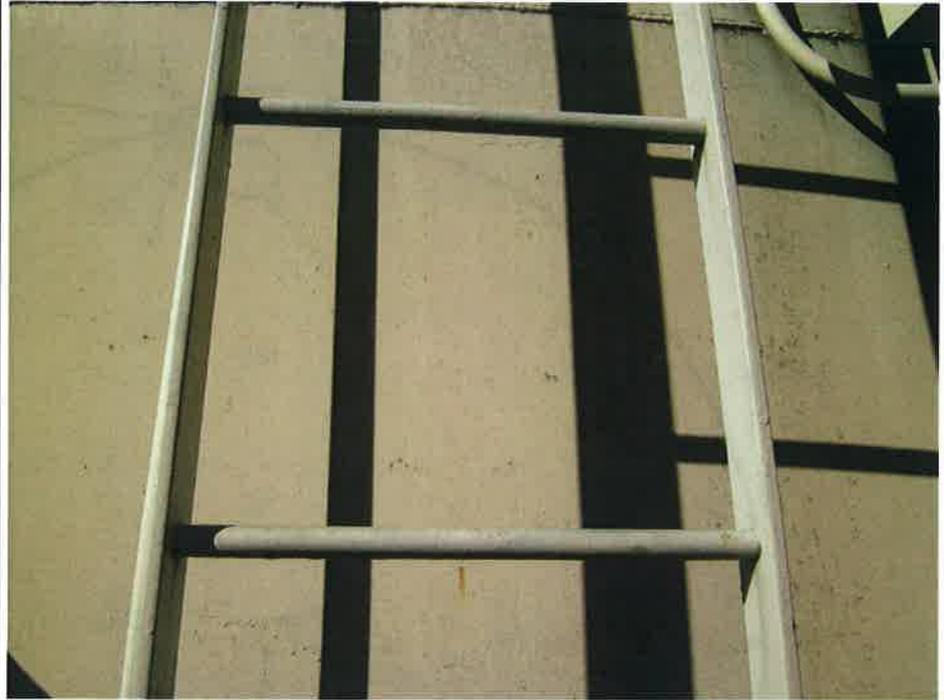
Condition:
Rust Grade¹ 9.

Description:
Exterior Ladder appeared to be in good condition with a minor amount of corrosion.

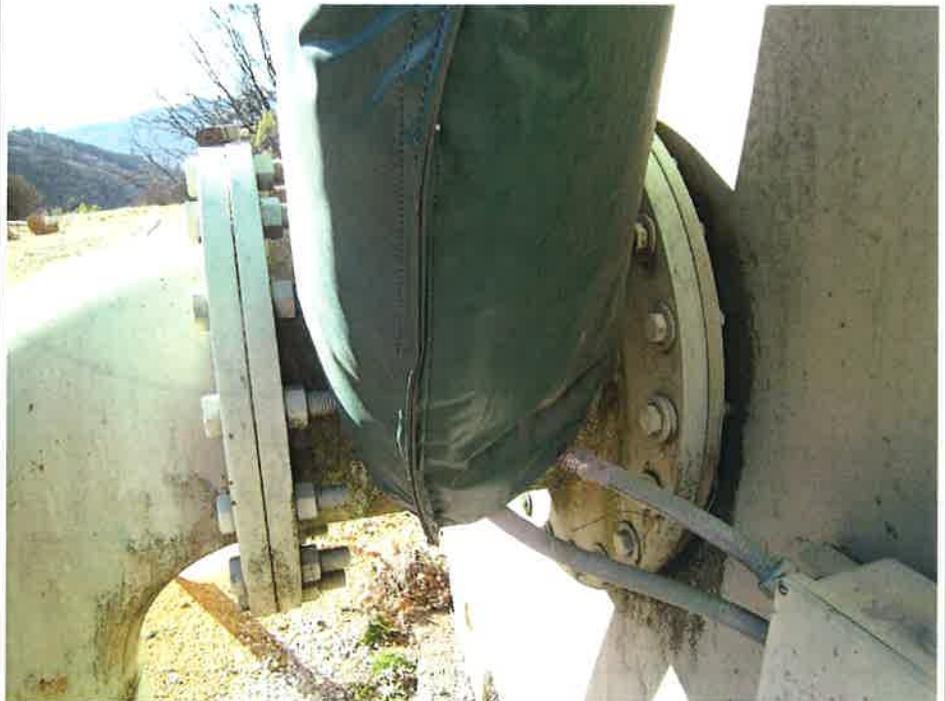
Image #2

Inlet 12:05

Condition:
Rust Grade¹ 9.

Description:
16" Inlet appeared to be in good condition with a minor amount of corrosion.

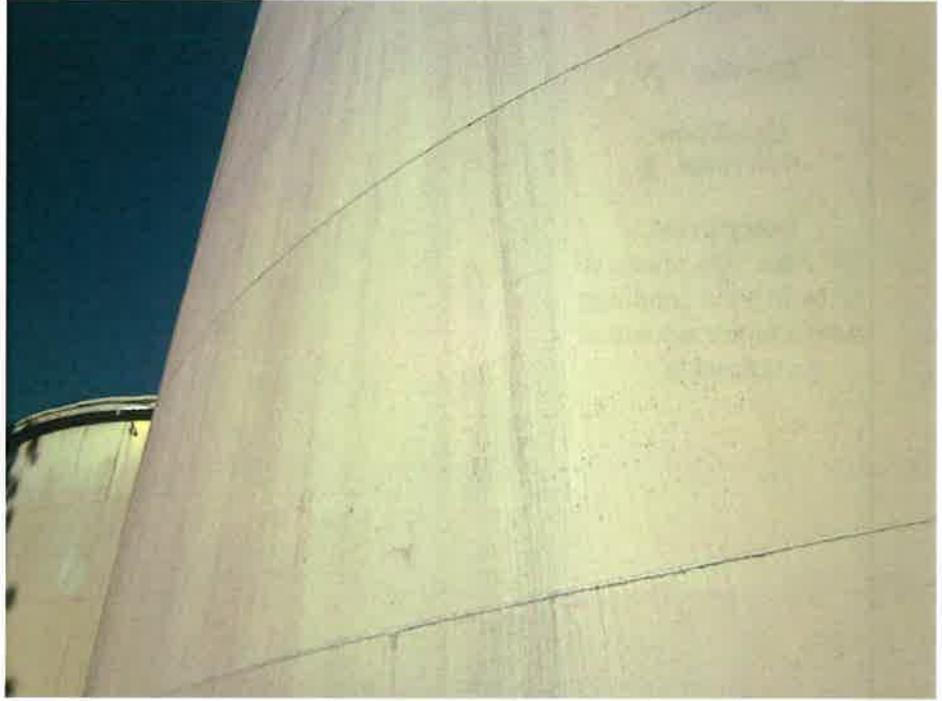
Image #3

Condition:
Rust Grade¹ 9.

Description:
Exterior Wall
appeared to be in good
condition with a minor
amount of corrosion.

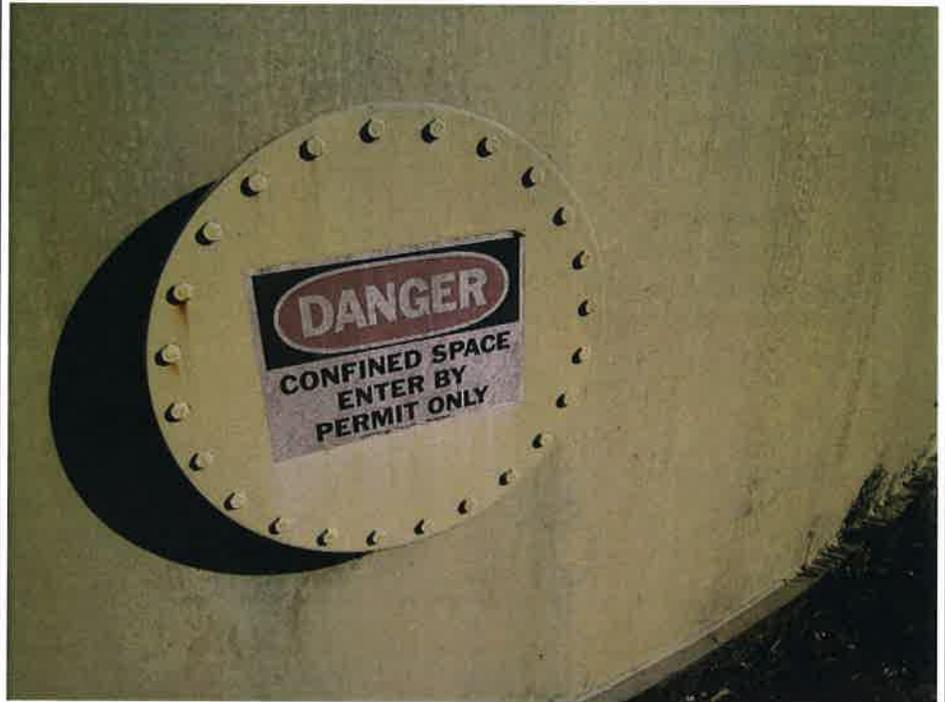
Image #5

Condition:
Rust Grade! 9.

Description:
24" Man Way appeared to be in good condition with a minor amount of corrosion.

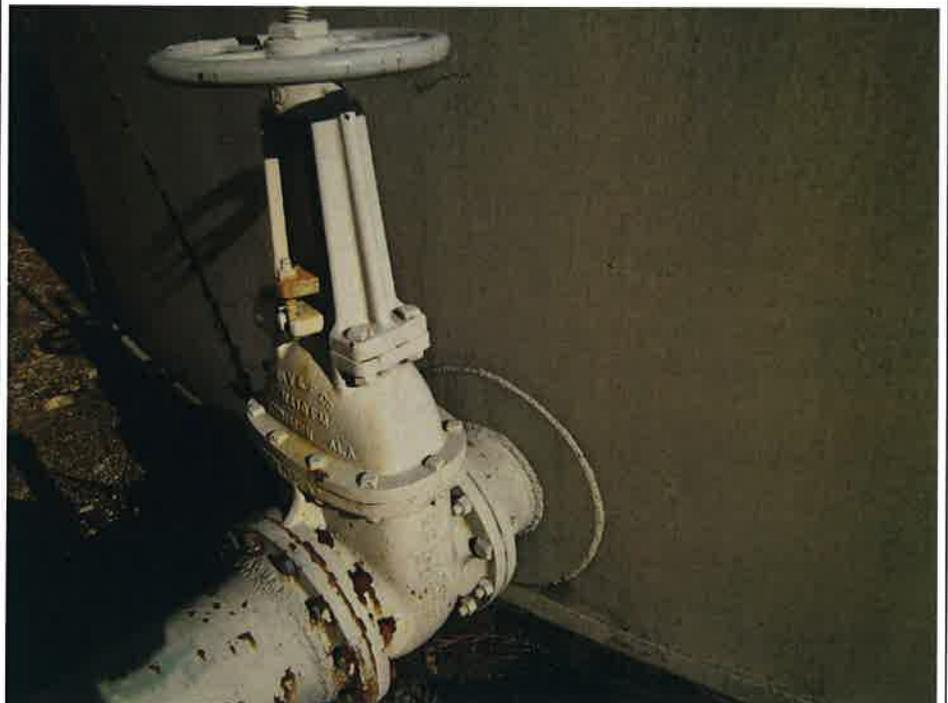
Image #6

Outlet to Bureau 5:00

Condition:
Rust Grade! 8.

Description:
Outlet to Bureau appeared to be in good condition with a minor amount of corrosion.

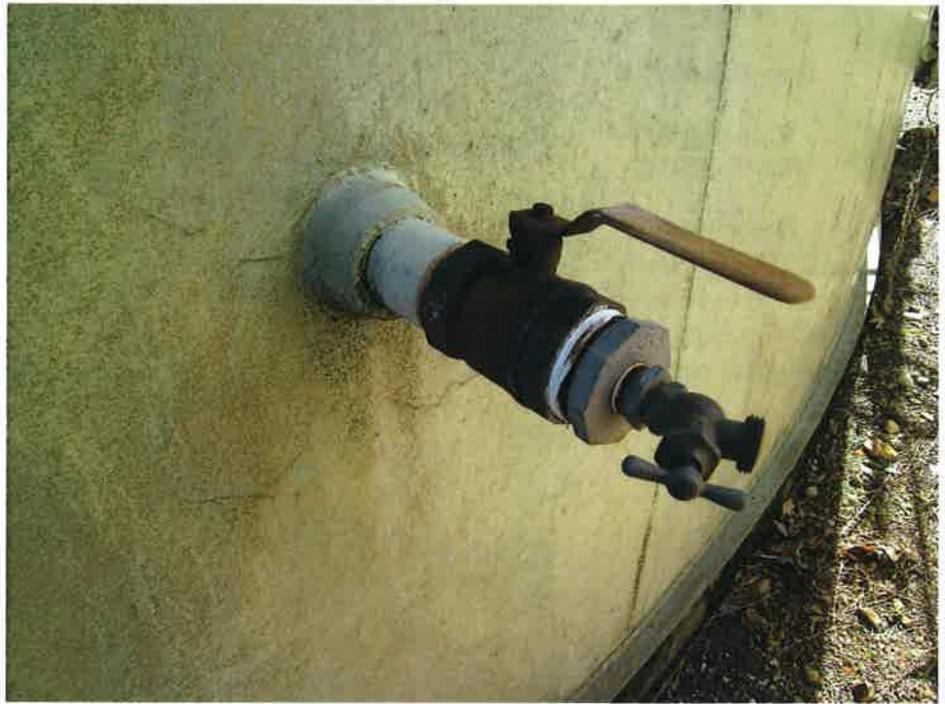
Image #7

Condition:
Rust Grade¹ 8.

Description:
2" Water Tap appeared to be in good condition with a minor amount of corrosion.

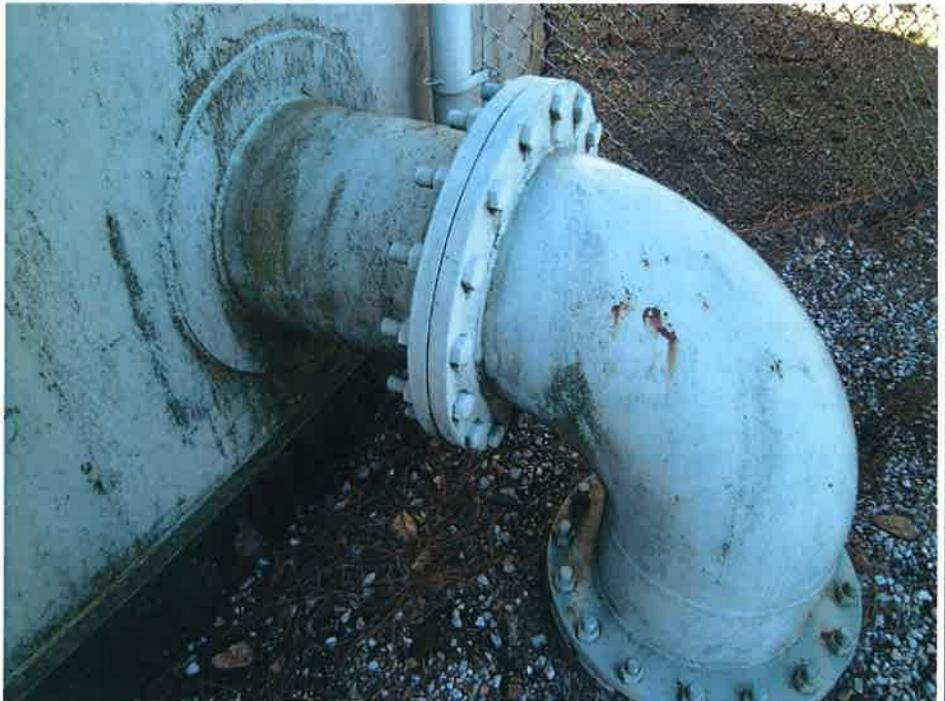
Image #8

Outlet 8:00

Condition:
Rust Grade¹ 9.

Description:
18" Outlet appeared to be in good condition with a minor amount of corrosion.

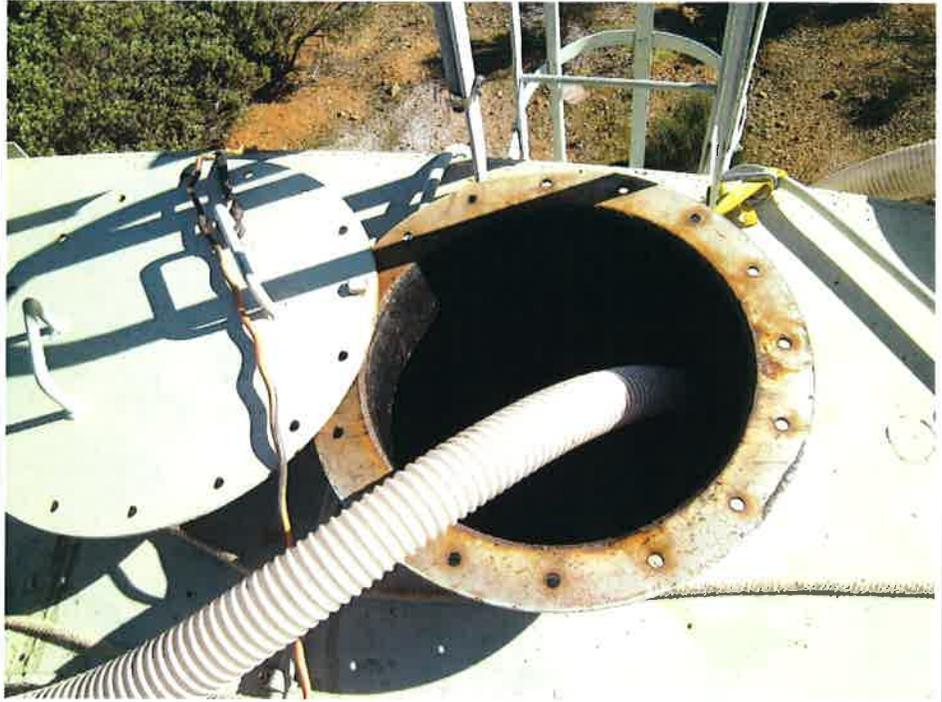
Image #9

Condition:
Rust Grade! 8.

Description:
20" Entry Hatch
appeared to be in good
condition with a minor
amount of corrosion.

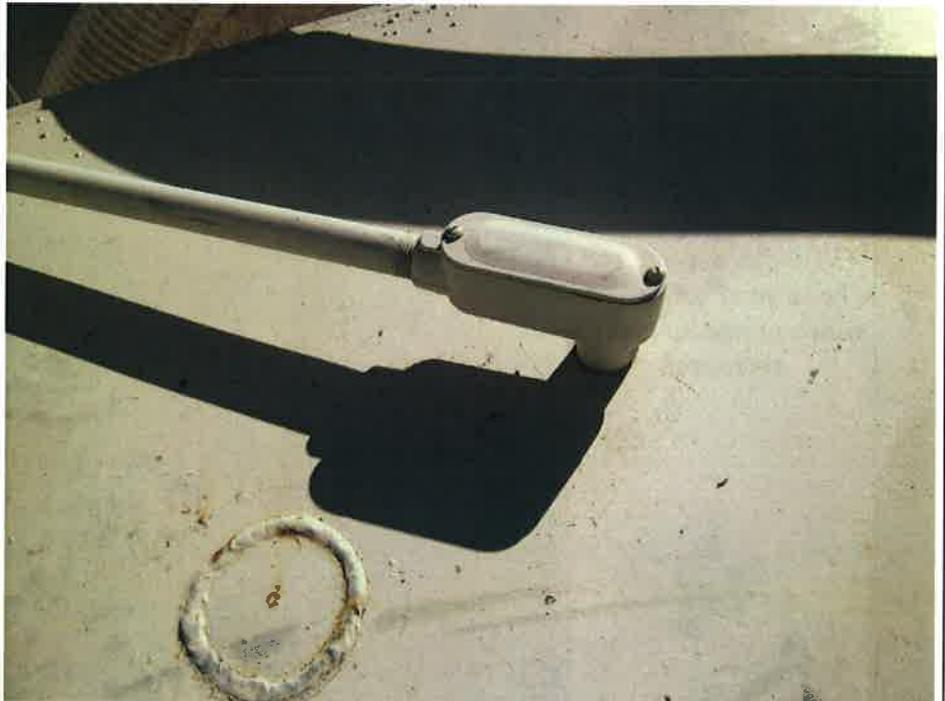
Image #10

Telemetry Penetration
12:05

Condition:
Rust Grade! 9.

Description:
1" Telemetry
Penetration appeared to
be in good condition
with a minor amount of
corrosion.

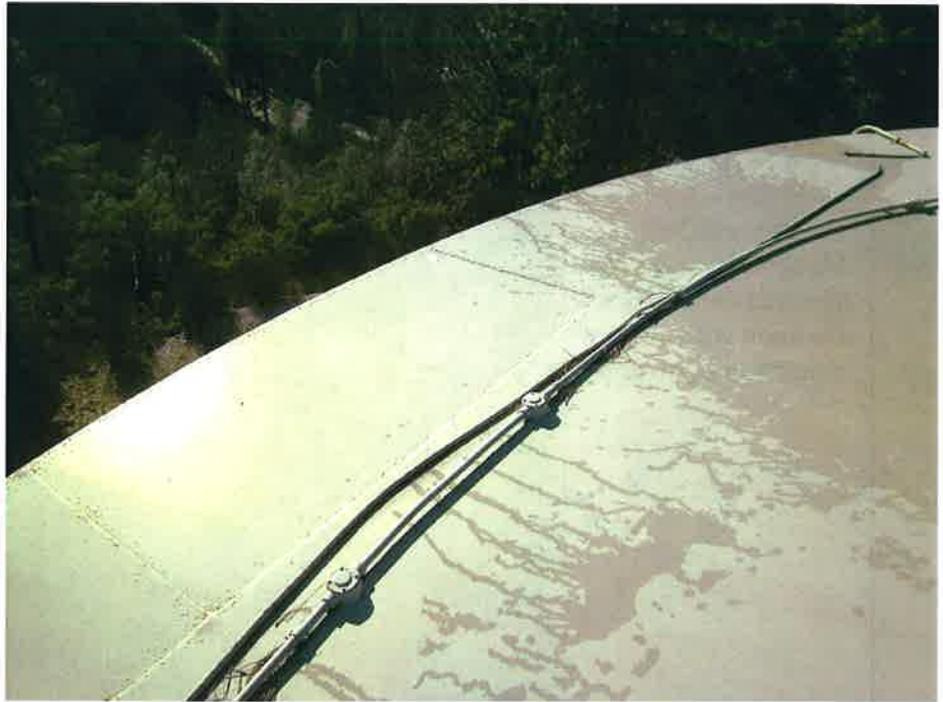
Image #11

Condition:
Rust Grade¹ 9.

Description:
Roof appeared to be in condition with a minor amount of corrosion.

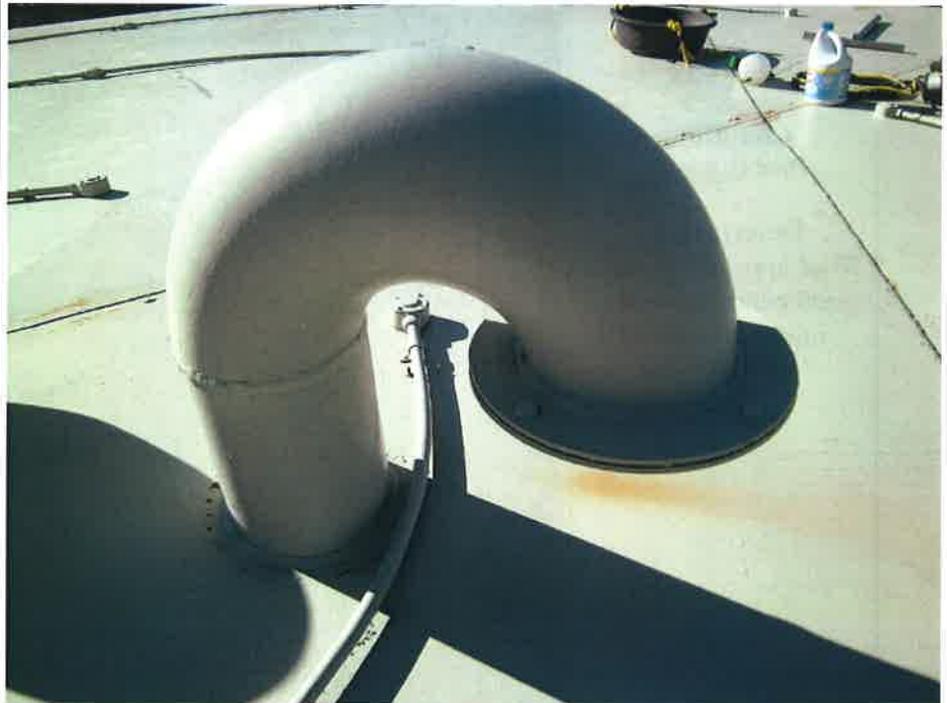
Image #12

Center Vent

Condition:
Rust Grade¹ 9.

Description:
8" Vent appeared to be in good condition with a minor amount of corrosion.

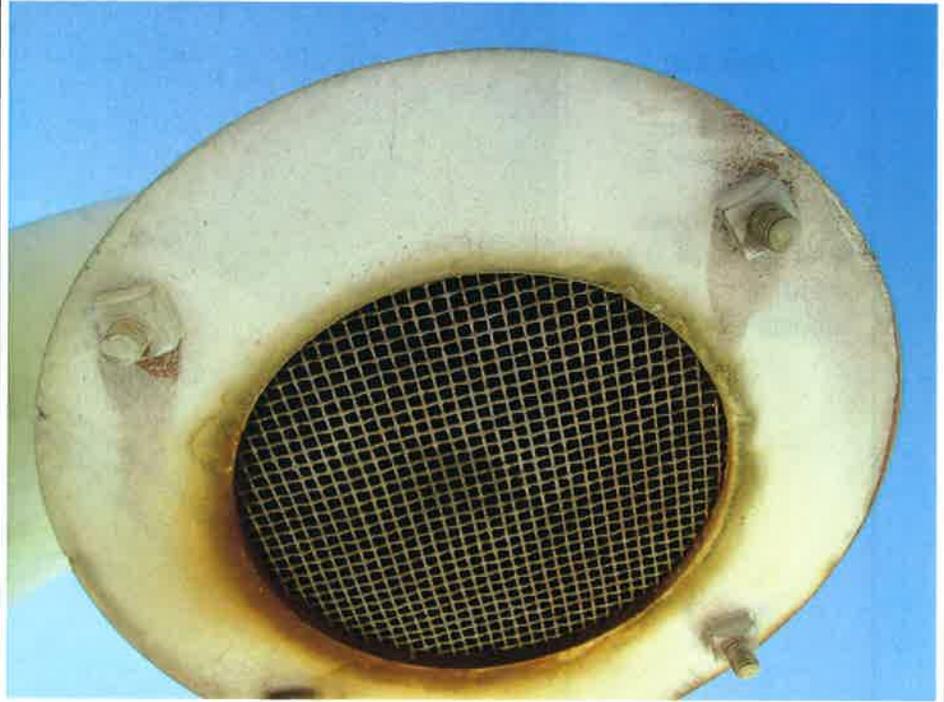
Image #13

Condition:
Rust Grade! 9.

Description:
Medium Vent Screen appeared to be in good condition with a minor amount of corrosion.

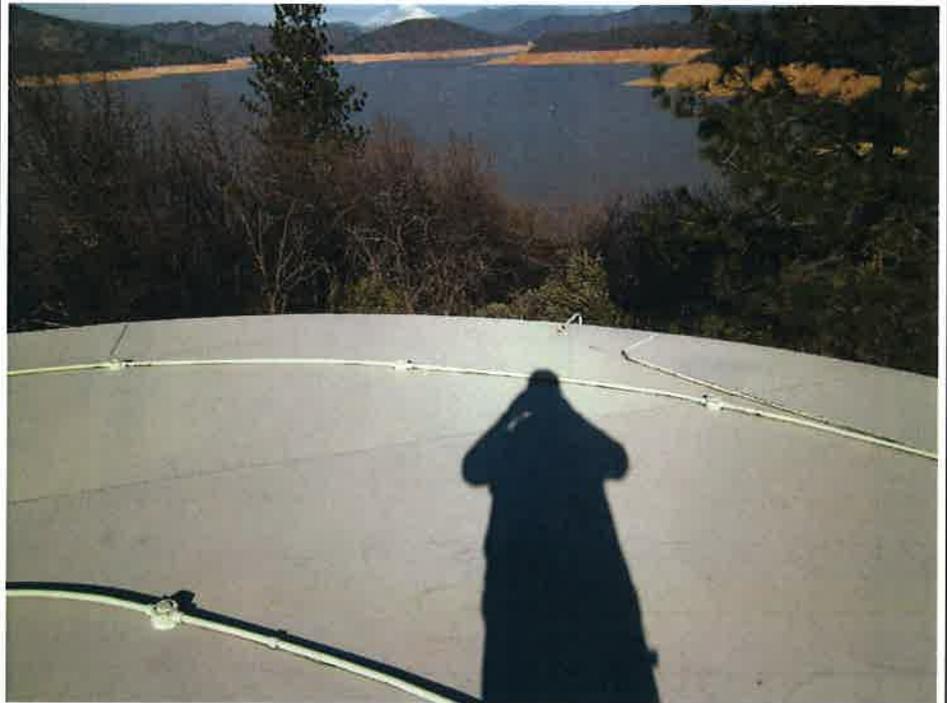
Image #14

Roof 9:00

Condition:
Rust Grade! 9.

Description:
Roof appeared to be in good condition with a minor amount of corrosion.

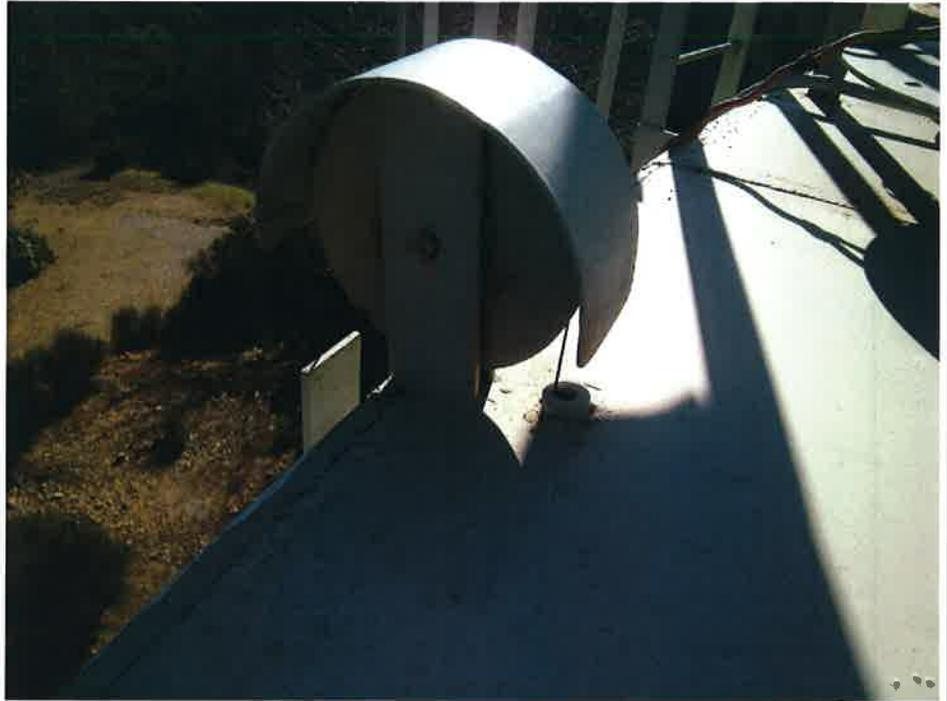
Image #15

Condition:
Rust Grade¹ 9.

Description:
1" Liquid Level
Indicator Penetration
appeared to be in good
condition with a minor
amount of corrosion.

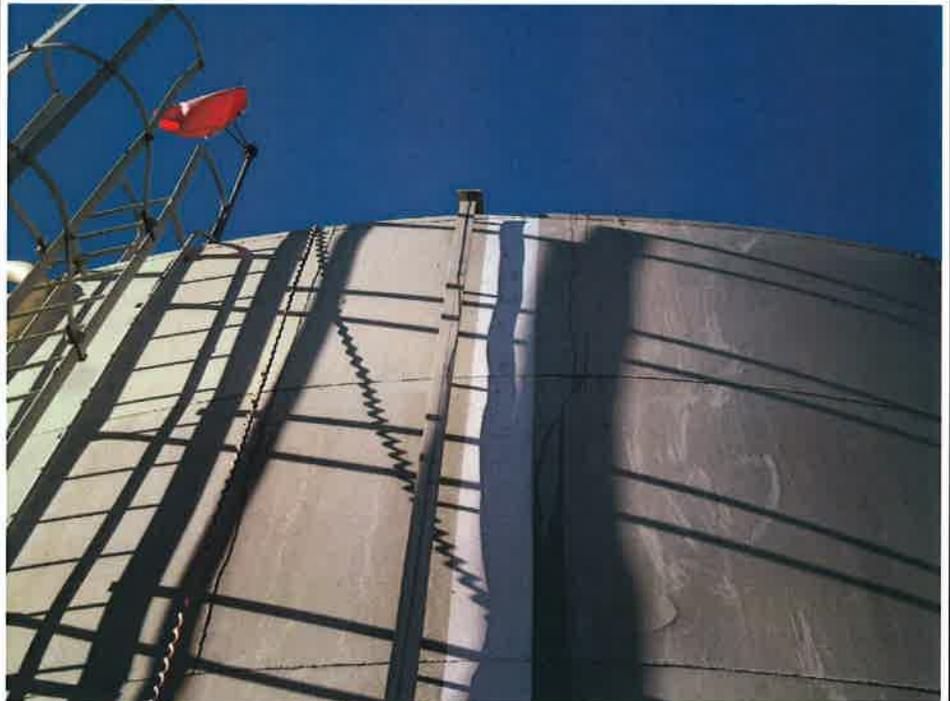
Image #16

*Liquid Level Indicator
Reader Board 11:55*

Condition:
Rust Grade¹ 9.

Description:
Liquid Level Indicator
Reader Board appeared
to be in good working
condition with a minor
amount of corrosion.

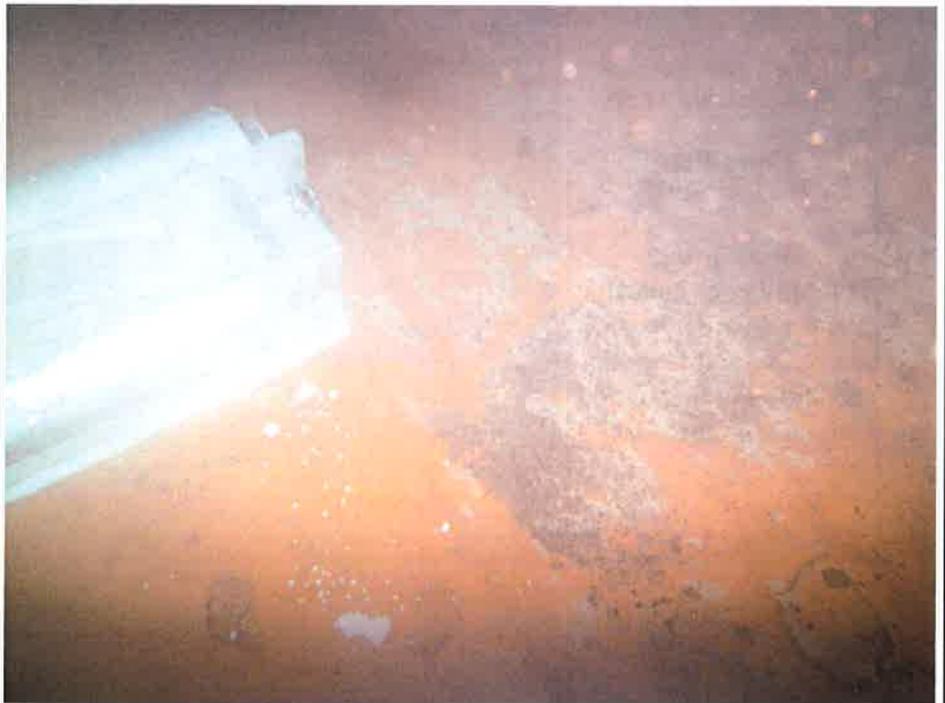
Image #18

Sediment

A heavy amount of rust scale and debris was removed from reservoir floor.

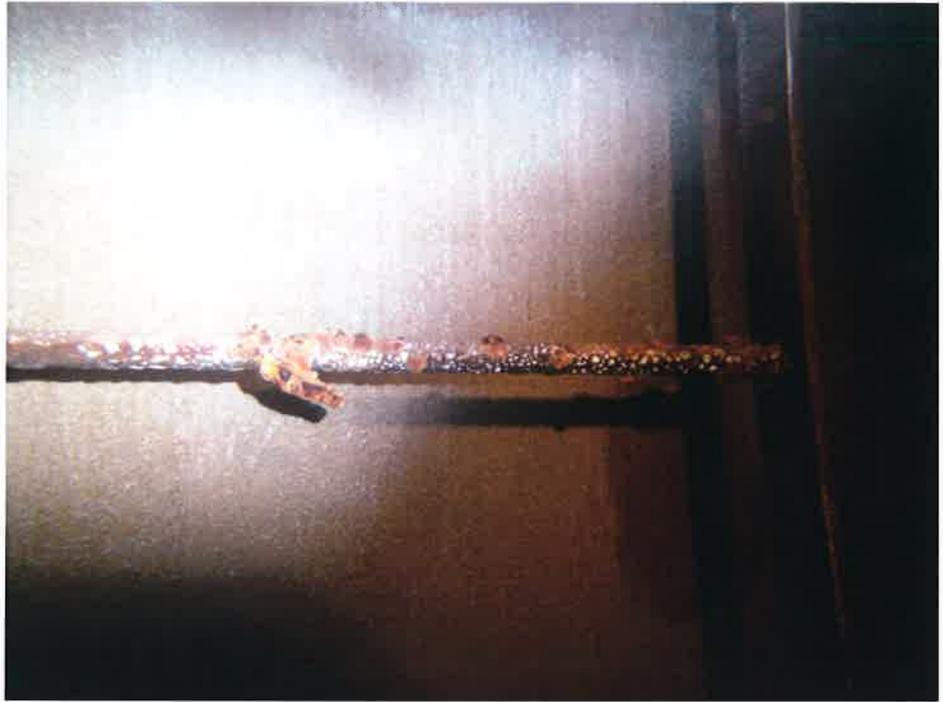
Image #19

Condition:
Rust Grade¹ 6.

Description:
Interior Ladder appeared to be in fair condition with a minor amount of corrosion.

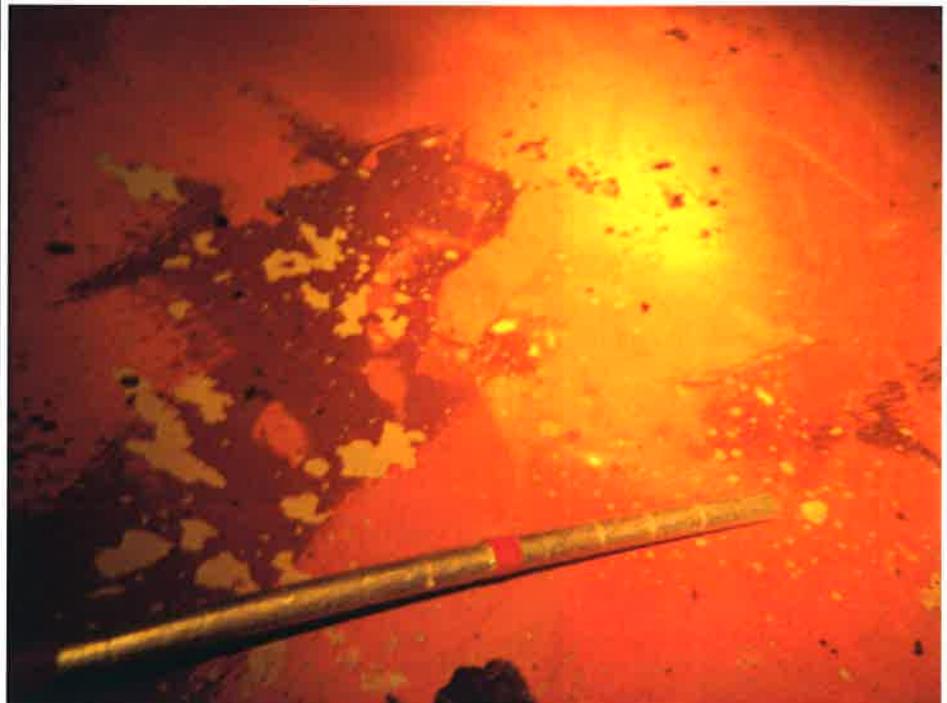
Image #20

Floor 12:00

Condition:
Rust Grade¹ 8.

Description:
Floor appeared to be in fair condition with a minor amount of corrosion.

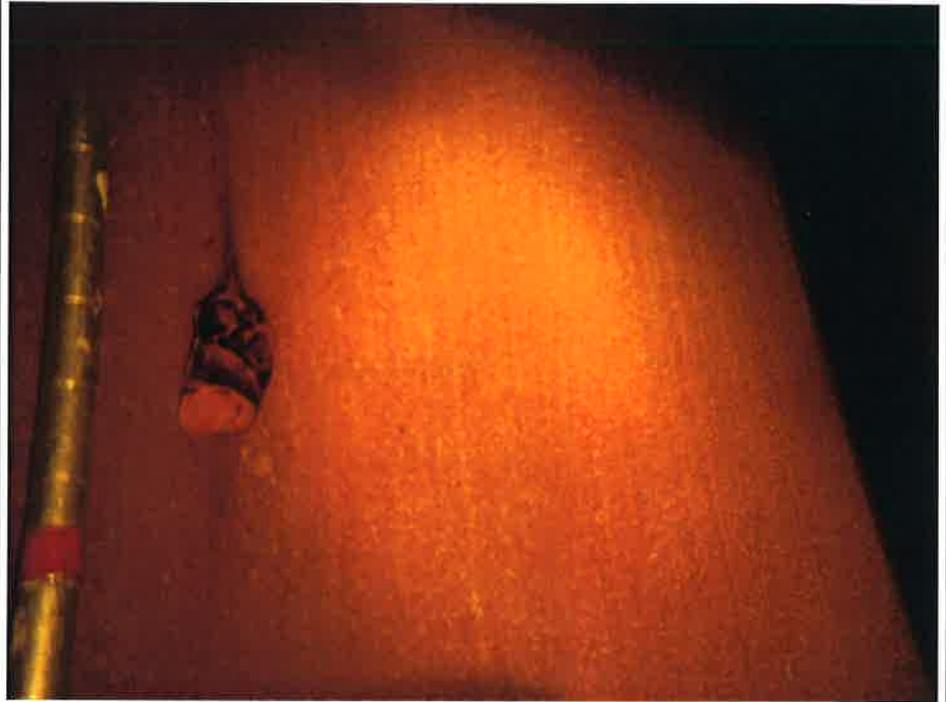
Image #21

Condition:
Rust Grade¹ 8.

Description:
Wall appeared to be in fair condition with a minor amount of corrosion.
