CITY OF SHASTA LAKE

2016-2026 WATER MASTER PLAN

FINAL • OCTOBER 2016

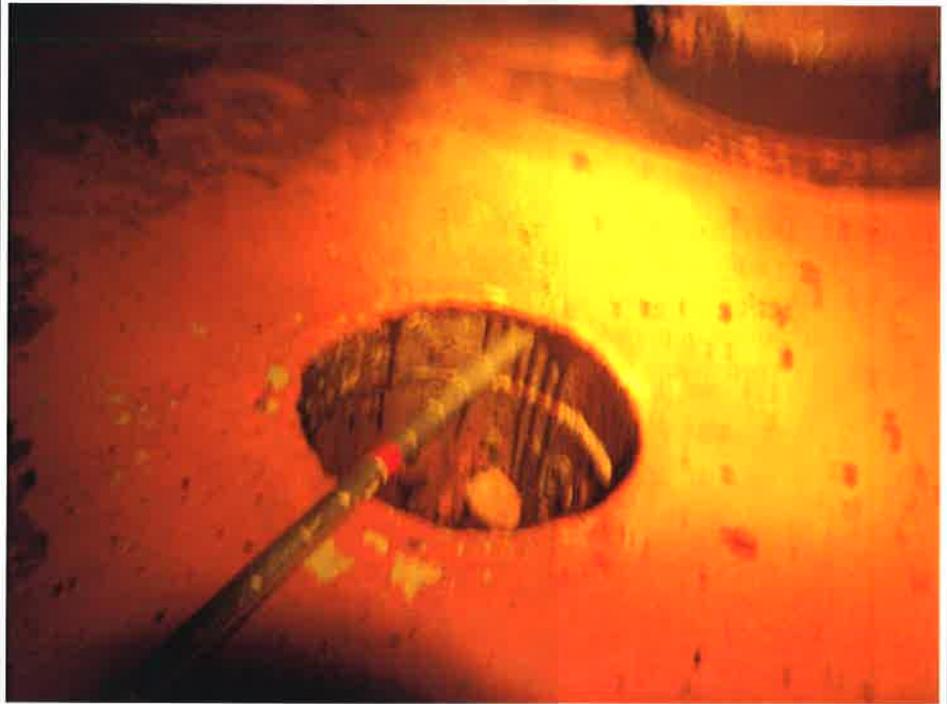
Condition:
Rust Grade' 8.

Description:
6" Drain appeared to be in good condition with a minor amount of corrosion.

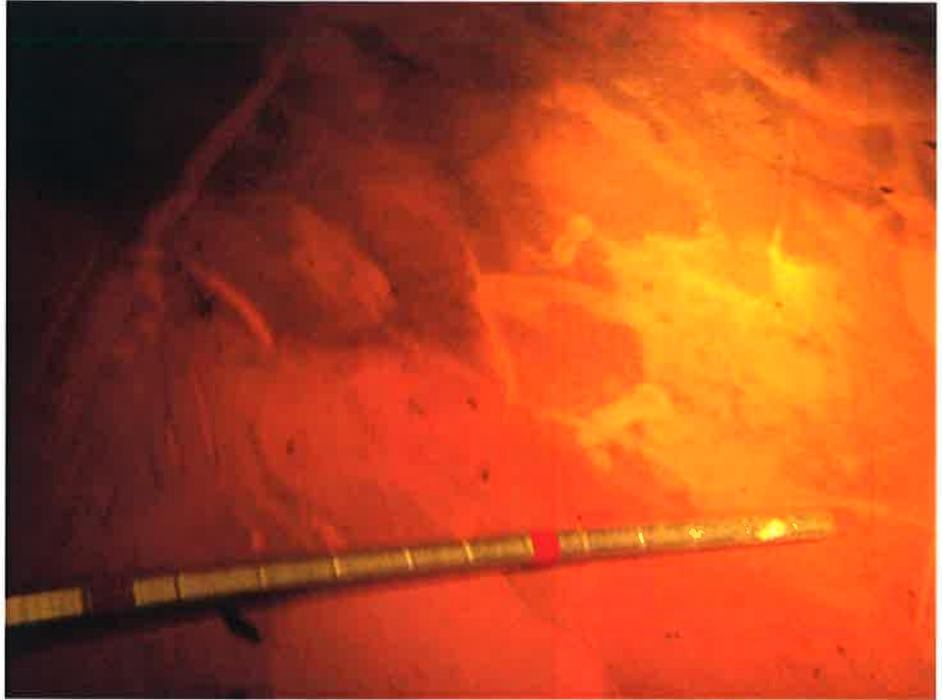
Condition:
Rust Grade¹ 8.

Description:
Floor appeared to be in fair condition with a minor amount of corrosion.

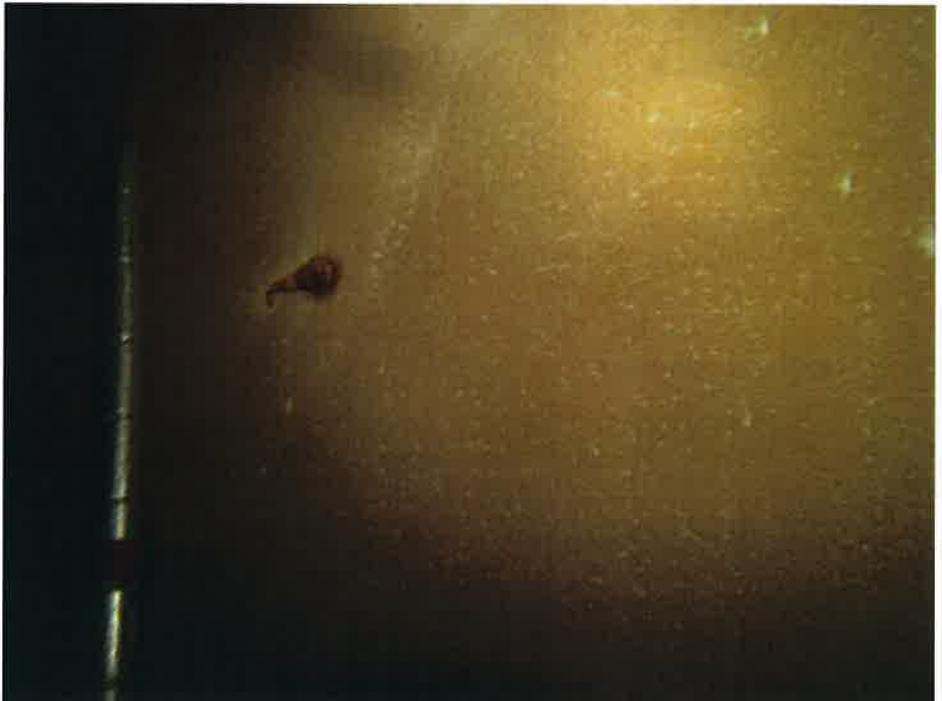
Image #26

Wall 3:00

Condition:
Rust Grade¹ 8.

Description:
Wall appeared to be in fair condition with a minor amount of corrosion.

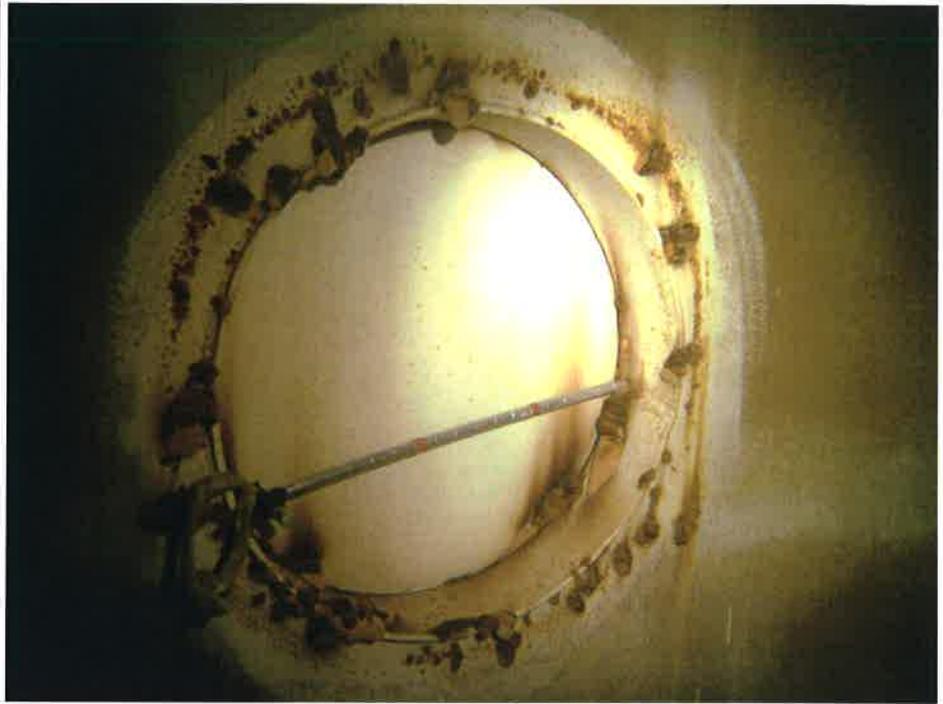
Image #27

Condition:
Rust Grade' 4.

Description:
Man Way appeared to be in fair condition with a moderate amount of corrosion.

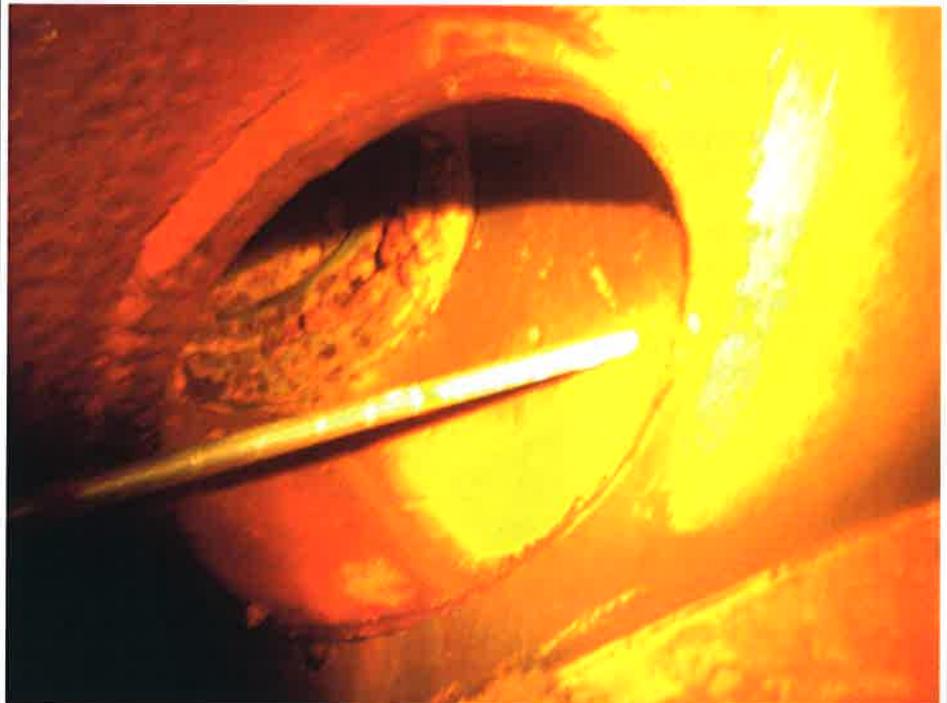
Image #28

Outlet to Bureau 5:00

Condition:
Rust Grade' 7.

Description:
10" Outlet to Bureau appeared to be in fair condition with a minor amount of corrosion.

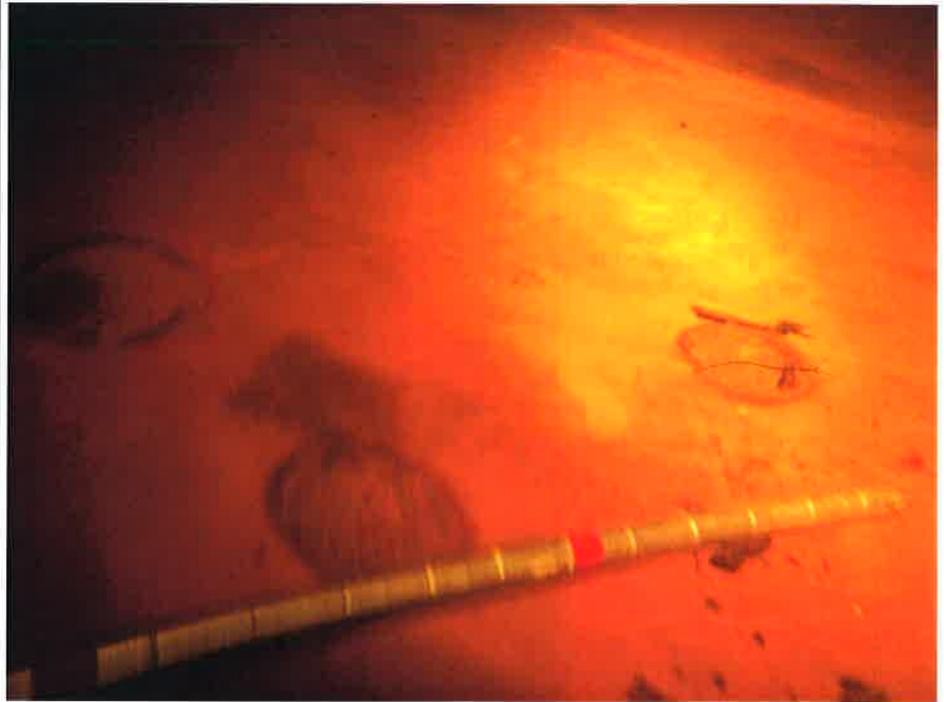
Image #29

Condition:
Rust Grade! 7.

Description:
Floor appeared to be in fair condition with a minor amount of corrosion.

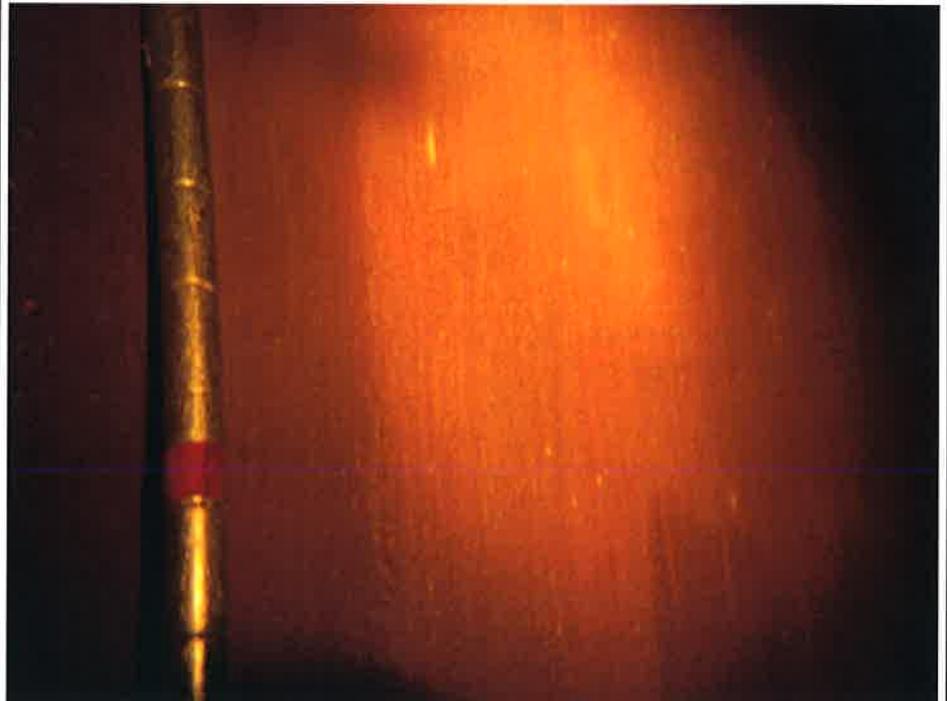
Image #30

Wall 6:00

Condition:
Rust Grade! 7.

Description:
Wall appeared to be in fair condition with a minor amount of corrosion.

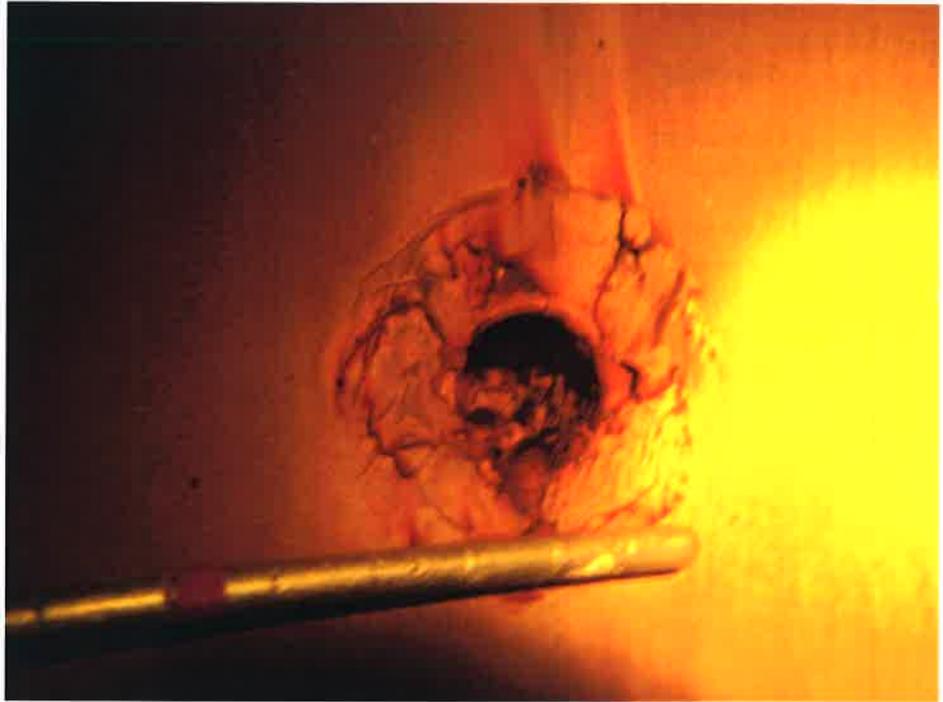
Condition:
Rust Grade' 0.

Description:
2" Water Tap appeared to be in poor condition with a heavy amount of corrosion.

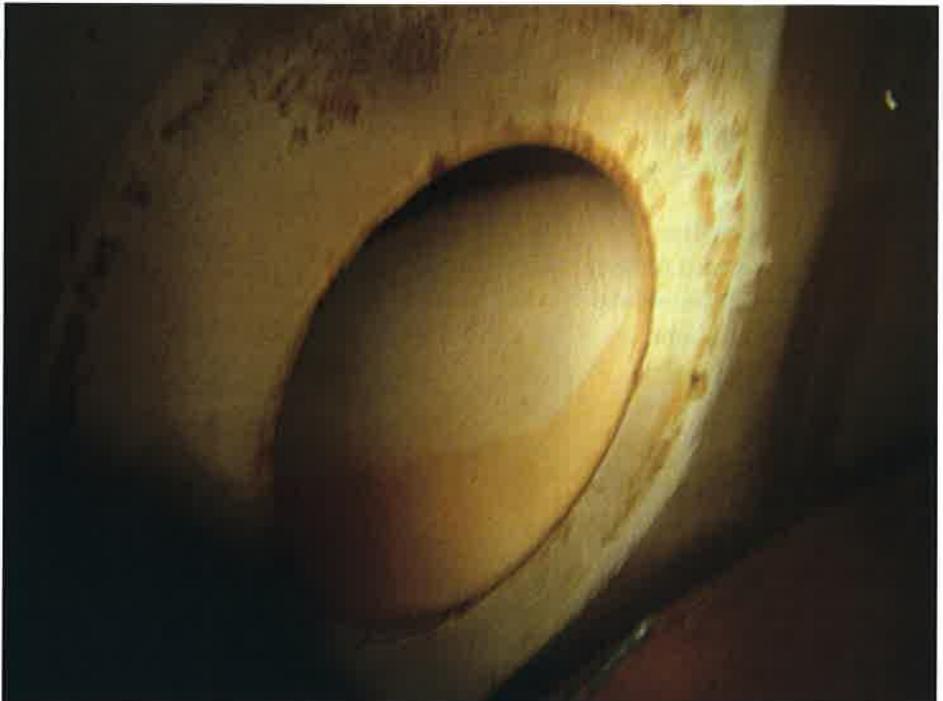
Image #32

Outlet 8:00

Condition:
Rust Grade' 7.

Description:
Outlet appeared to be in fair condition with a minor amount of corrosion.

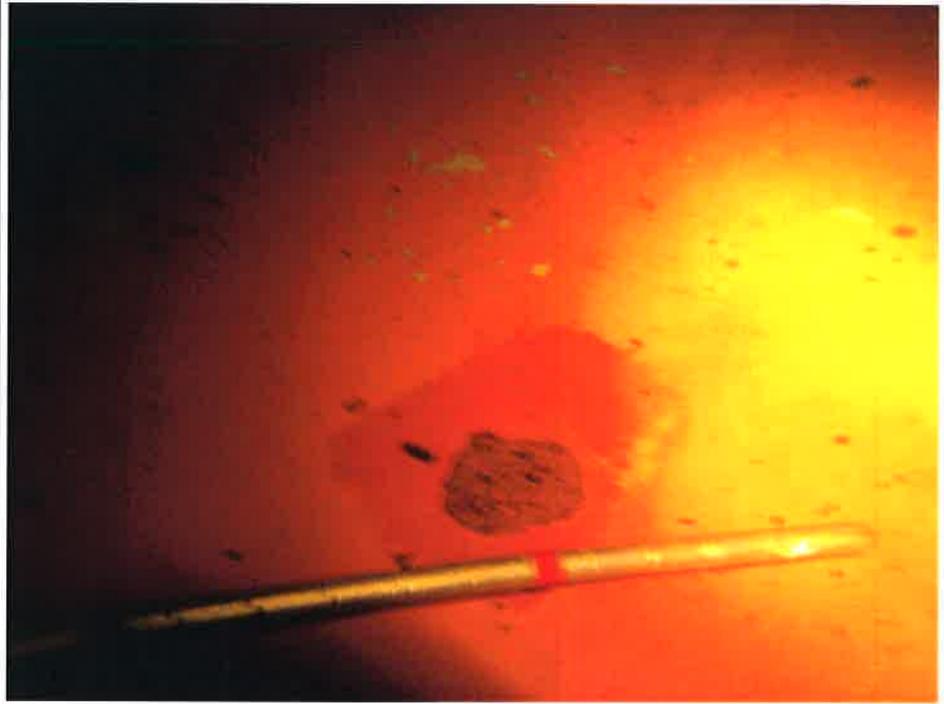
Image #33

Condition:
Rust Grade! 8.

Description:
Floor appeared to be in fair condition with a minor amount of corrosion.

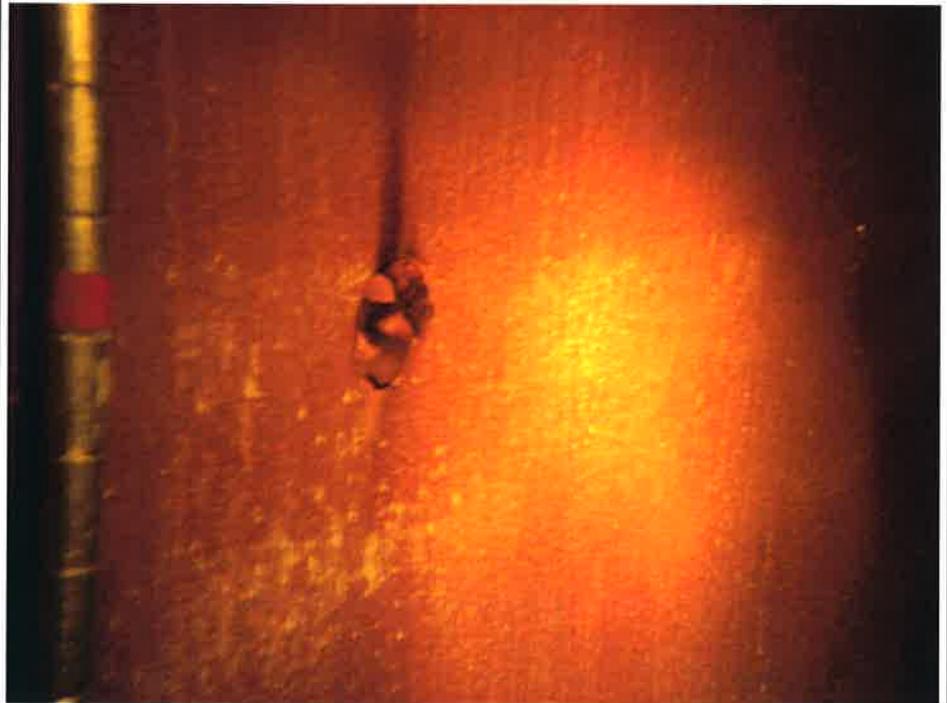
Image #34

Wall 9:00

Condition:
Rust Grade! 8.

Description:
Wall appeared to be in fair condition with a minor amount of corrosion.

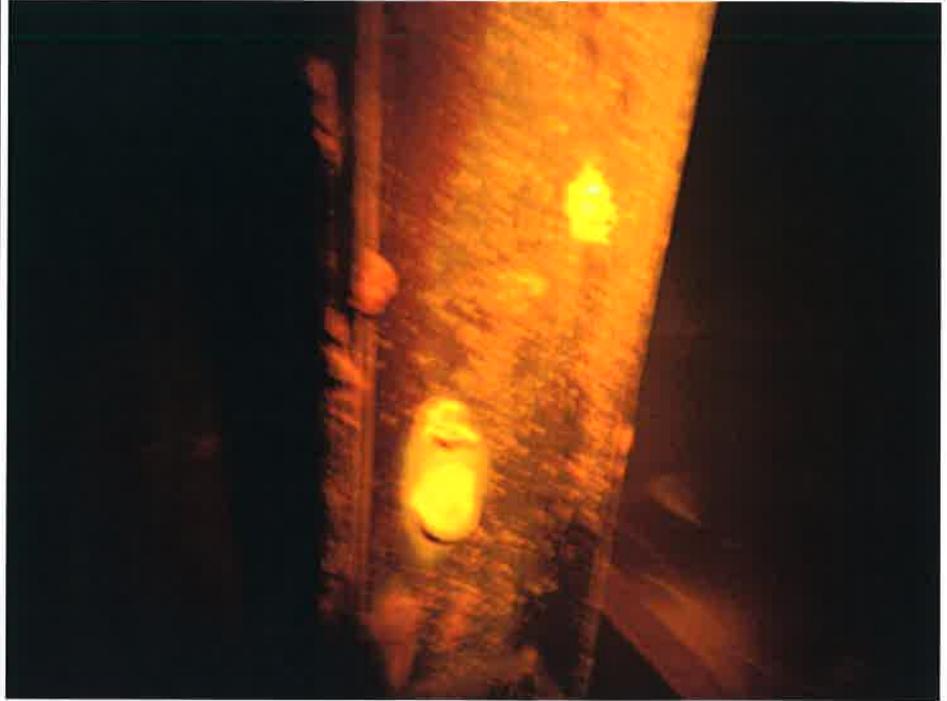
Image #35

Condition:
Rust Grade' 3.

Description:
8" Column appeared to be in fair condition with a heavy amount of corrosion.

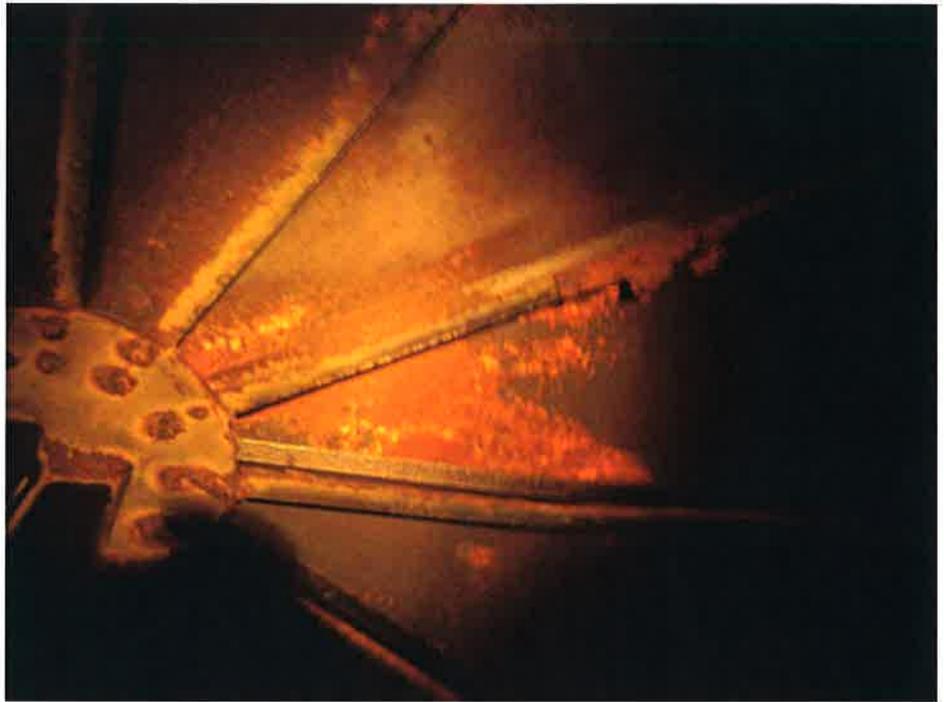
Condition:
Rust Grade' 2.

Description:
Ceiling appeared to be in poor condition with a heavy amount of corrosion.

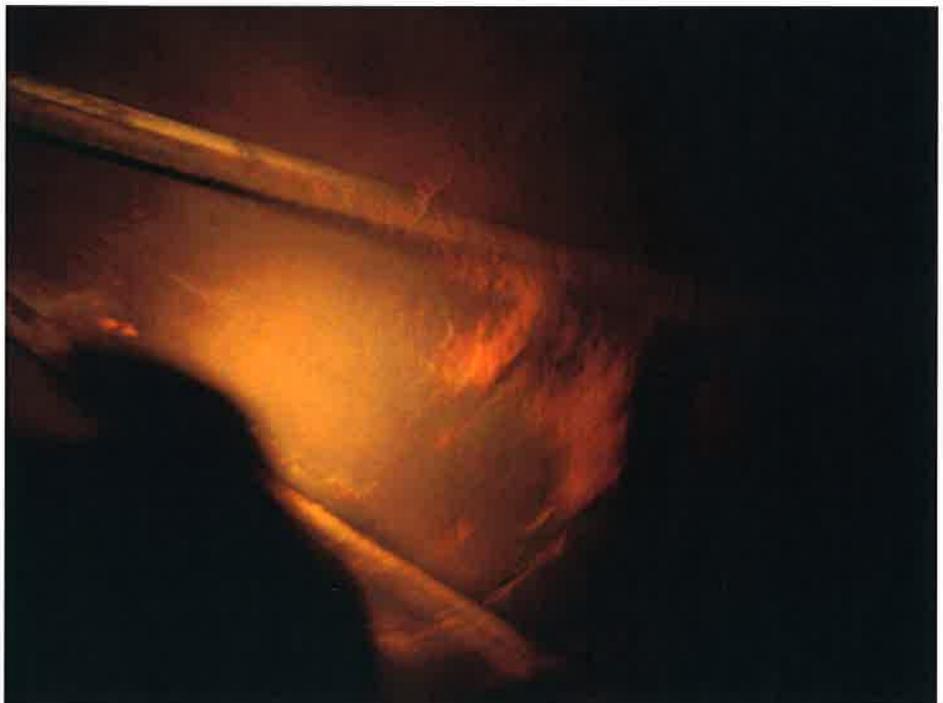
Image #38

Ceiling 6:00

Condition:
Rust Grade' 2.

Description:
Ceiling appeared to be in poor condition with a heavy amount of corrosion.

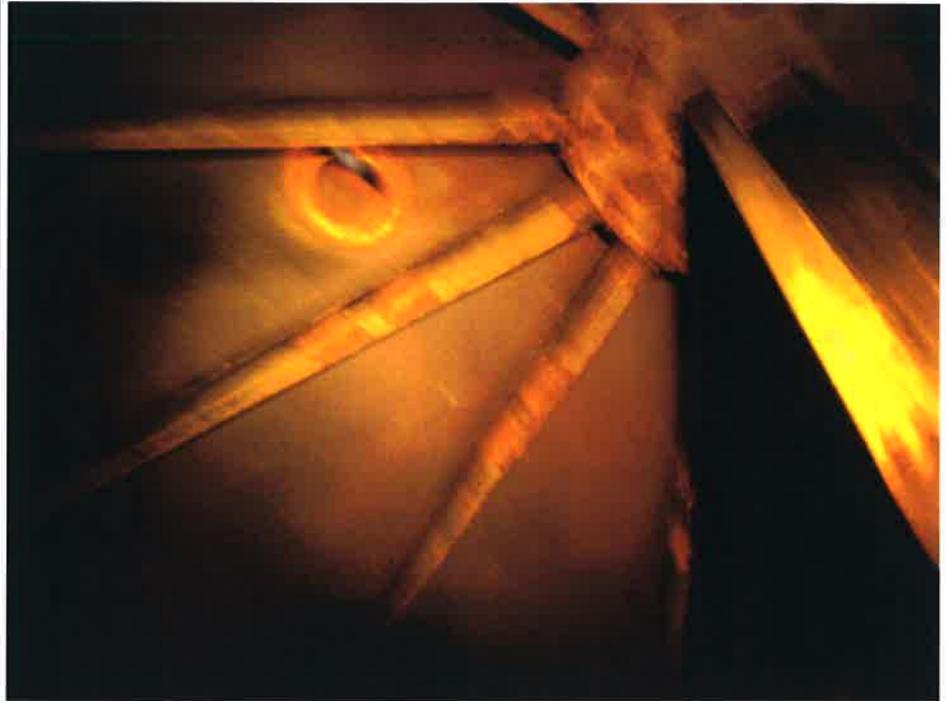
Image #39

Condition:
Rust Grade' 2.

Description:
Ceiling appeared to be in poor condition with a heavy amount of corrosion.

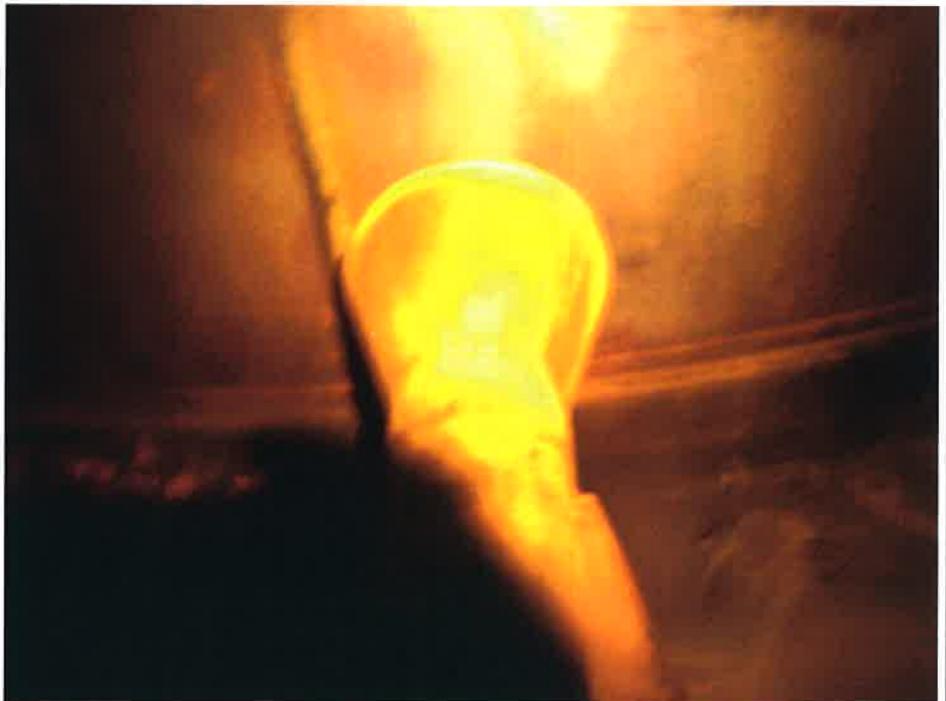
Image #40

Overflow Bell 2:05

Condition:
Rust Grade' 8.

Description:
16" Overflow Bell appeared to be in fair condition with a minor amount of corrosion.

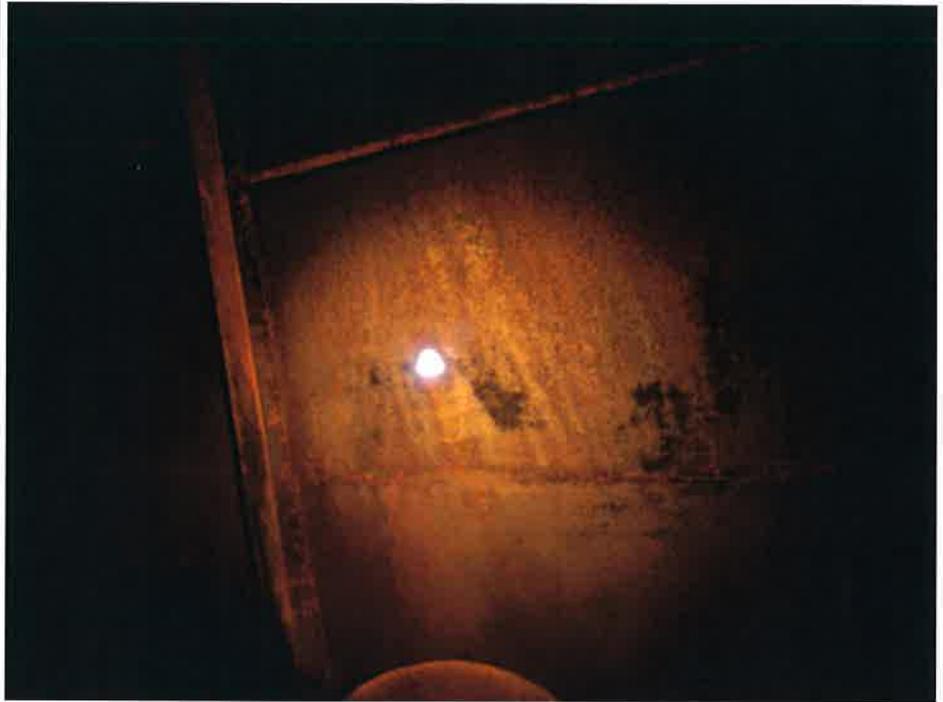
Image #41

Condition:
Rust Grade' 0.

Description:
2" Hole in ceiling was observed and should be patched immediately.

Recommendation	Estimated Time - Hrs.
Replace liquid level indicator float with a more durable stainless steel type float.	Please contact our sales office for an estimate.
Patch hole observed during interior inspection of ceiling located at 2:05, picture #41 immediately.	Please contact our sales office for an estimate.
Remove the existing interior coating and apply a new NSF approved epoxy type coating. The existing interior coating was in such disrepair that it would not be cost effective to attempt to patch all of the problem areas.	LiquiVision Technology does not perform this service.
Perform a regular cleaning, inspection and repair cycle every 2-3 years in order to ensure superior water quality and proper maintenance of coating condition and appurtenances is performed.	Please contact our sales office for an estimate.
Total Estimated Hours

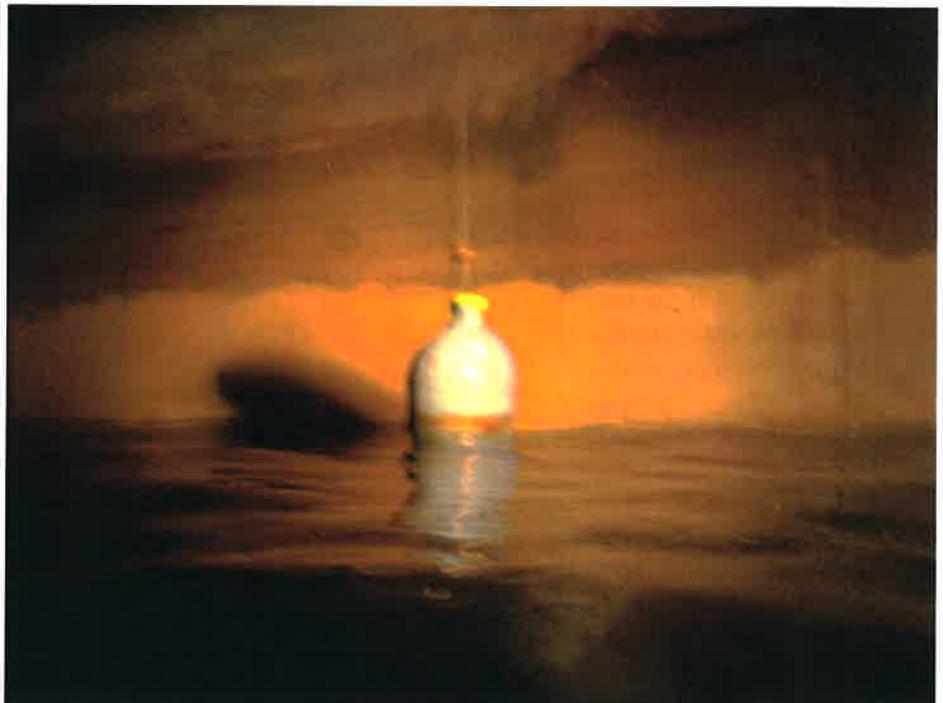
Image #42

*Liquid Level Indicator
Float 11:55*

Description:
Liquid Level Indicator
Float appeared to be in
fair condition and
suspended properly.

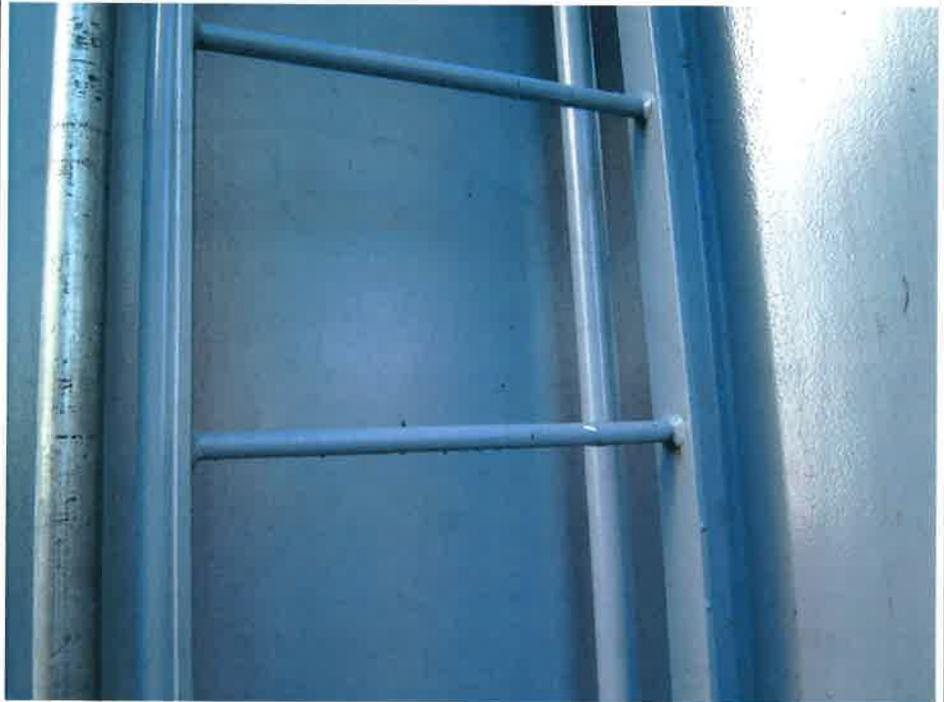
Condition:
Rust Grade¹ 9.

Description:
Exterior Ladder appeared to be in good condition with a minor amount of corrosion.

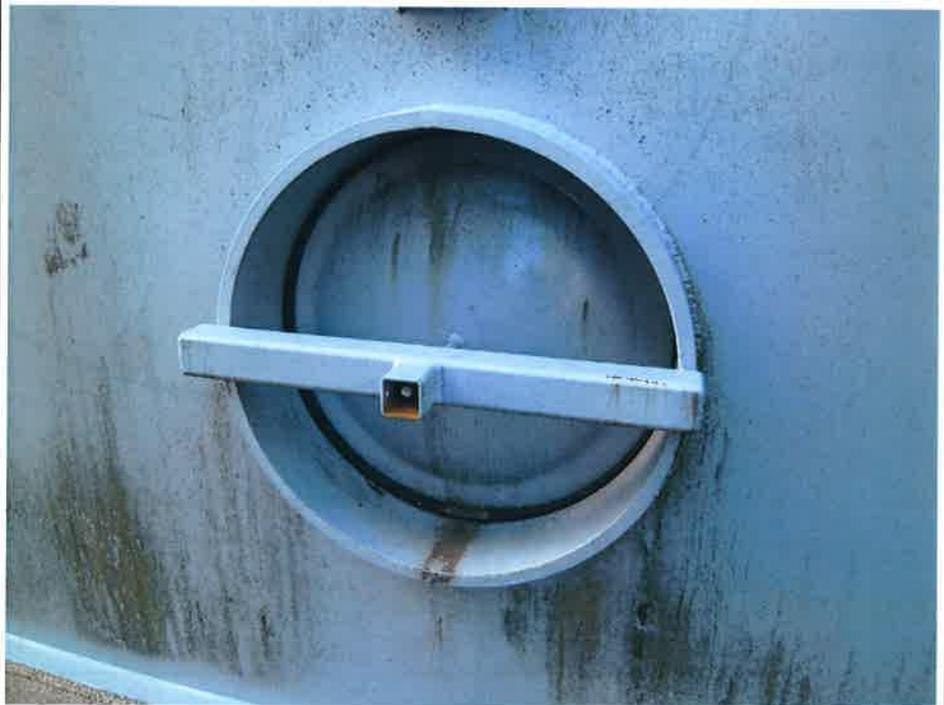
Image #2

Man Way 6:45

Condition:
Rust Grade¹ 9.

Description:
30" Man Way appeared to be in good condition with a minor amount of corrosion.

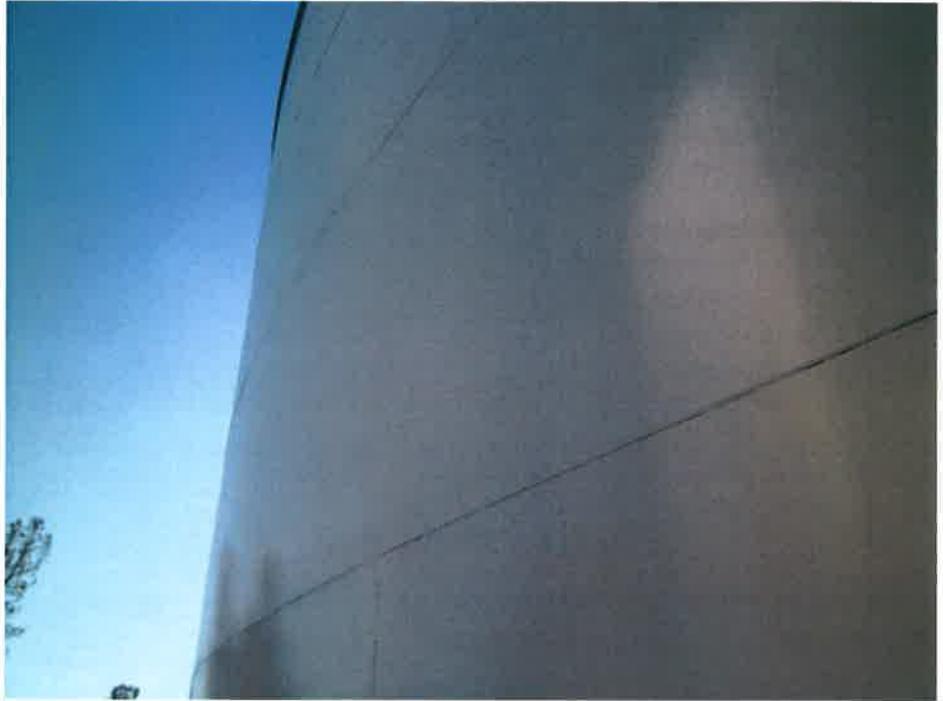
Image #3

Condition:
Rust Grade¹ 9.

Description:
Exterior Wall
appeared to be in good
condition with a minor
amount of corrosion.

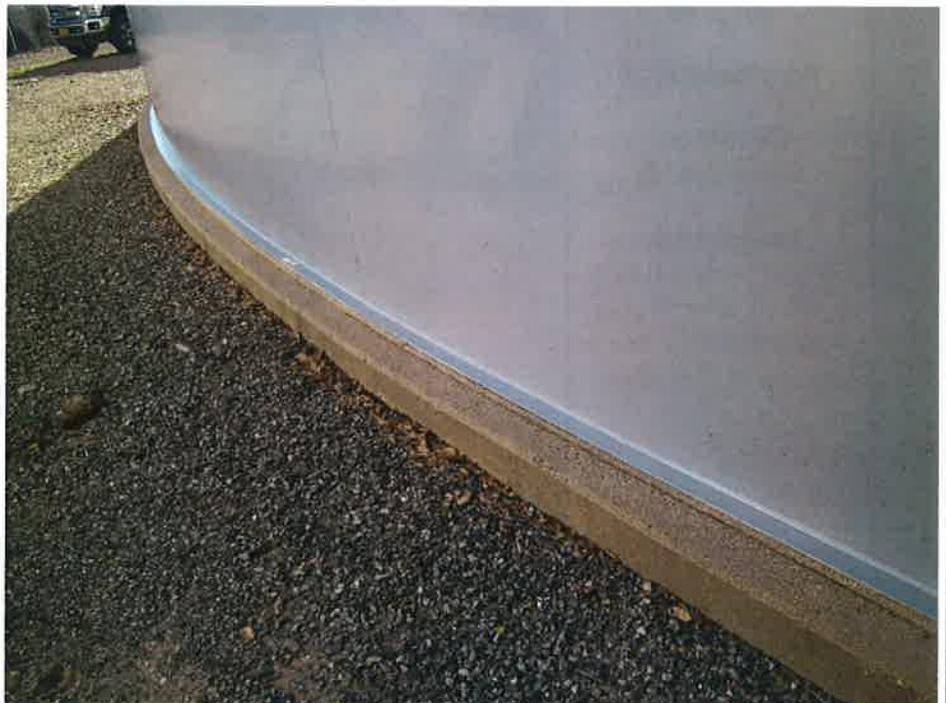
Image #4

Exterior Base 8:00

Condition:
Concrete Deform³ GC.

Description:
Exterior Base
appeared to be in good
condition with no
concrete problems.

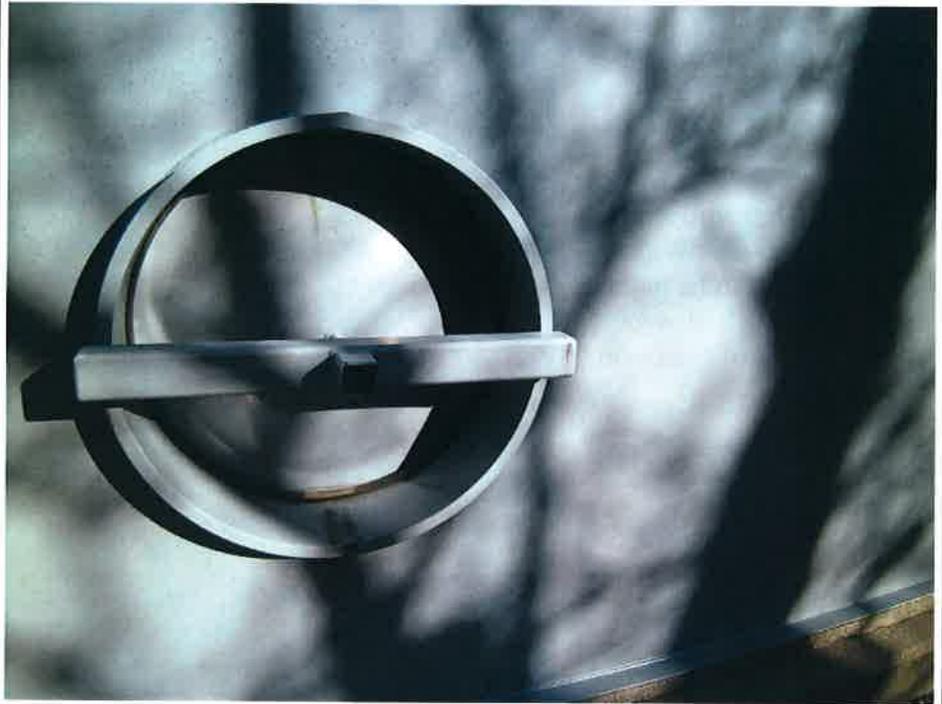
Image #5

Condition:
Rust Grade! 10.

Description:
30" Man Way appeared to be in good condition with no signs of corrosion.

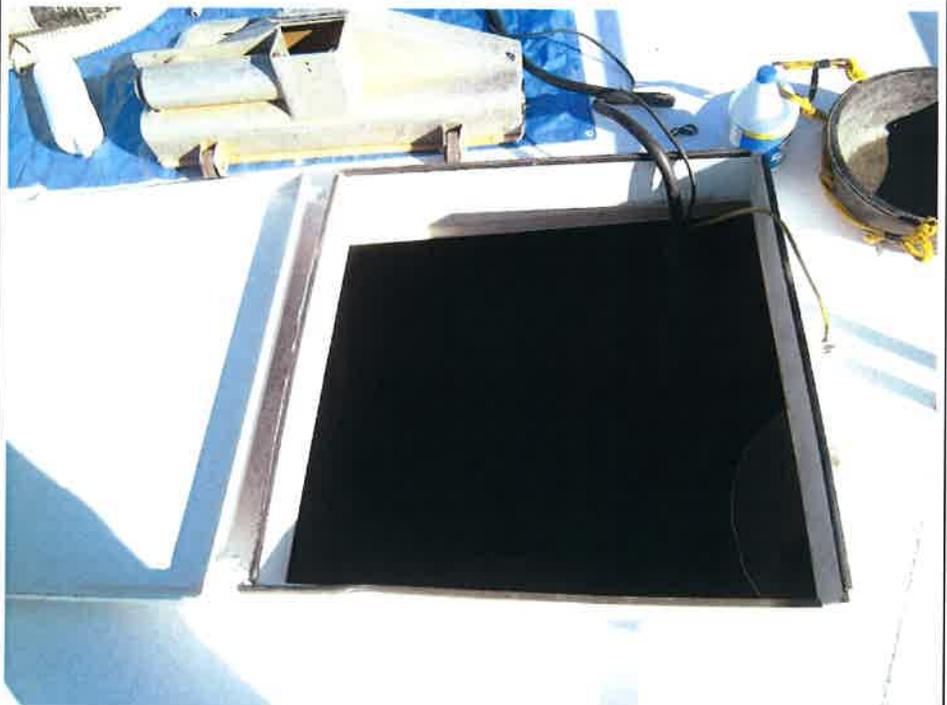
Image #6

Entry Hatch 12:00

Condition:
Rust Grade! 9.

Description:
36"x36" Entry Hatch appeared to be in good condition with a minor amount of corrosion.

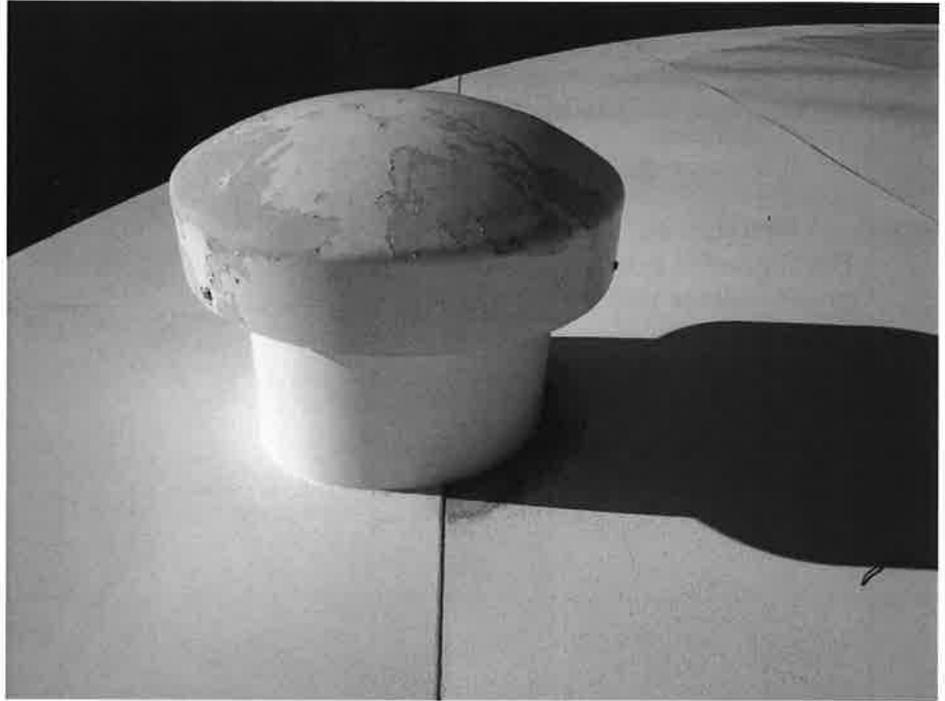
Image #7

Condition:
Rust Grade' 9.

Description:
24" Side Vent appeared to be in good condition with a minor amount of corrosion and delamination observed.

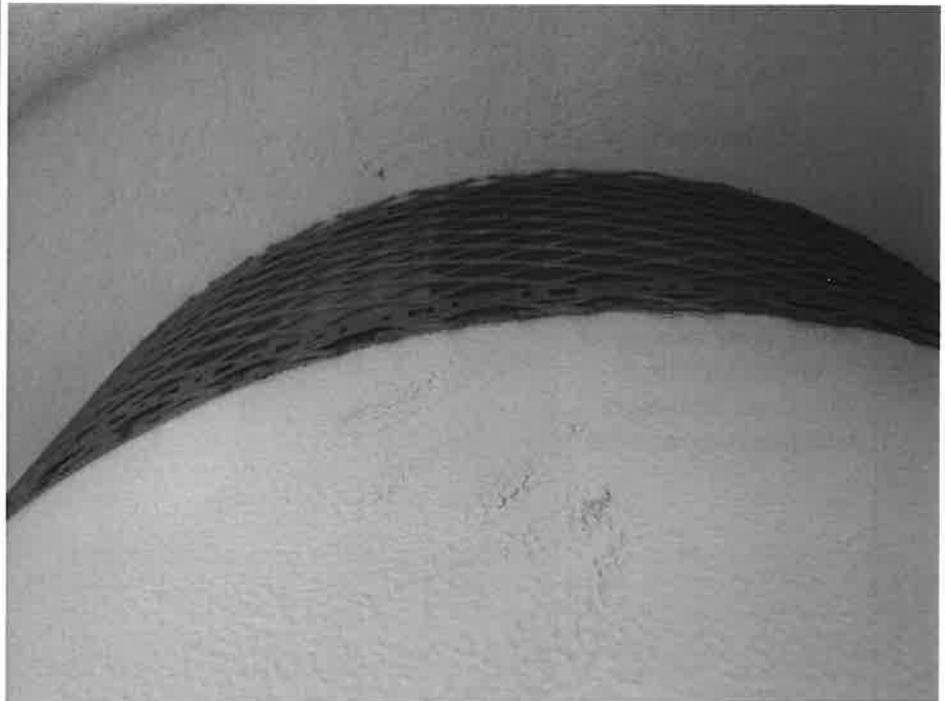
Image #8

Vent Screen 1:30

Condition:
Rust Grade' 9.

Description:
Large and Fine Mesh Vent Screens appeared to be in good condition with a minor amount of corrosion.

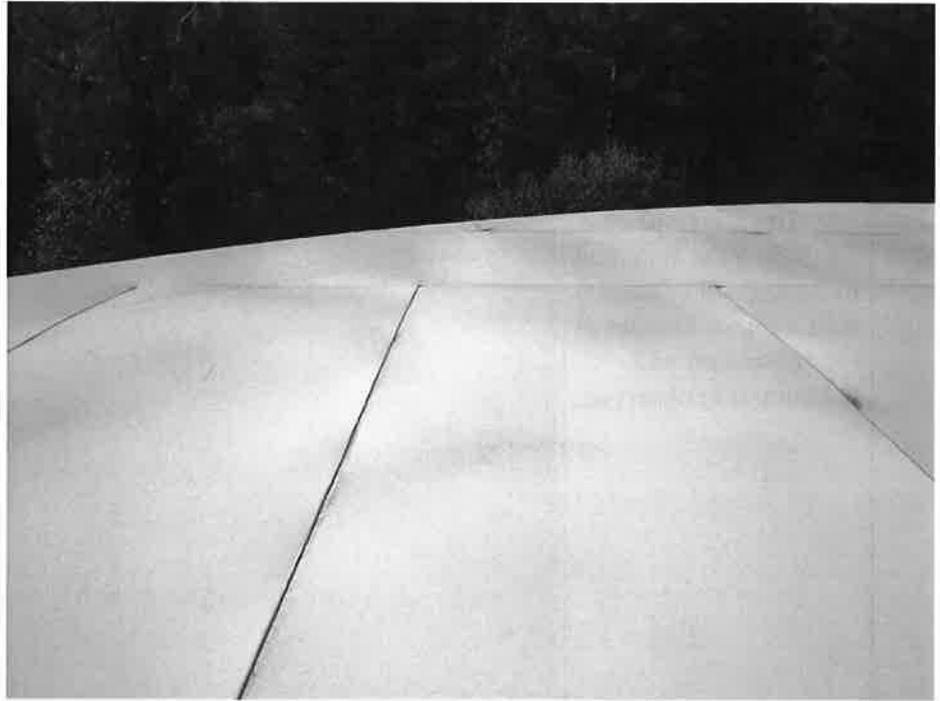
Image #9

Condition:
Rust Grade¹ 8.

Description:
Roof appeared to be in good condition with a minor amount of corrosion and delamination observed.

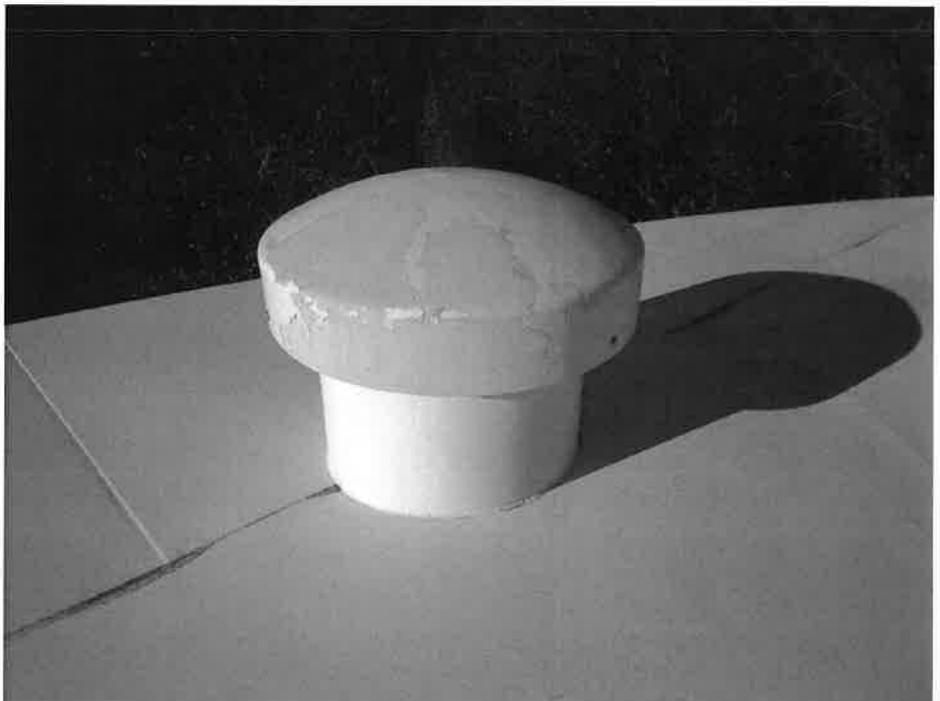
Image #10

Side Vent 4:30

Condition:
Rust Grade¹ 9.

Description:
Side Vent appeared to be in good condition with a minor amount of corrosion with a moderate amount of delamination observed.

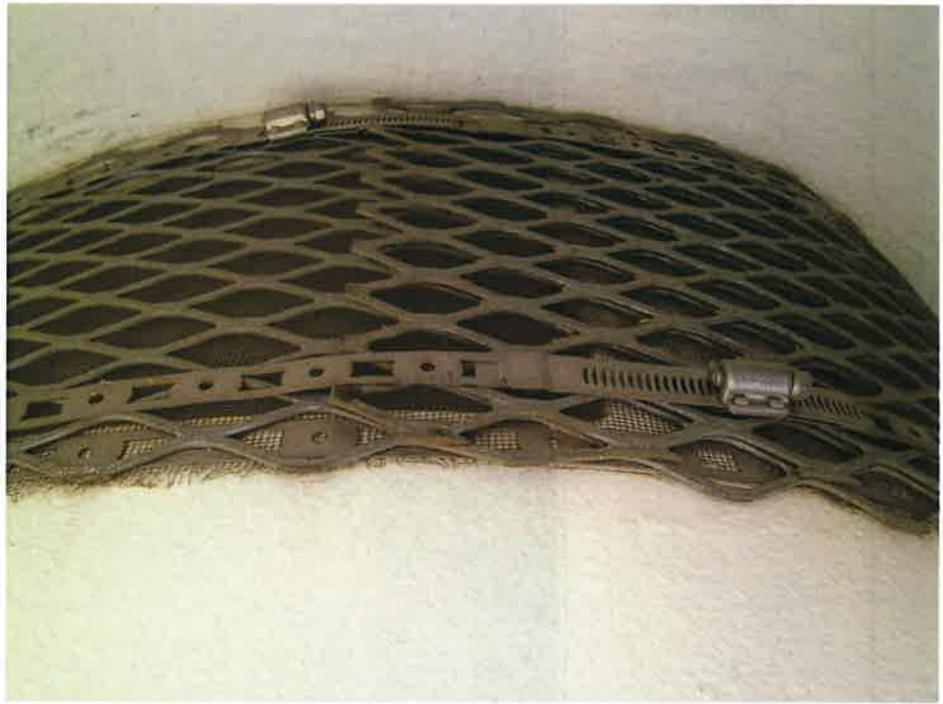
Image #11

Condition:
Rust Grade' 10.

Description:
Large and Fine Mesh Vent Screens appeared to be in good condition with no signs of corrosion.

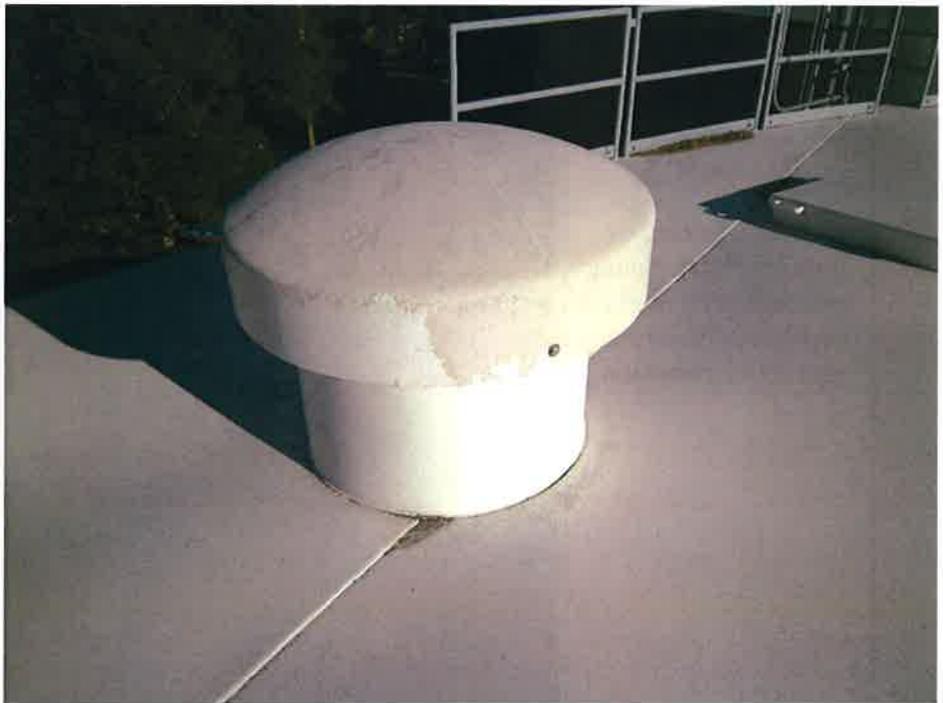
Image #12

Side Vent 7:30

Condition:
Rust Grade' 9.

Description:
24" Side Vent appeared to be in good condition with a minor amount of corrosion and minor amount of delamination observed.

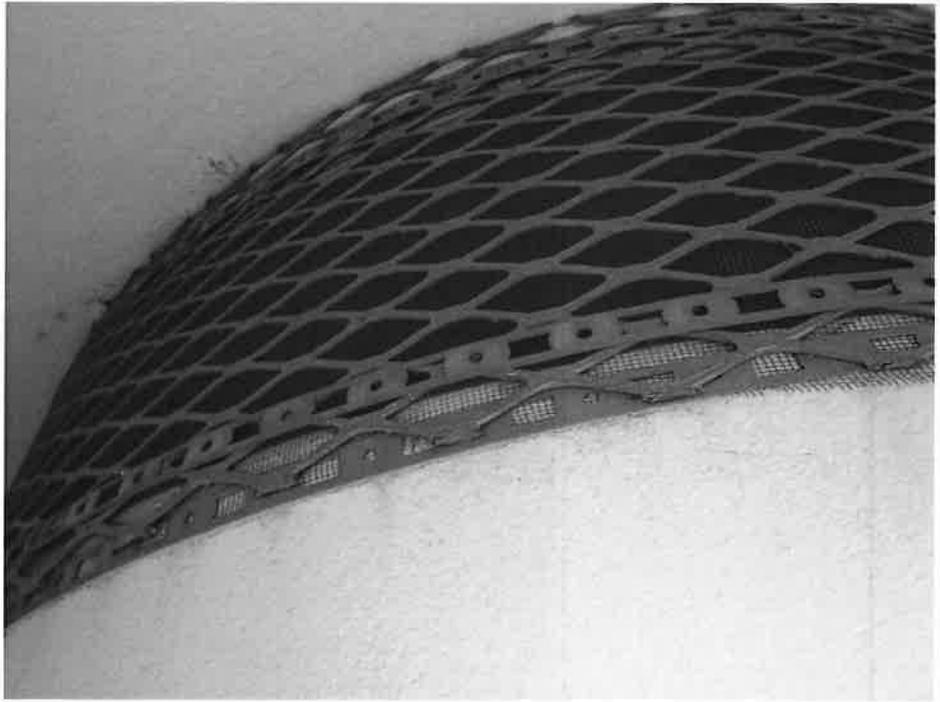
Image #13

Condition:
Rust Grade! 10.

Description:
Large and Fine Mesh Vent Screens appeared to be in good condition with a minor amount of corrosion.

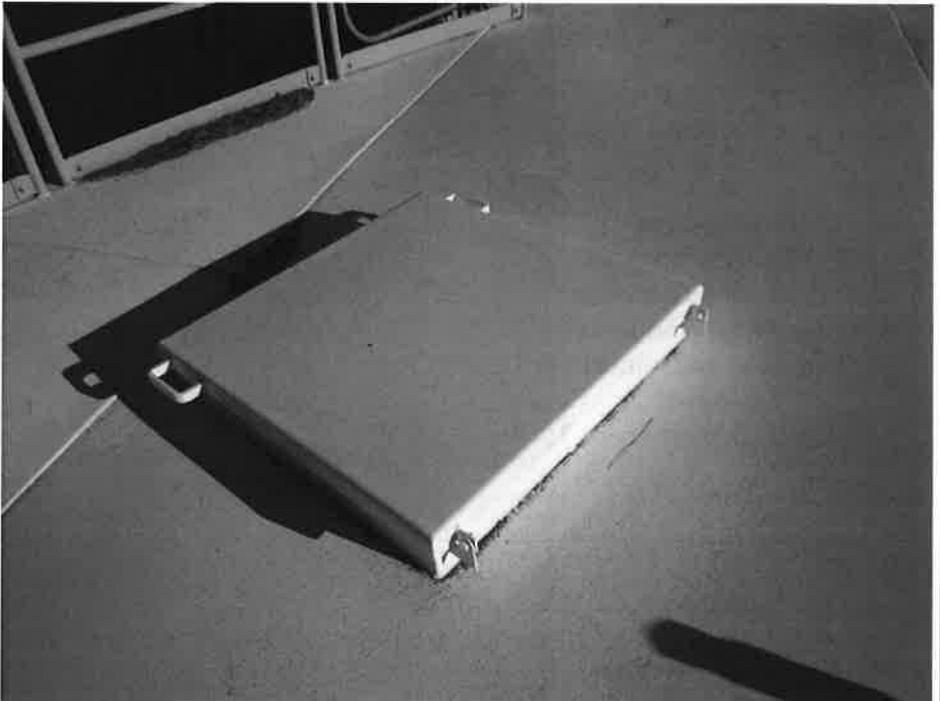
Image #14

Entry Hatch 8:00

Condition:
Rust Grade! 9.

Description:
36"x36" Entry Hatch appeared to be in good condition with a minor amount of corrosion.
