CITY OF SHASTA LAKE

2016-2026 WATER MASTER PLAN

FINAL • OCTOBER 2016

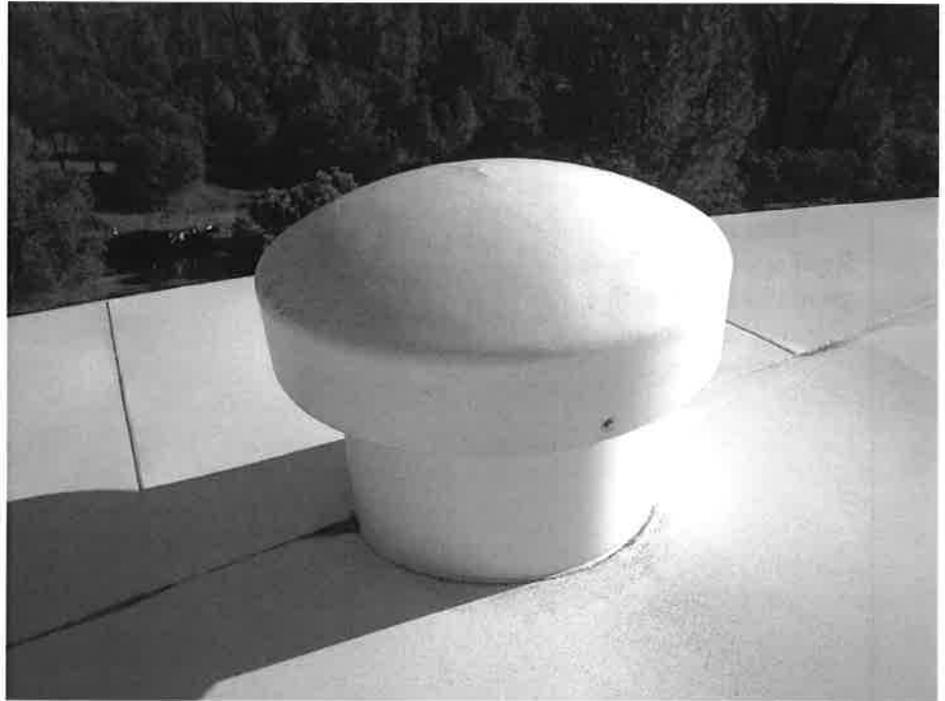
Image #15

Condition:
Rust Grade' 9.

Description:
24" Side Vent appeared to be in good condition with a minor amount of corrosion.

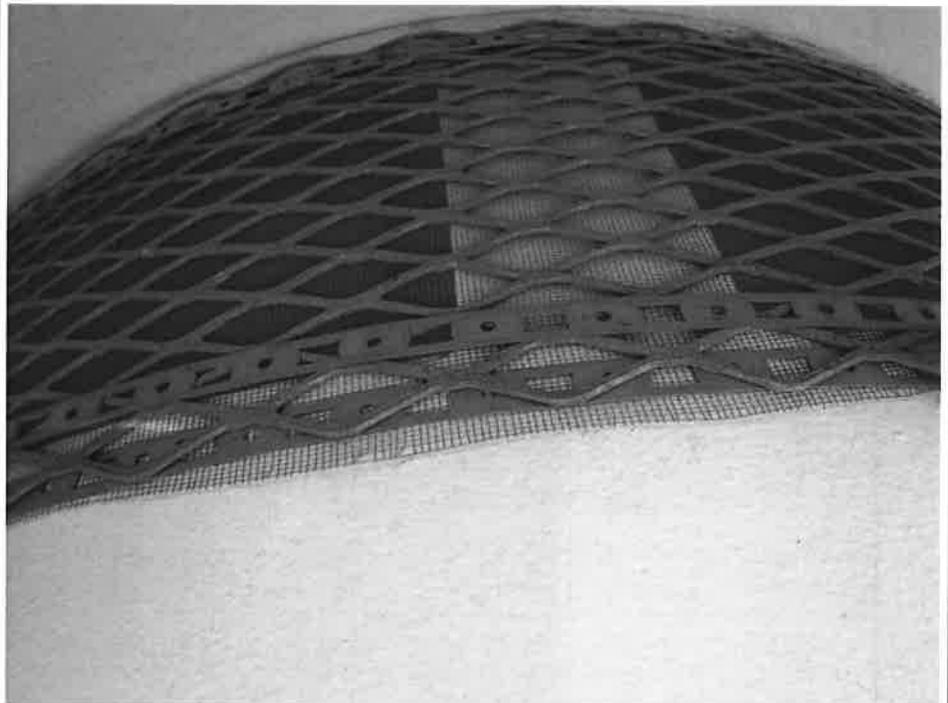
Image #16

Vent Screen 10:30

Condition:
Rust Grade' 10.

Description:
Large and Fine Mesh Vent Screens appeared to be in good condition with a minor amount of corrosion.

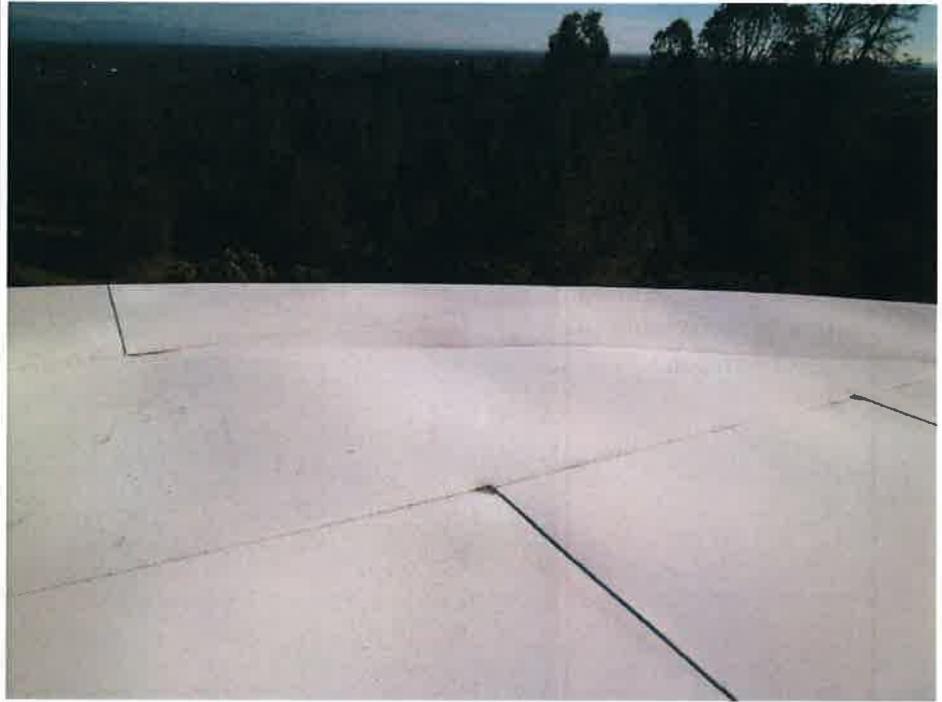
Image #17

Condition:
Rust Grade¹ 9.

Description:
Roof appeared to be in good condition with a minor amount of corrosion.

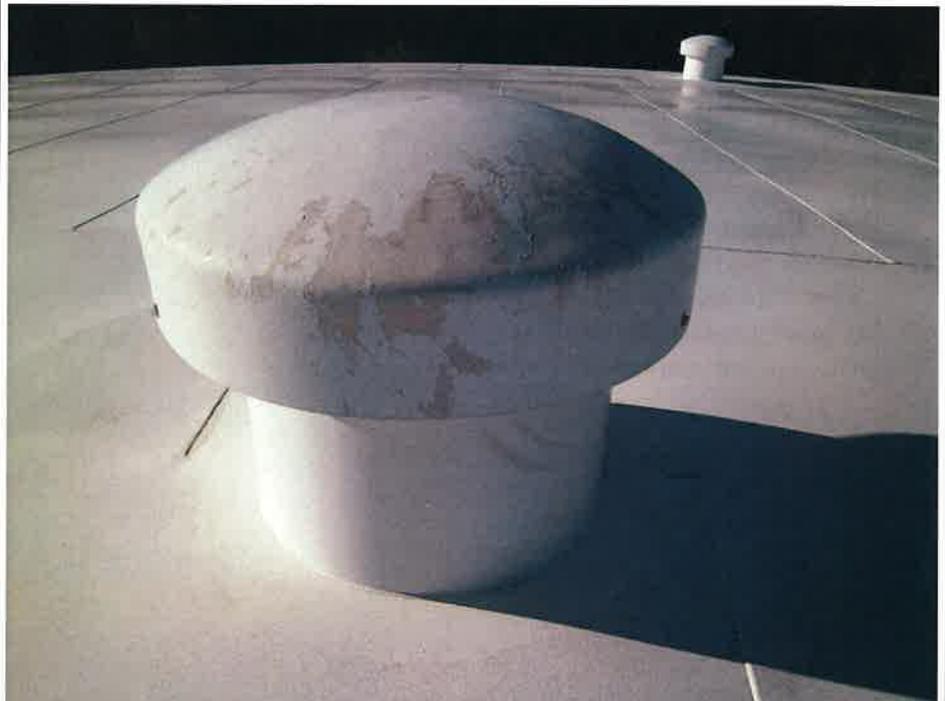
Image #18

Vent Center

Condition:
Rust Grade¹ 9.

Description:
24" Vent appeared to be in good condition with a minor amount of corrosion and delamination observed.

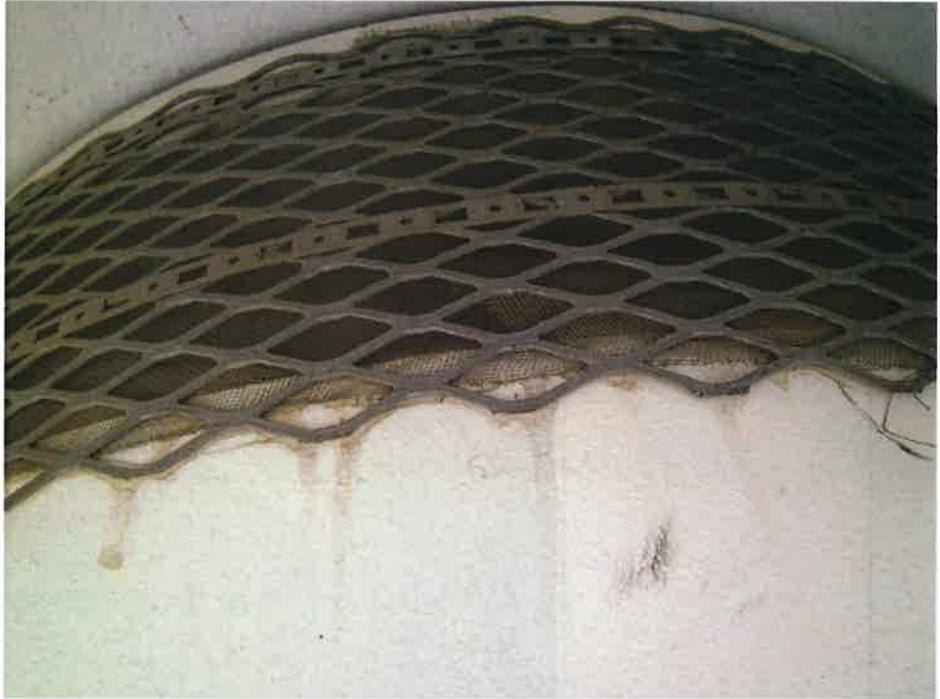
Image #19

Condition:
Rust Grade¹ 10.

Description:
Large and Fine Mesh Vent Screens appeared to be in good condition with a minor amount of corrosion.

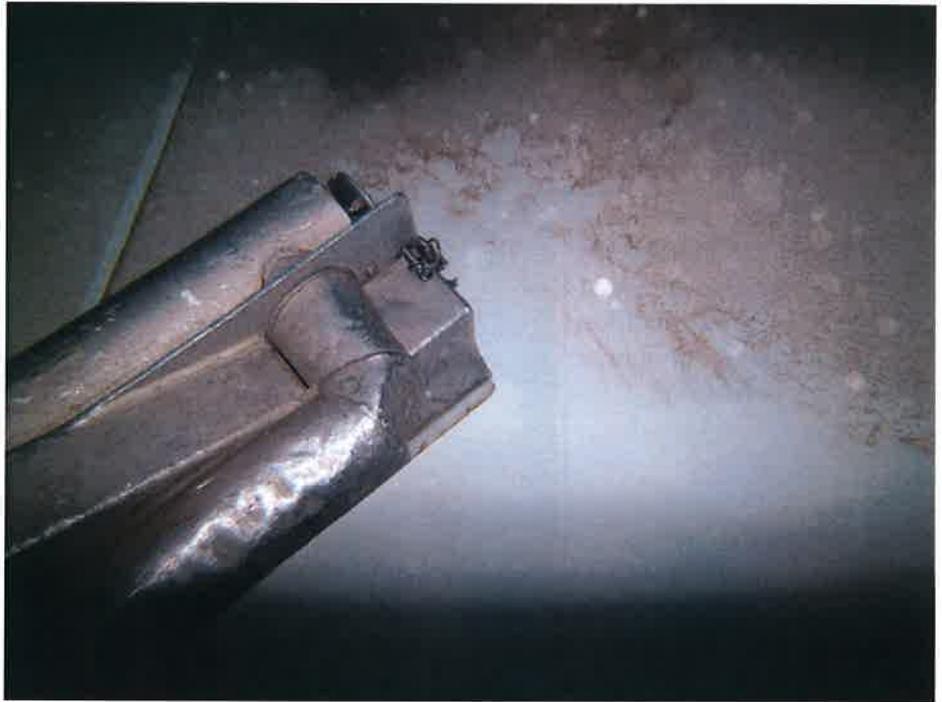
Image #21

Sediment

Description:
1/32" of sediment was removed from reservoir floor.

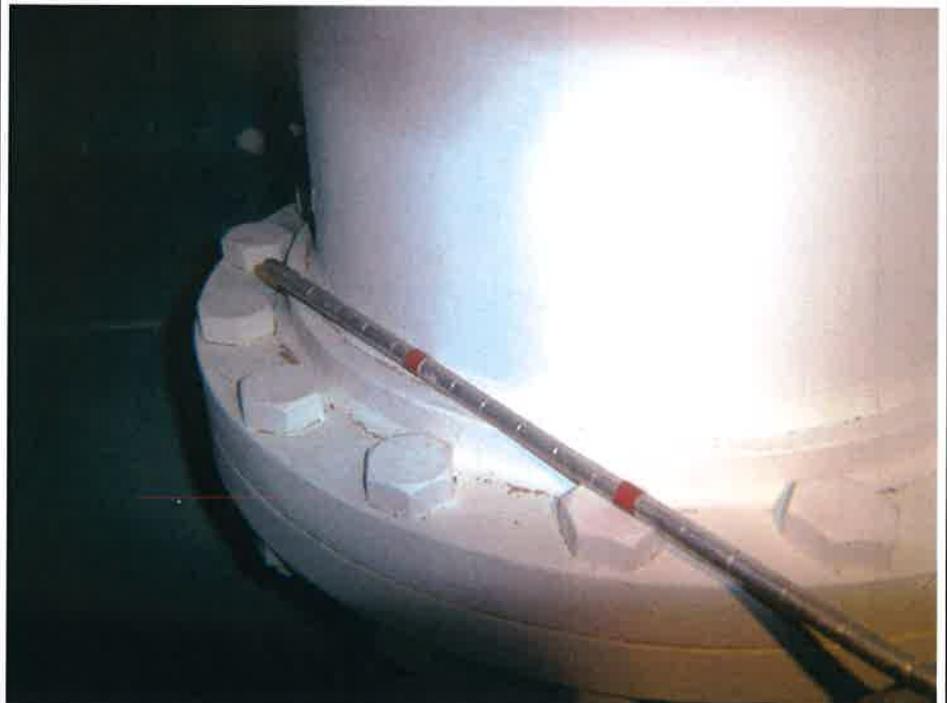
Image #22

Overflow 12:05

Condition:
Rust Grade¹ 10.

Description:
20" Overflow appeared to be in good condition with no signs of corrosion.

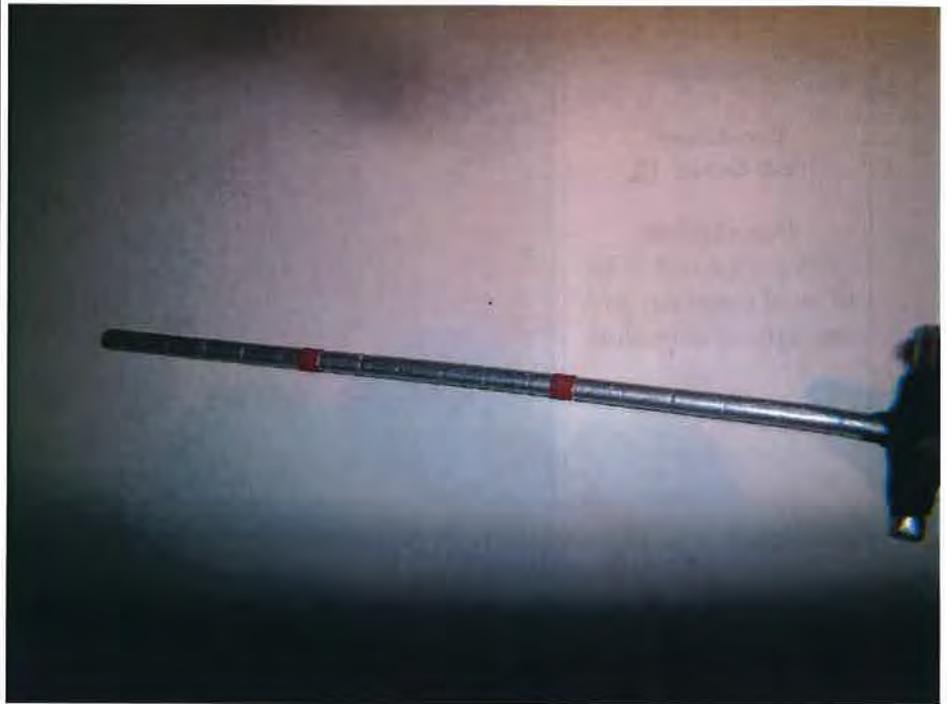
Image #23

Condition:
Rust Grade' 10.

Description:
Floor appeared to be in good condition with no signs of corrosion.

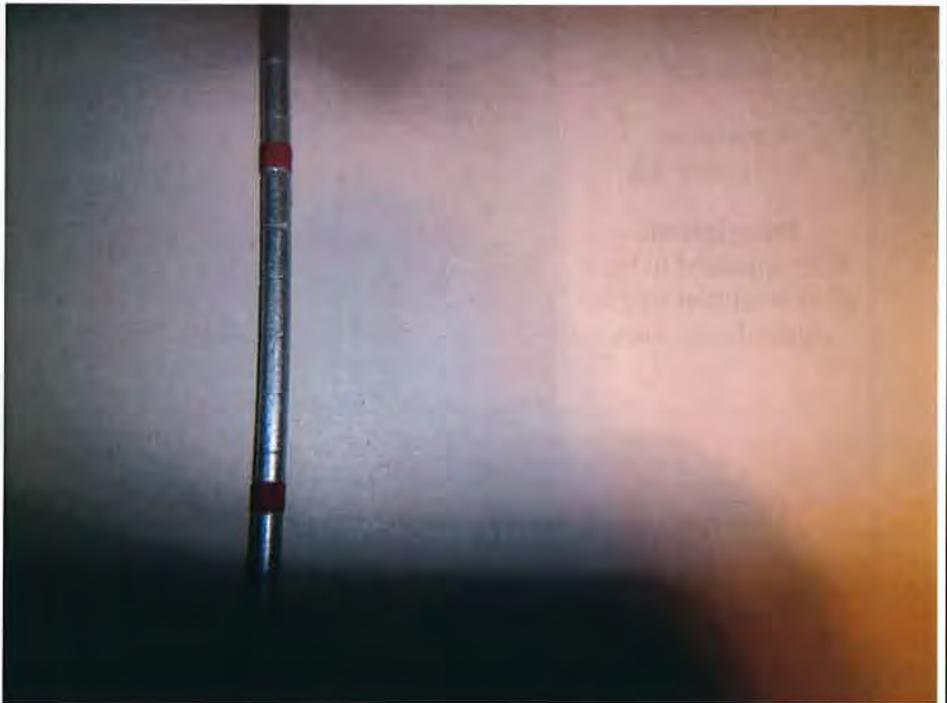
Image #24

Wall 12:00

Condition:
Rust Grade' 10.

Description:
Wall appeared to be in good condition with no signs of corrosion.

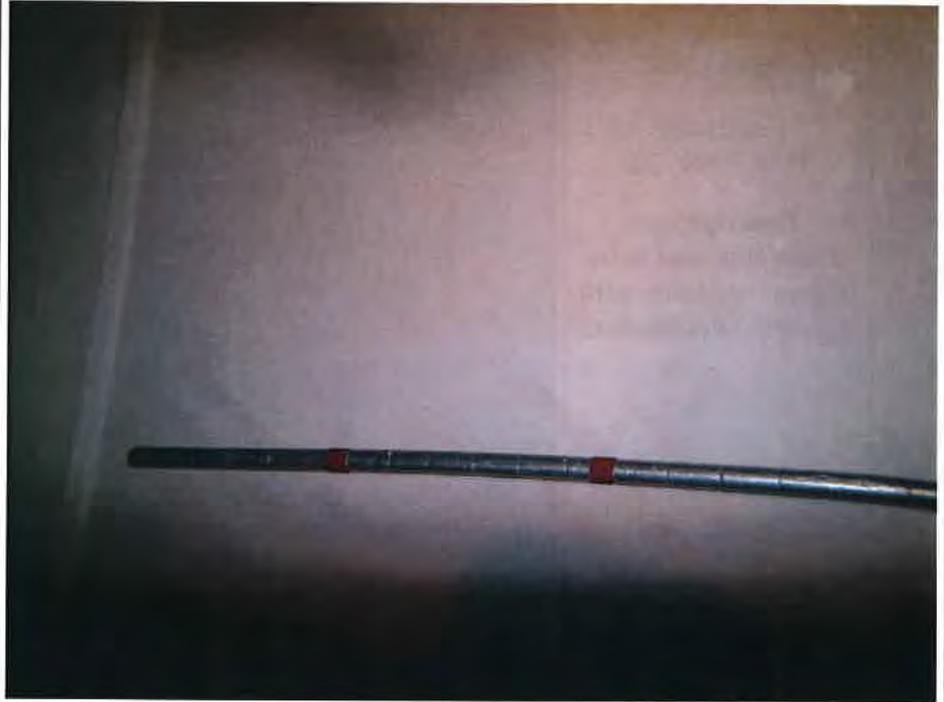
Image #25

Condition:
Rust Grade¹ 10.

Description:
Floor appeared to be in good condition with no signs of corrosion.

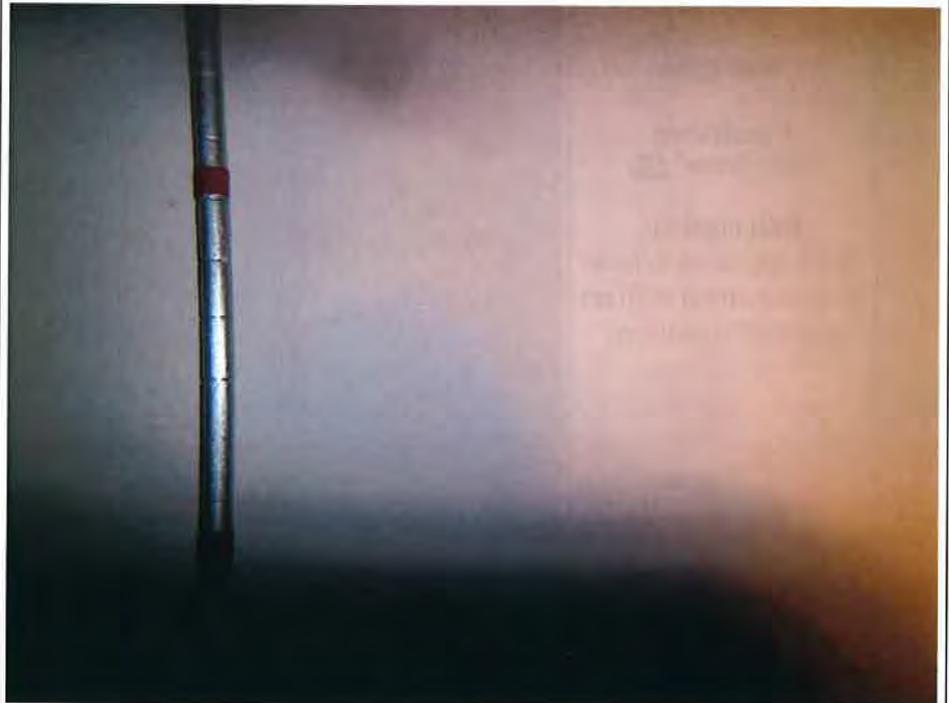
Image #26

Wall 3:00

Condition:
Rust Grade¹ 10.

Description:
Wall appeared to be in good condition with no signs of corrosion.

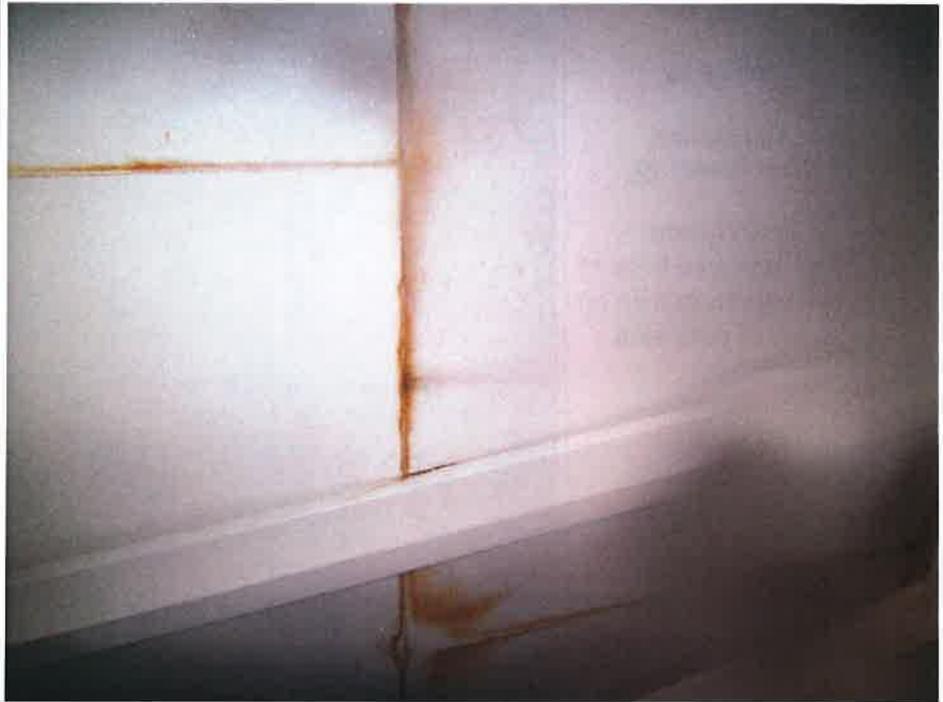
Image #27

Condition:
Rust Grade' 7.

Description:
Ceiling appeared to be in good condition with a minor amount of corrosion.

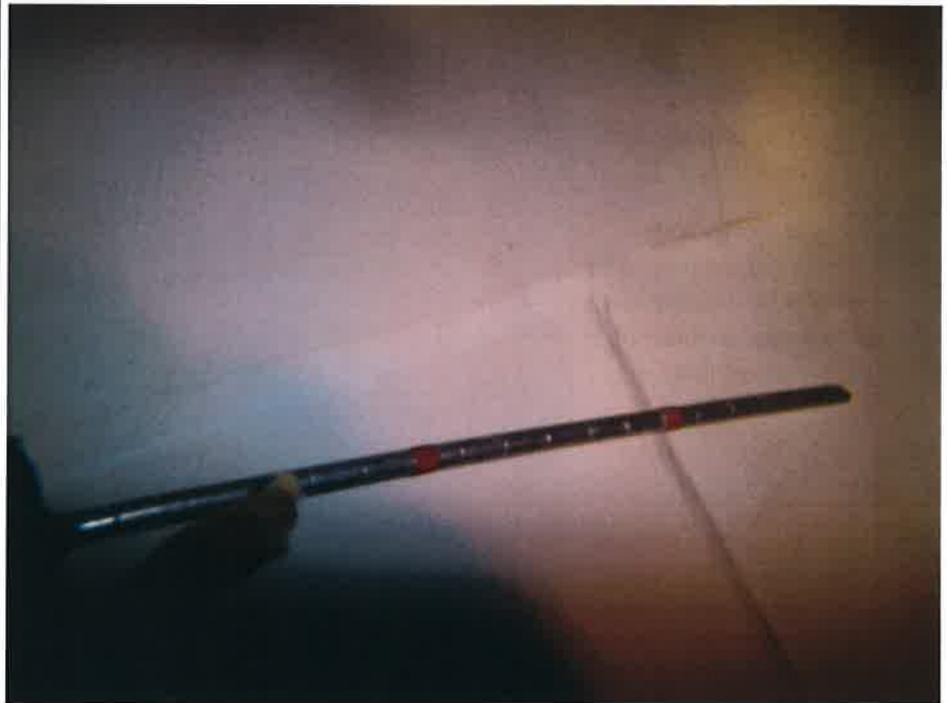
Condition:
Rust Grade' 10.

Description:
Floor appeared to be in good condition with no signs of corrosion.

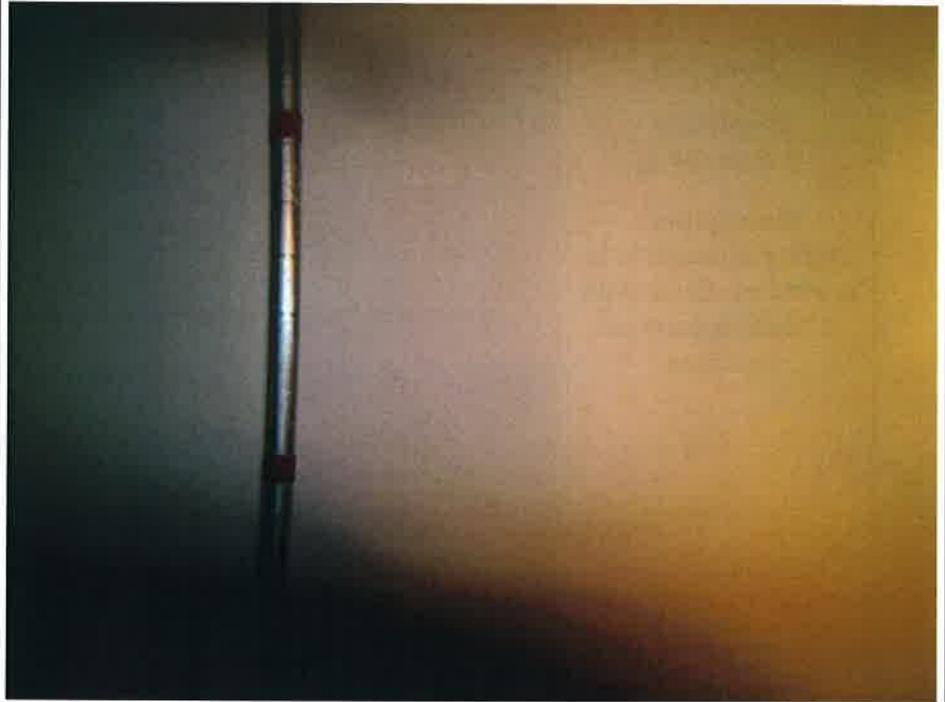
Image #29

Condition:
Rust Grade¹ 10.

Description:
Wall appeared to be in good condition with no signs of corrosion.

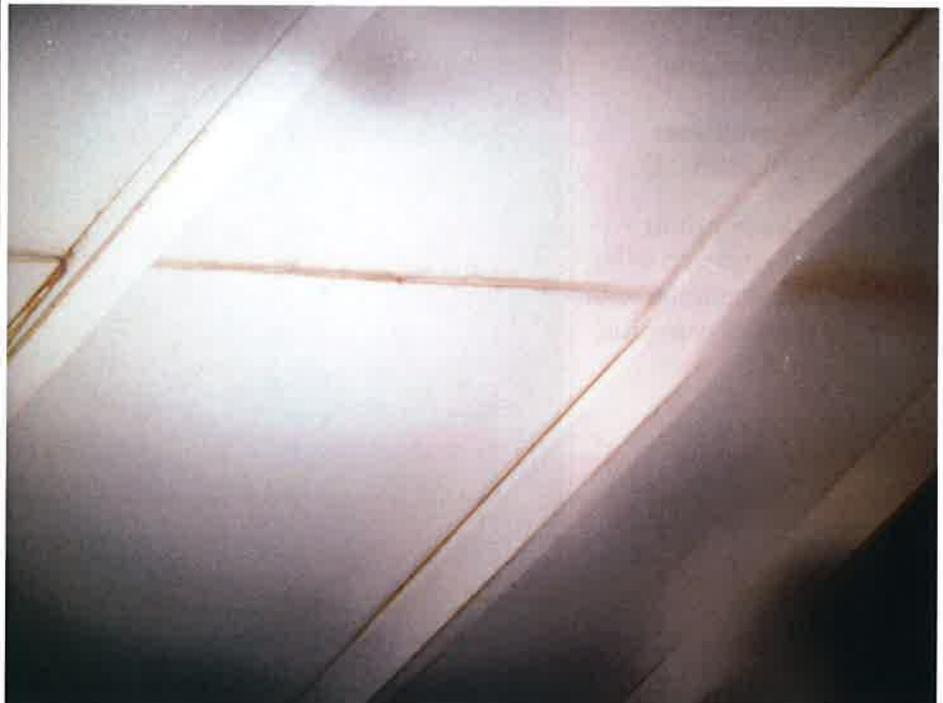
Image #30

Ceiling 6:00

Condition:
Rust Grade¹ 7.

Description:
Ceiling appeared to be in good condition with a minor amount of corrosion.

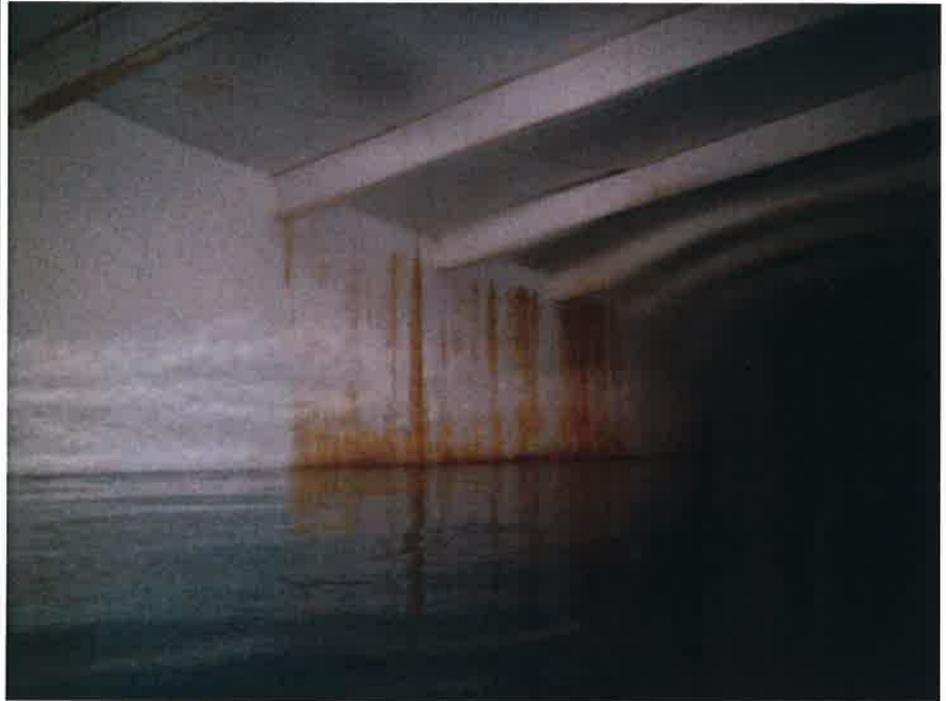
Image #31

Condition:
Rust Grade' 6.

Description:
Upper Wall appeared to be in good condition with a moderate amount of corrosion.

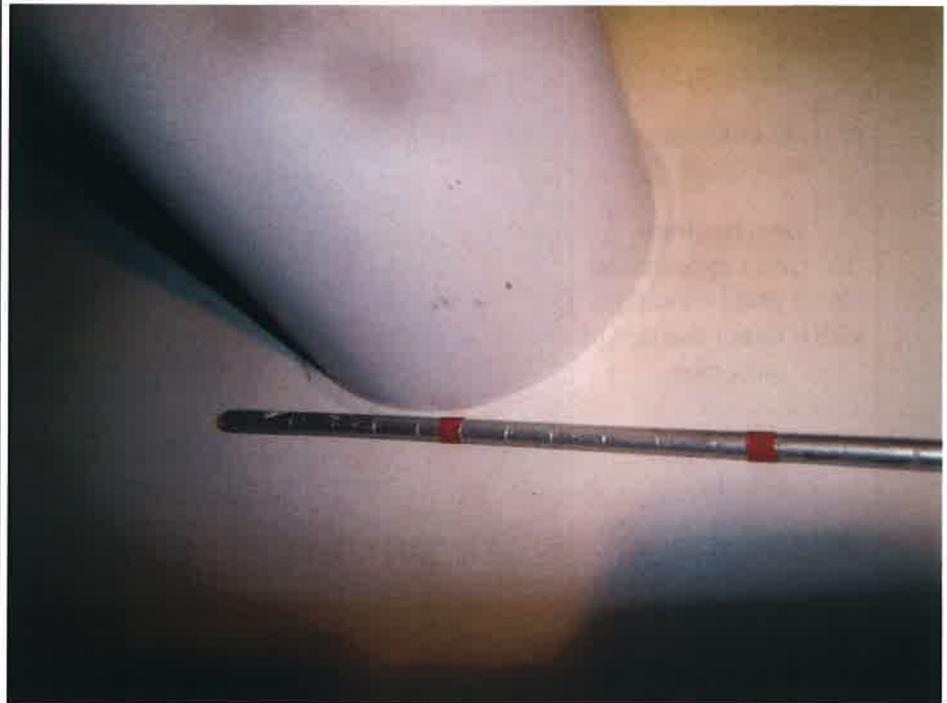
Image #32

Column 6:00

Condition:
Rust Grade' 10.

Description:
8" Column appeared to be in good condition with no signs of corrosion.

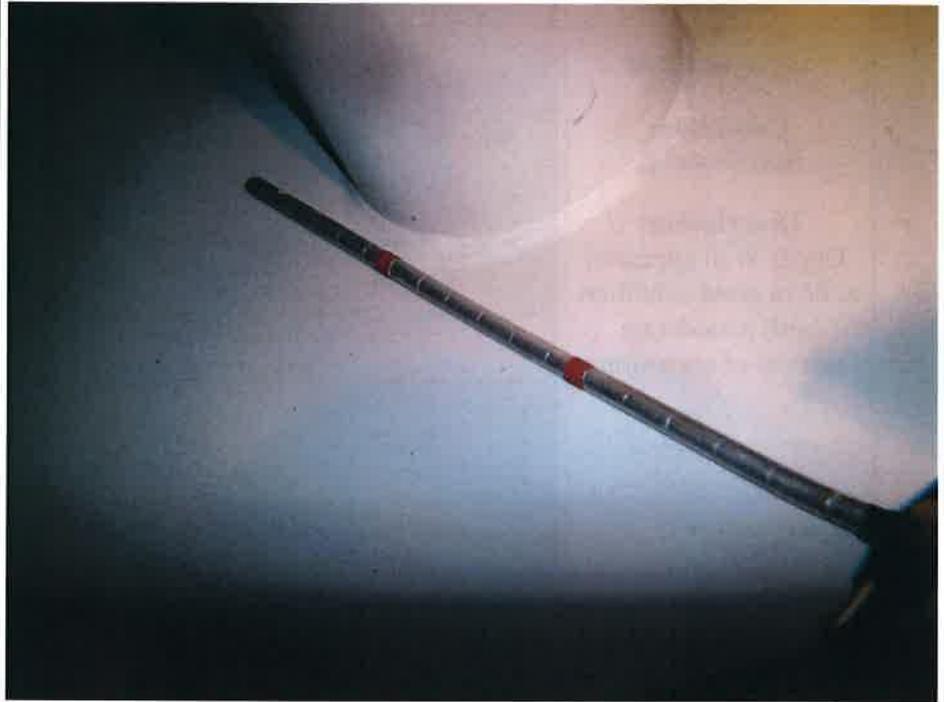
Image #33

Condition:
Rust Grade¹ 10.

Description:
8" Column appeared to be in good condition with no signs of corrosion.

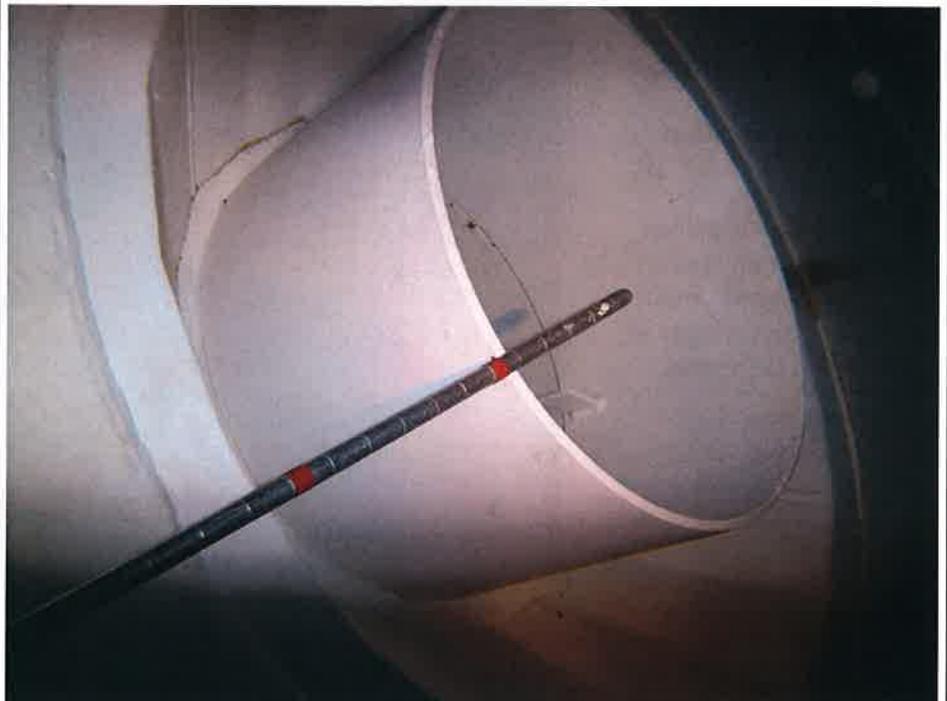
Image #34

Drain 11:55

Condition:
Rust Grade¹ 9.

Description:
18" Drain appeared to be in good condition with a minor amount of corrosion.

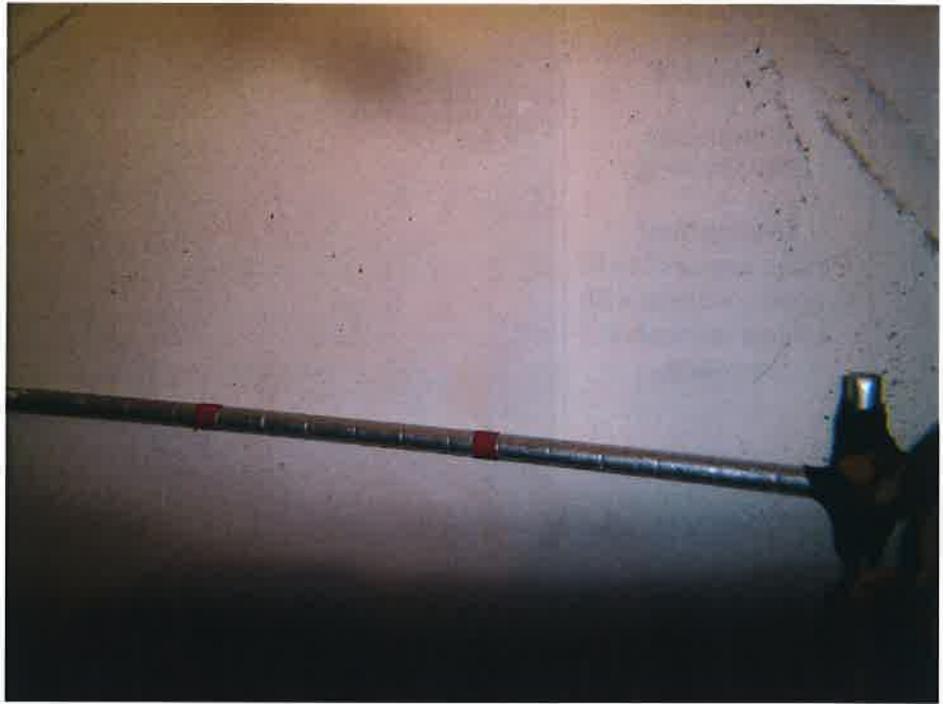
Image #35

Condition:
Rust Grade¹ 10.

Description:
Floor appeared to be in good condition with no signs of corrosion.

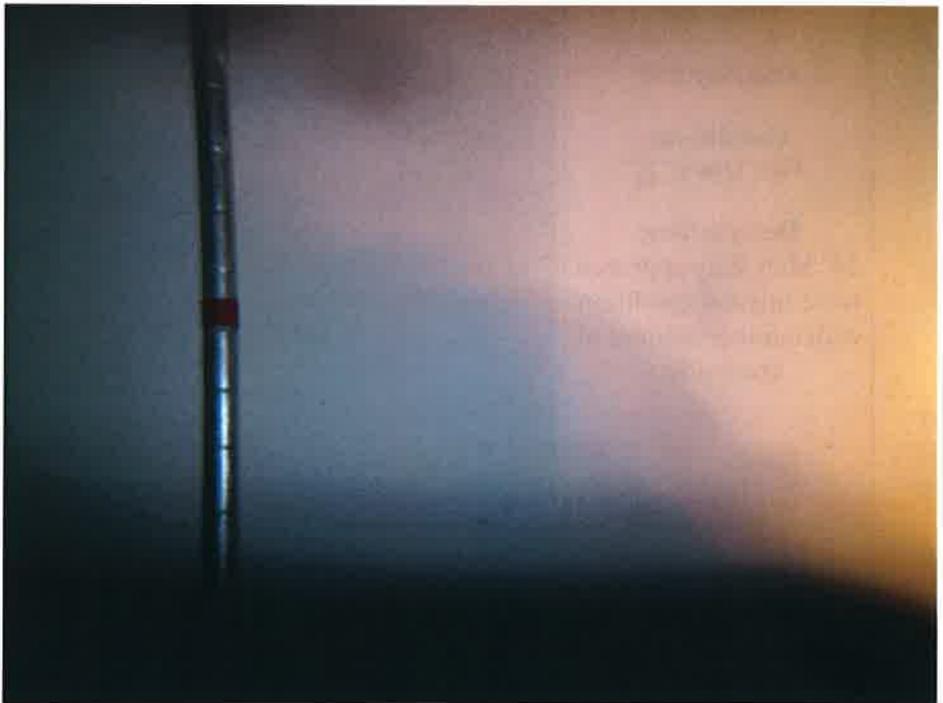
Image #36

Wall 9:00

Condition:
Rust Grade¹ 10.

Description:
Wall appeared to be in good condition with no signs of corrosion.

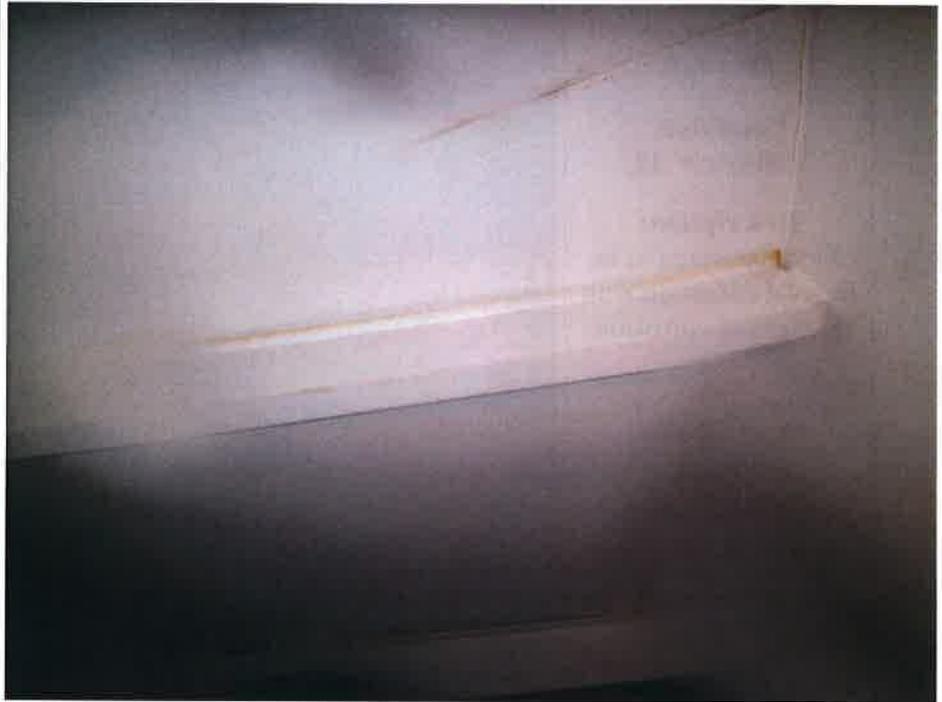
Image #37

Condition:
Rust Grade¹ 8.

Description:
Ceiling appeared to be in good condition with a minor amount of corrosion.

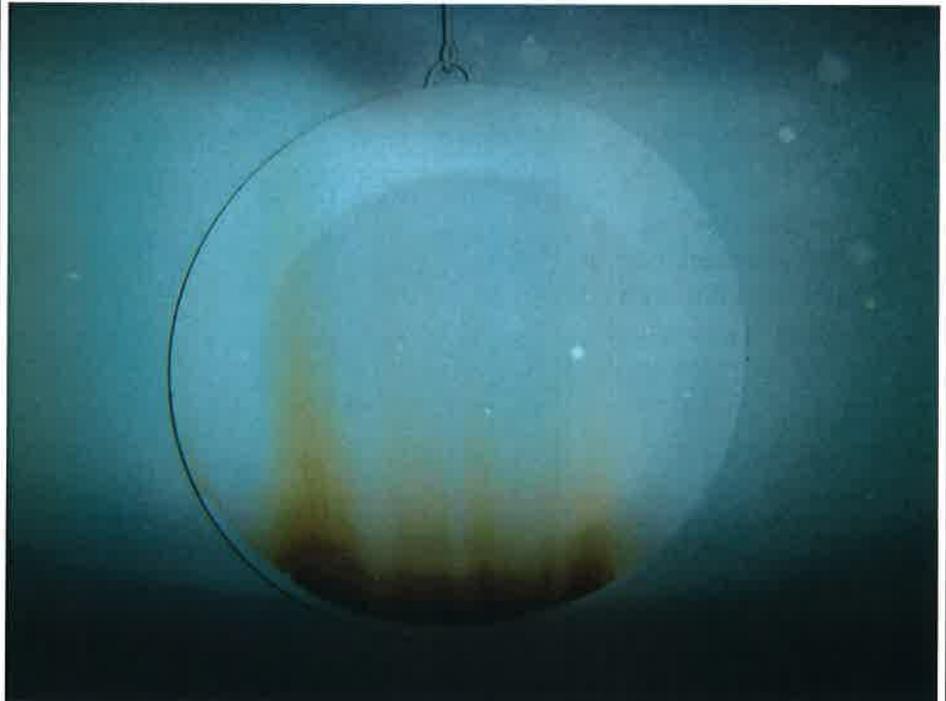
Image #38

Man Way 6:45

Condition:
Rust Grade¹ 7.

Description:
24" Man Way appeared to be in good condition with a minor amount of corrosion.

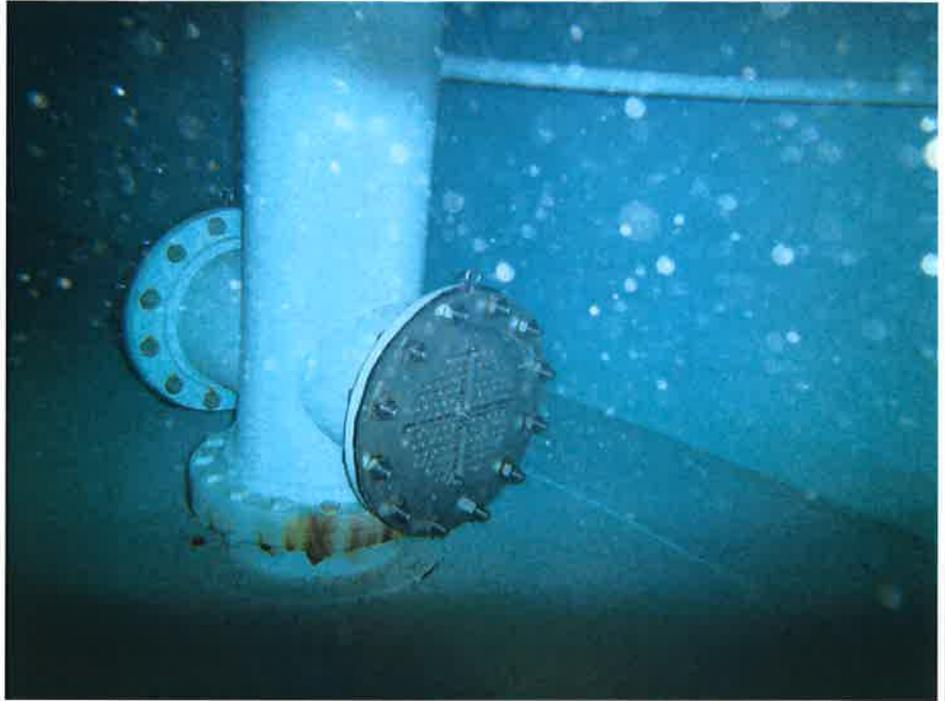
Image #39

Condition:
Rust Grade' 8.

Description:
18" Inlet / Outlet
appeared to be in good
condition with a minor
amount of corrosion.

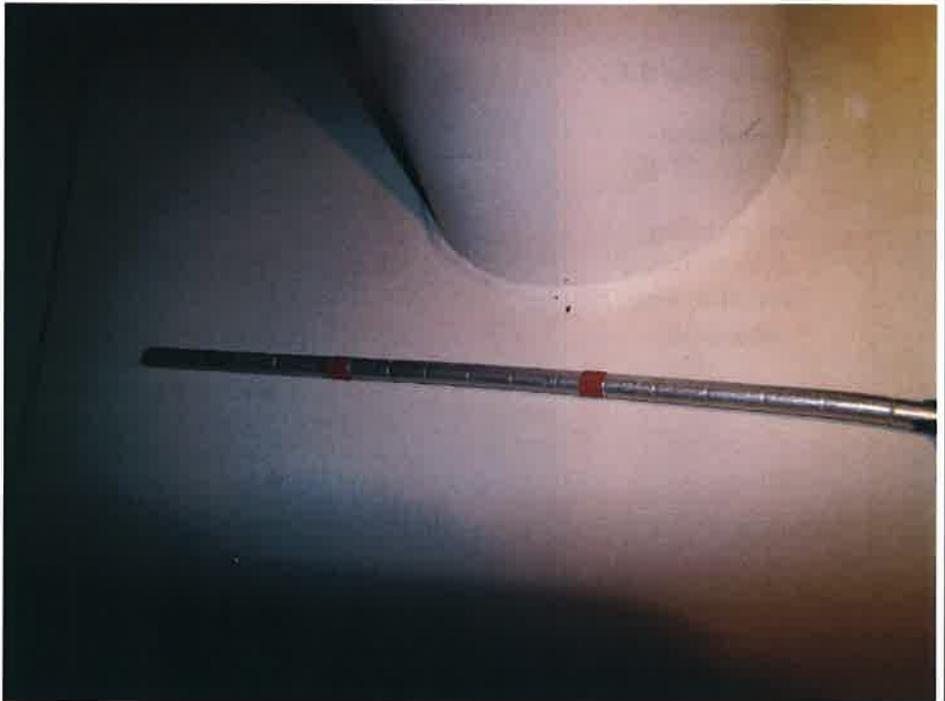
Image #40

Column 8:00

Condition:
Rust Grade' 10.

Description:
8" Column appeared to
be in good condition
with no signs of
corrosion.

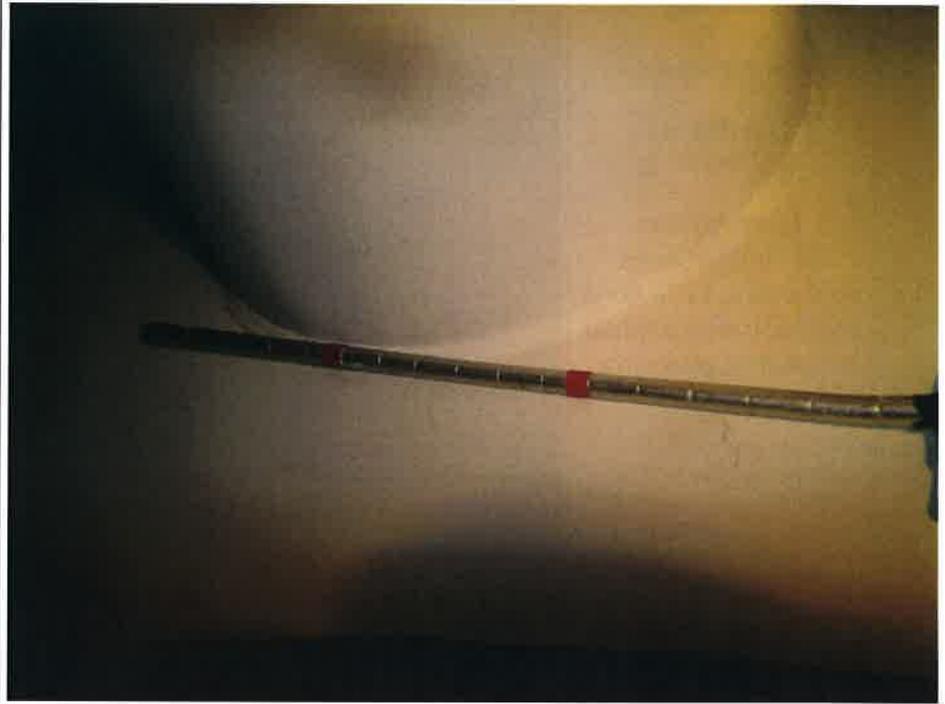
Image #41

Condition:
Rust Grade¹ 10.

Description:
18" Column appeared to be in good condition with no signs of corrosion.

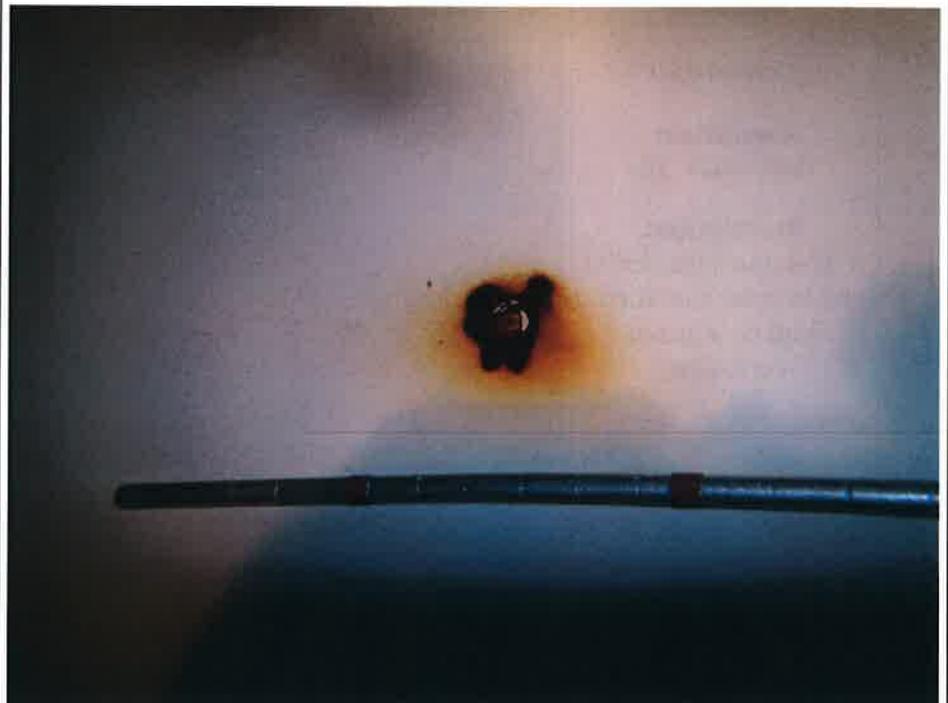
Image #42

Corrosion Spot 8:30

Condition:
Rust Grade¹ 0.

Description:
2" Spot of heavy corrosion was observed.

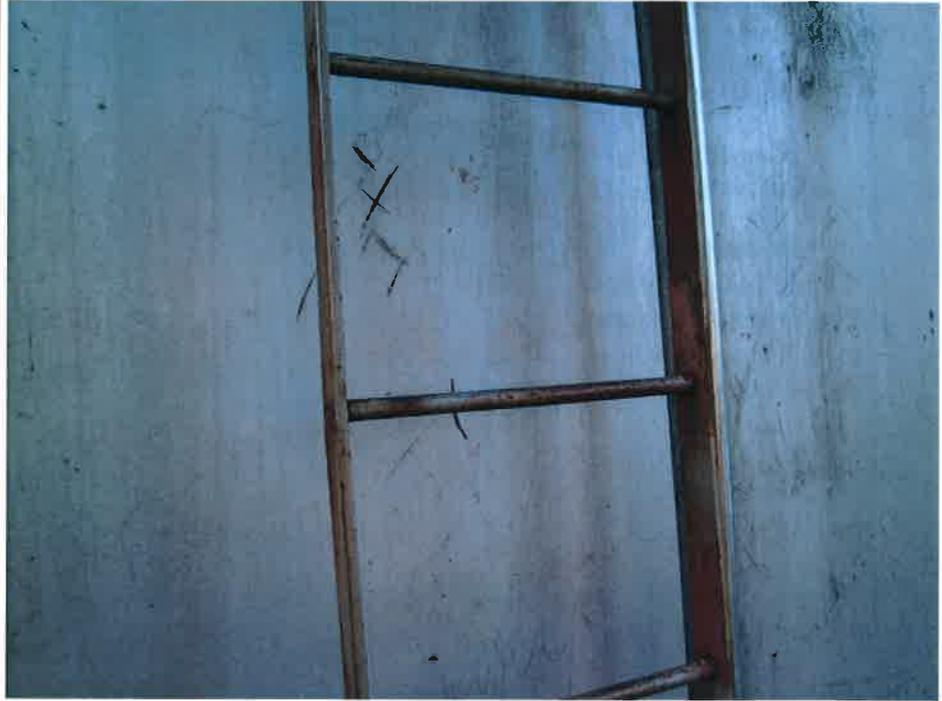
Condition:
Rust Grade' 8.

Description:
Exterior Ladder appeared to be in good condition with a minor amount of corrosion.

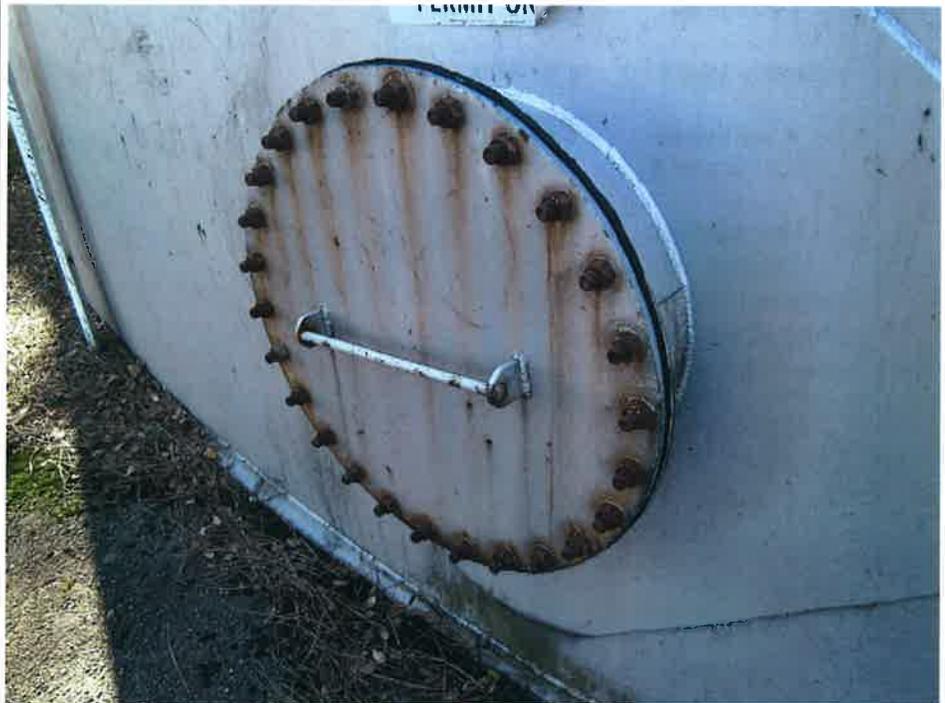
Image #2

Man Way 6:10

Condition:
Rust Grade' 7.

Description:
24" Man Way appeared to be in good condition with a minor amount of corrosion.

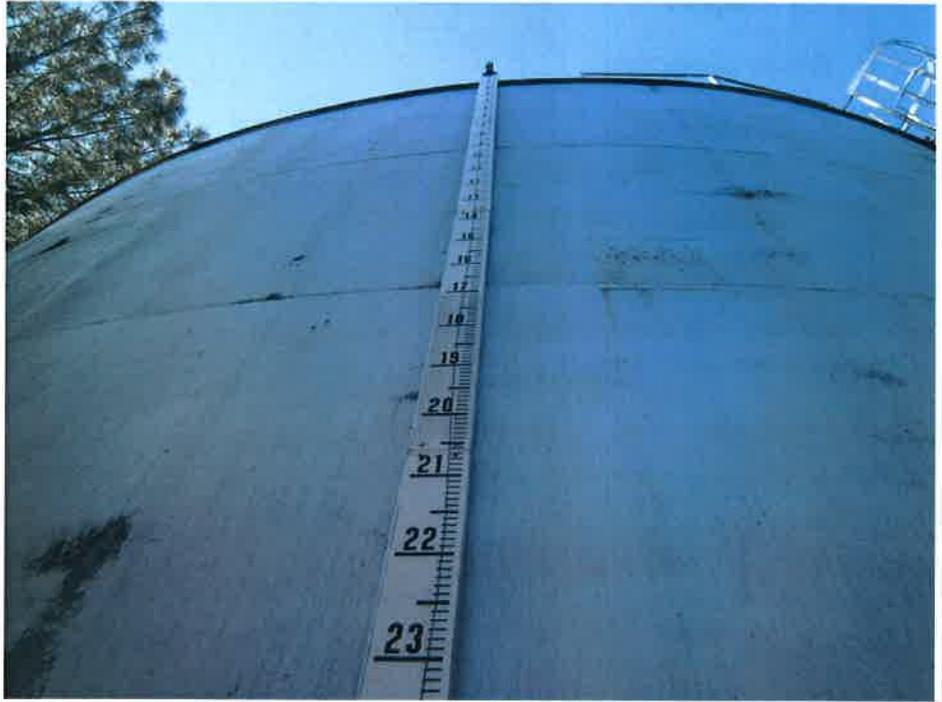
Image #3

Condition:
Rust Grade' 8.

Description:
Liquid Level Indicator
Reader Board appeared
to be in good condition
with a minor amount of
corrosion.

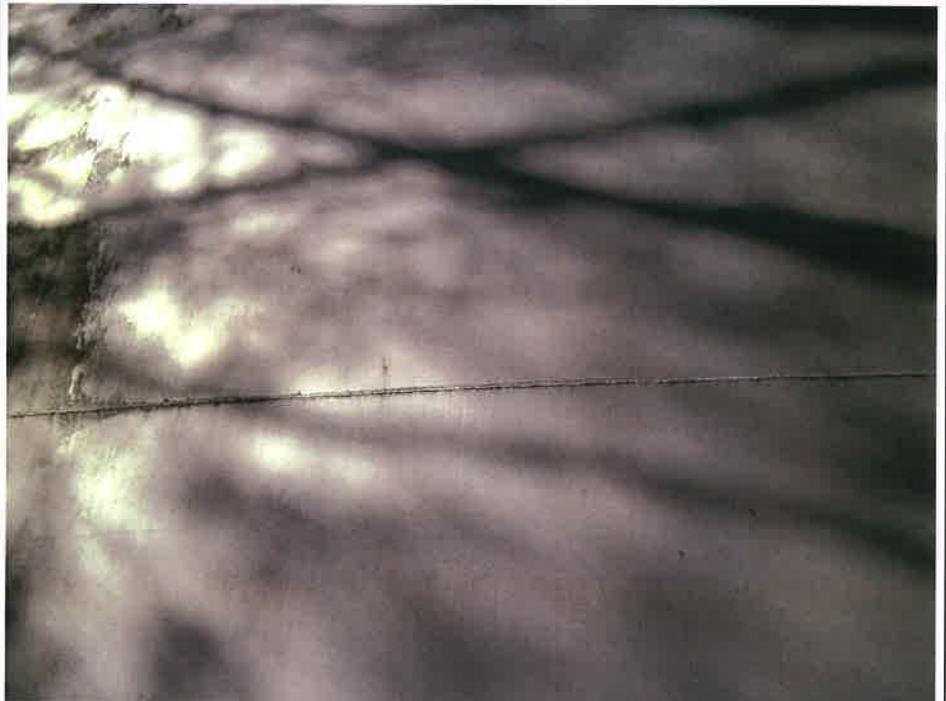
Image #4

Exterior Wall 9:00

Condition:
Rust Grade' 9.

Description:
Exterior Wall
appeared to be in good
condition with a minor
amount of corrosion.

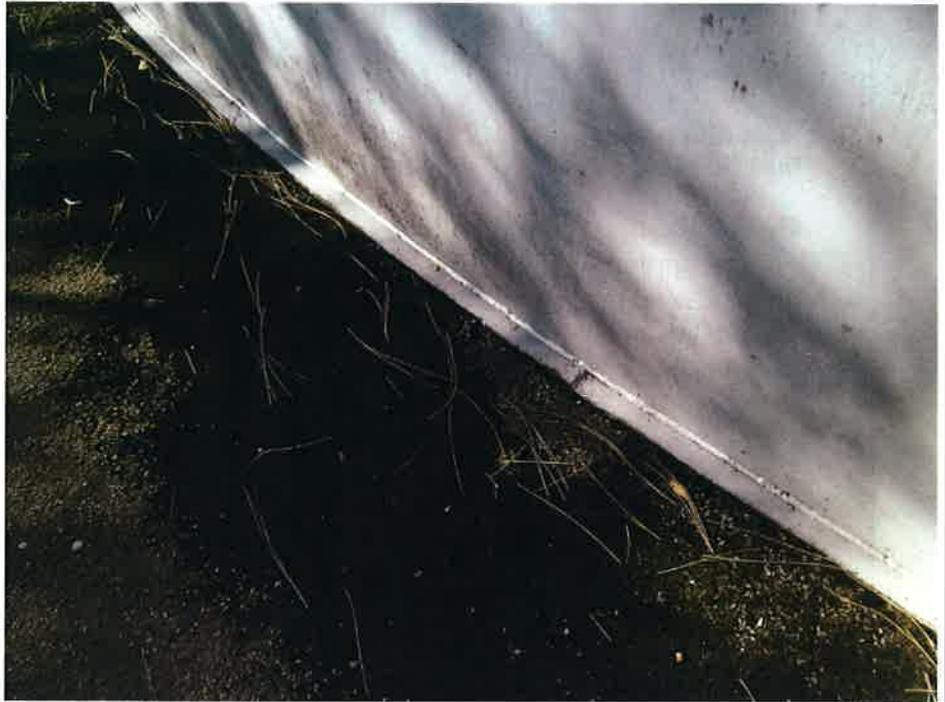
Image #5

Condition:
Concrete Deform³ GC.

Description:
Exterior Base appeared to be in good condition with no major discrepancies observed.

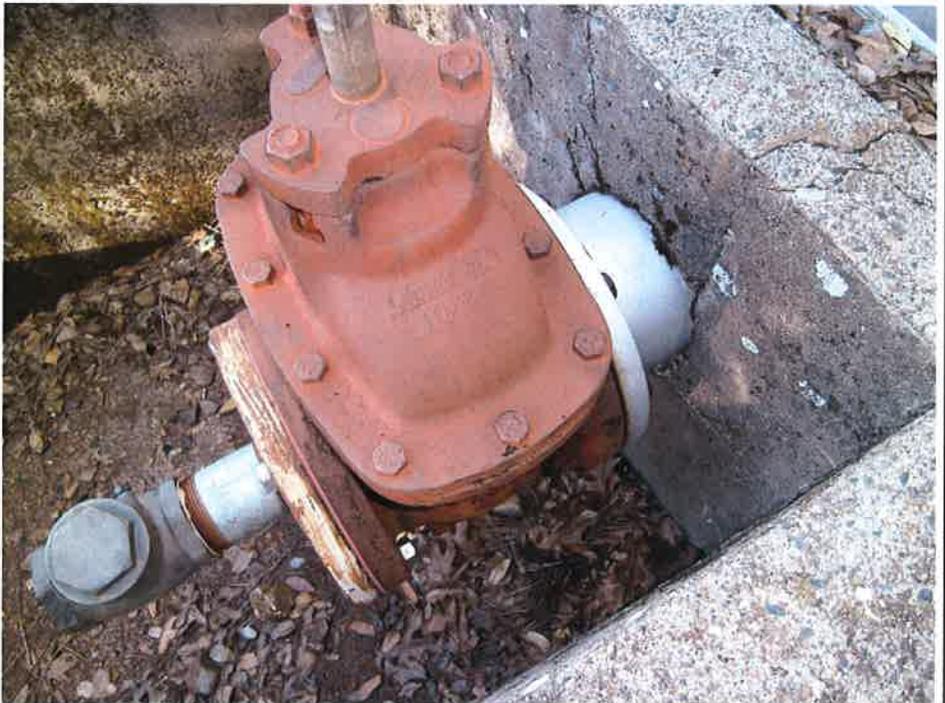
Image #6

Drain 11:00

Condition:
Rust Grade¹ 8.

Description:
6" Drain appeared to be in good condition with a minor amount of corrosion.
