CITY OF SHASTA LAKE

2016-2026 WATER MASTER PLAN

FINAL • OCTOBER 2016

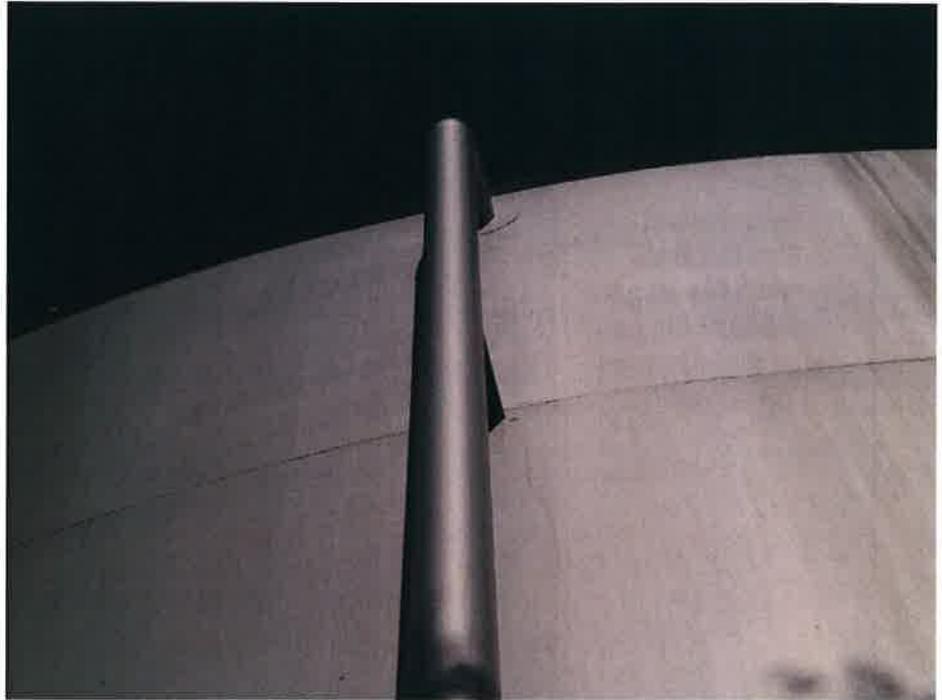
Image #7

Condition:
Rust Grade¹ 9.

Description:
8" Overflow appeared to be in good condition with a minor amount of corrosion.

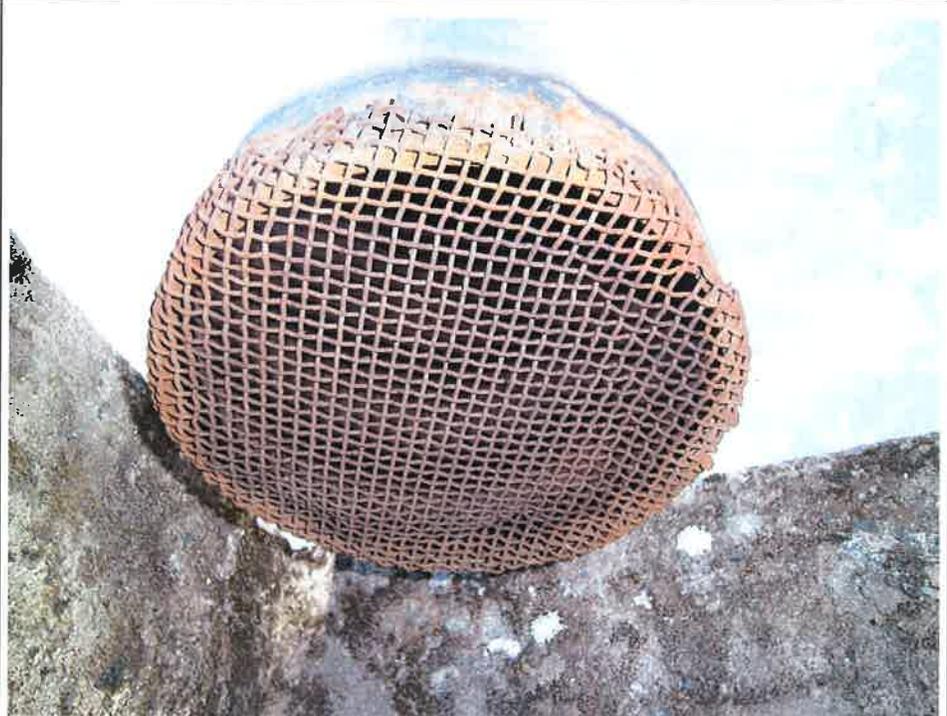
Image #8

Overflow Screen 11:30

Condition:
Rust Grade¹ 7.

Description:
Medium Mesh
Overflow Screen
appeared to be in good condition with a minor amount of corrosion.

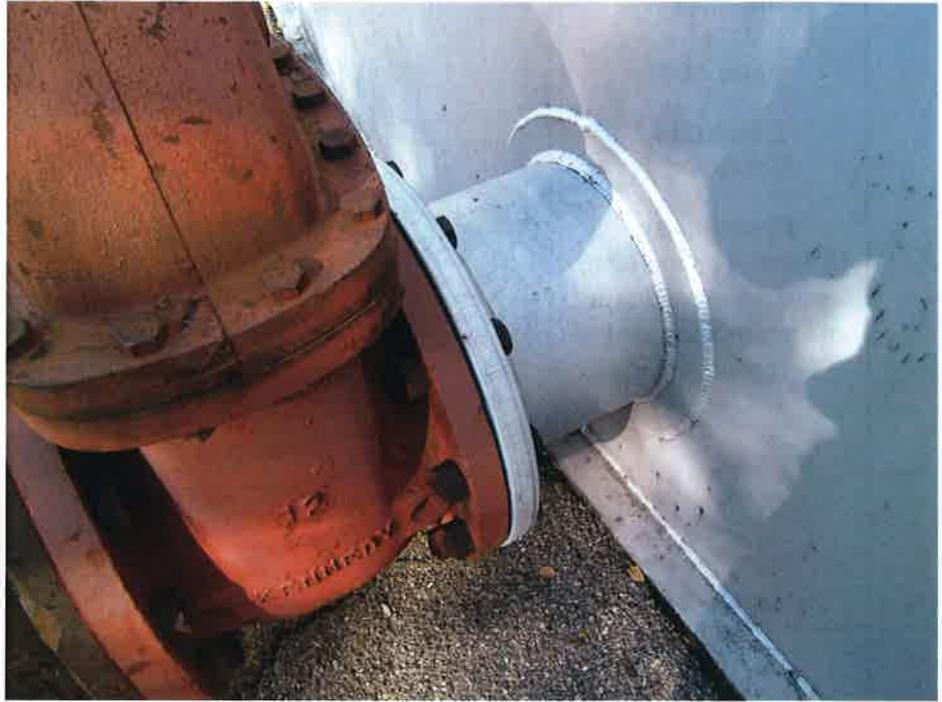
Image #9

Condition:
Rust Grade¹ 9.

Description:
12" Outlet appeared to be in good condition with a minor amount of corrosion.

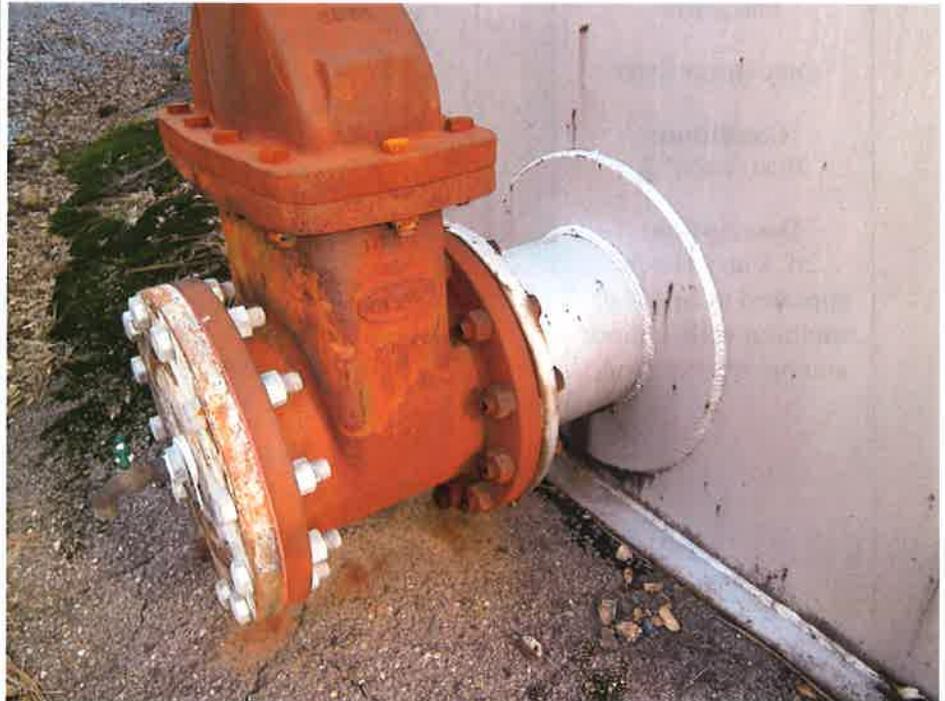
Image #10

Capped Off Penetration
4:30

Condition:
Rust Grade¹ 9.

Description:
10" Capped Off Penetration appeared to be in good condition with a minor amount of corrosion.

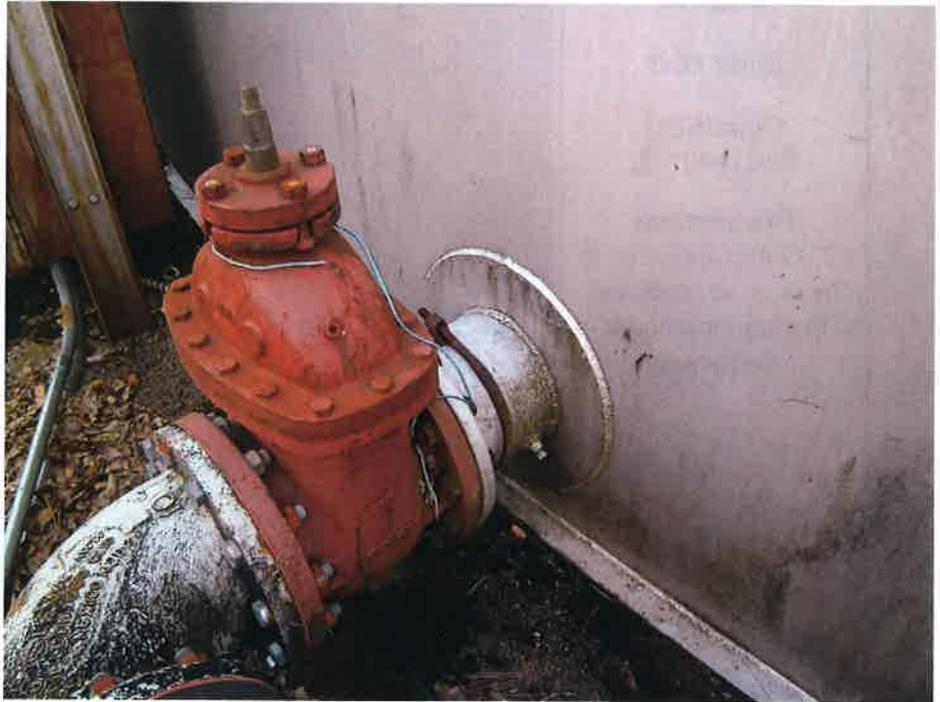
Image #11

Condition:
Rust Grade¹ 8.

Description:
10" Outlet appeared to be in good condition with a minor amount of corrosion.

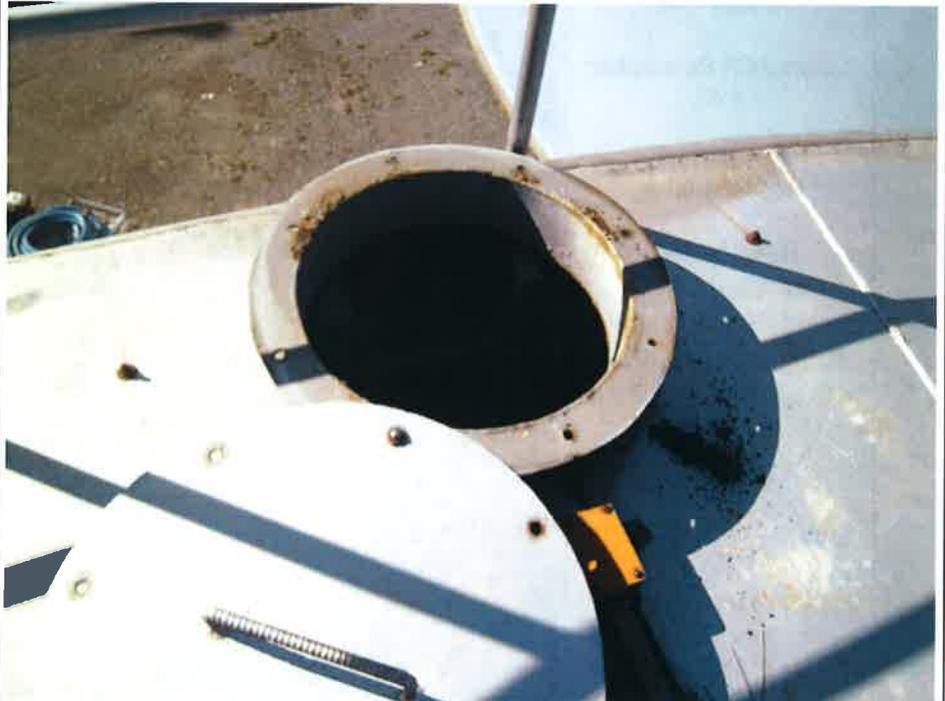
Image #12

Entry Hatch 12:00

Condition:
Rust Grade¹ 5.

Description:
20" Entry Hatch appeared to be in fair condition with a minor amount of corrosion.

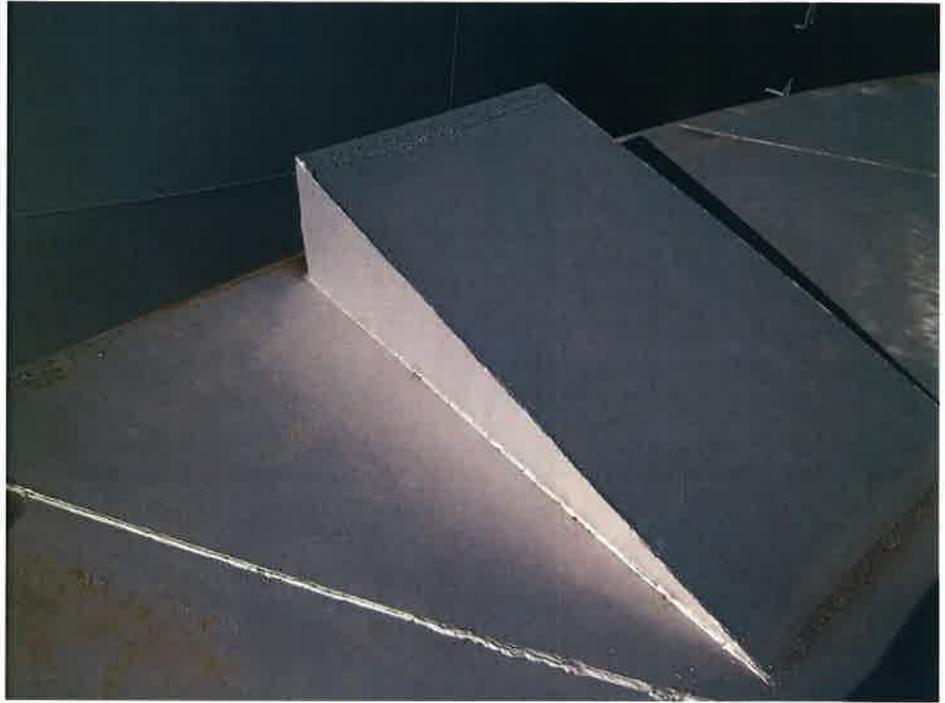
Image #13

Condition:
Rust Grade¹ 9.

Description:
30"x10" Side Vent
appeared to be in good
condition with a minor
amount of corrosion.

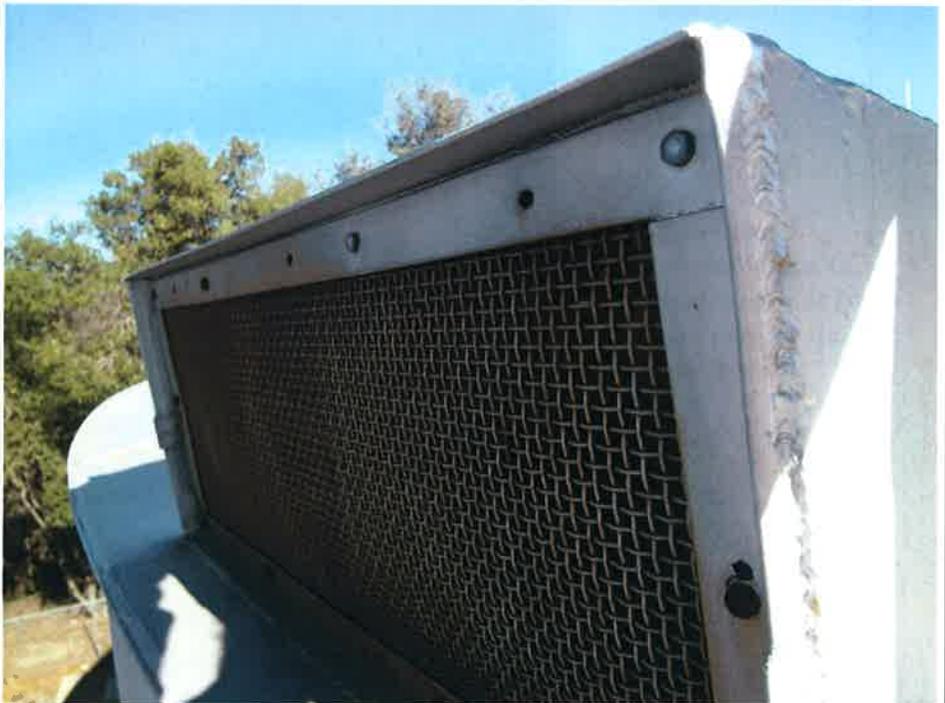
Image #14

Vent Screen 1:00

Condition:
Rust Grade¹ 7.

Description:
Medium Mesh Vent
Screen appeared to be
in good condition with
a minor amount of
corrosion.

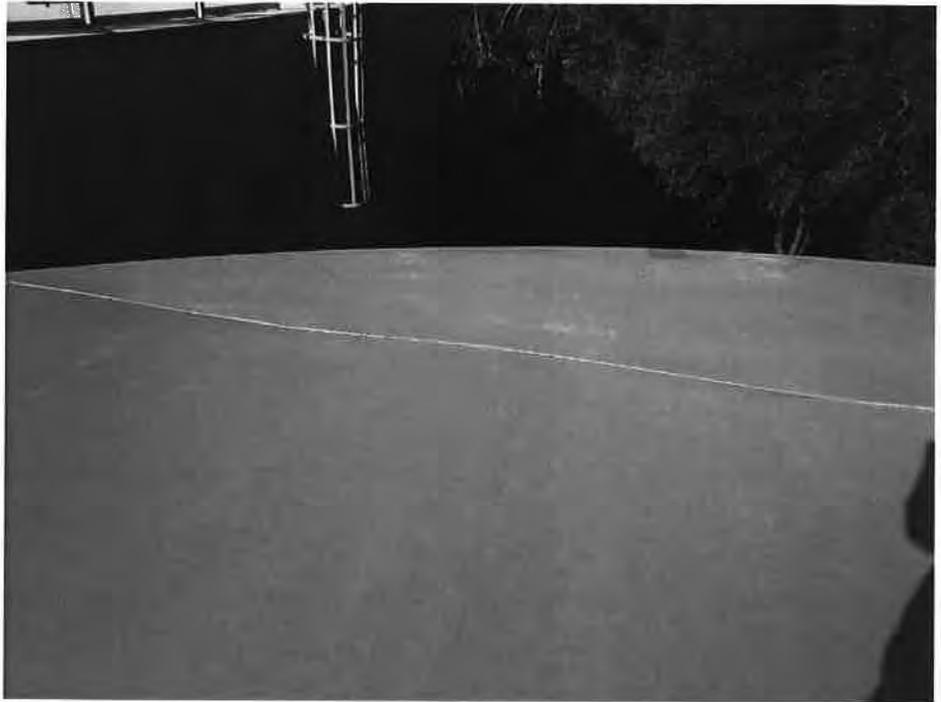
Image #15

Condition:
Rust Grade¹ 8.

Description:
Roof appeared to be in good condition with a minor amount of corrosion and chalking observed.

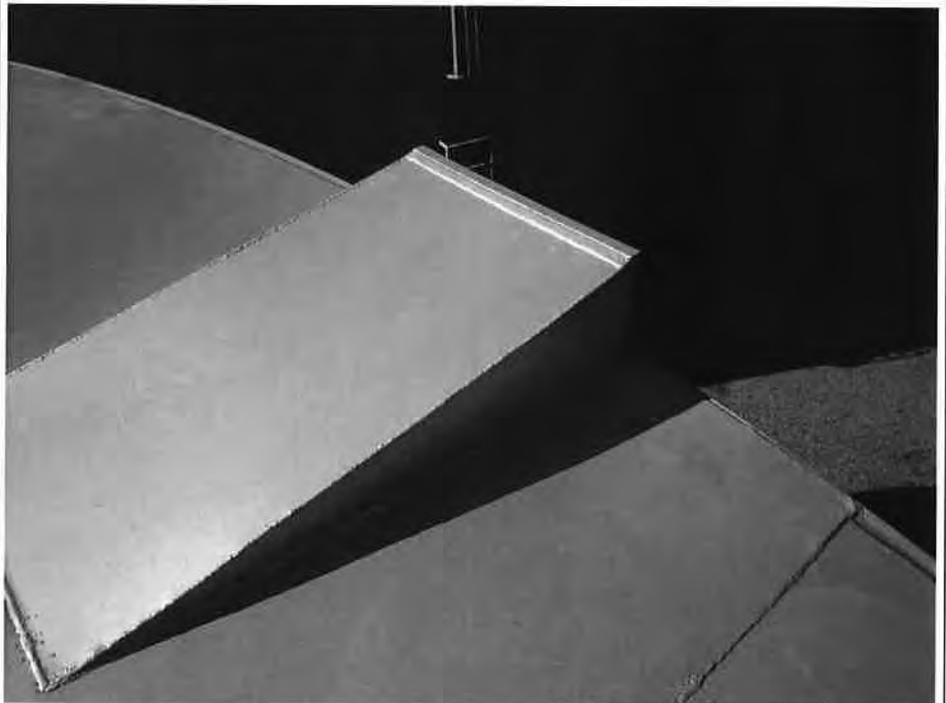
Image #16

Vent 3:00

Condition:
Rust Grade¹ 9.

Description:
30"x10" Vent appeared to be in good condition with a minor amount of corrosion.

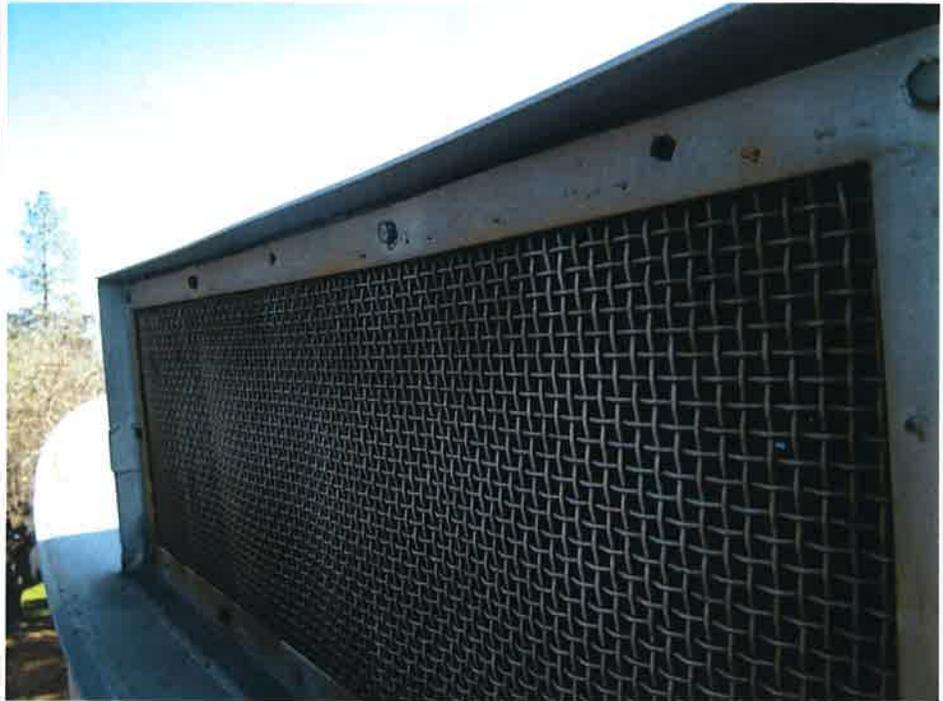
Image #17

Condition:
Rust Grade' 8.

Description:
Medium Mesh Vent
Screen appeared to be in good
condition with a minor amount of
corrosion.

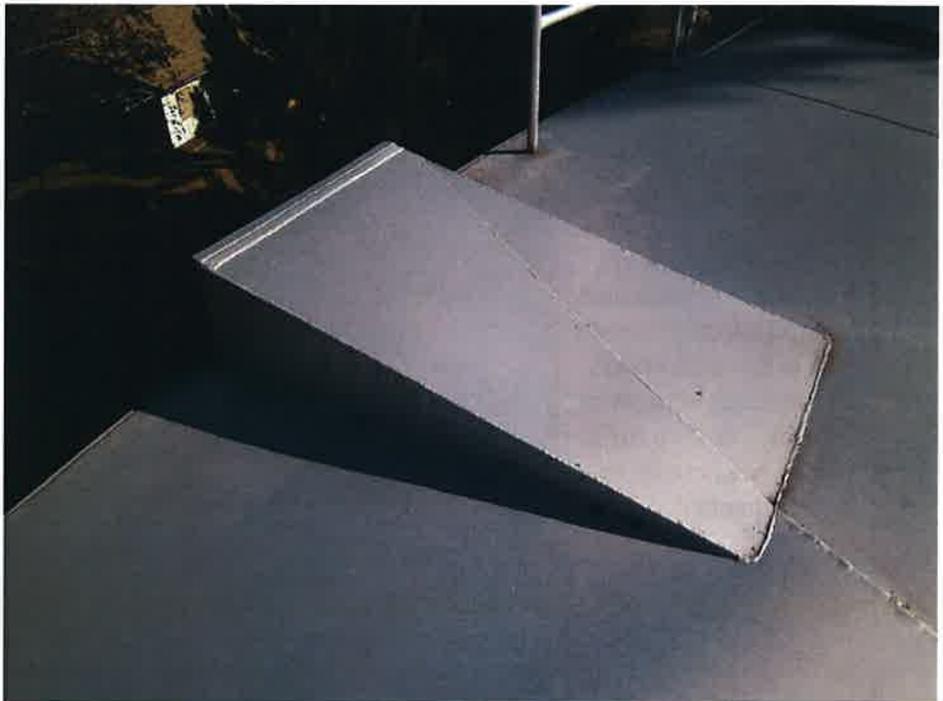
Image #18

Side Vent 5:00

Condition:
Rust Grade' 9.

Description:
30"x10" Side Vent
appeared to be in good
condition with a minor
amount of corrosion.

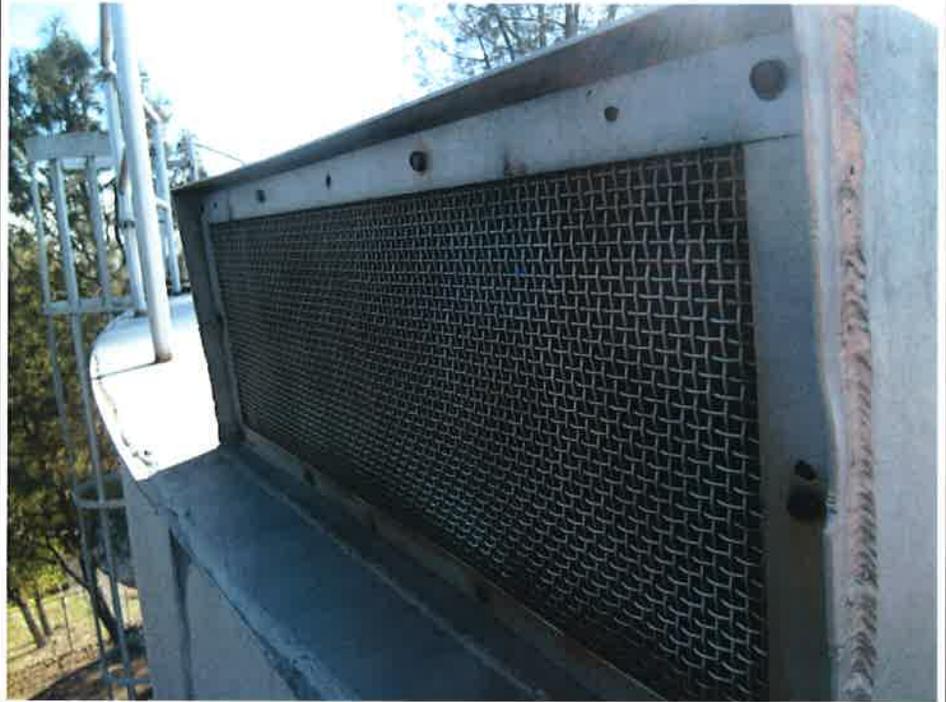
Image #19

Condition:
Rust Grade! 9.

Description:
Medium Mesh Vent
Screen appeared to be
in good condition with
a minor amount of
corrosion.

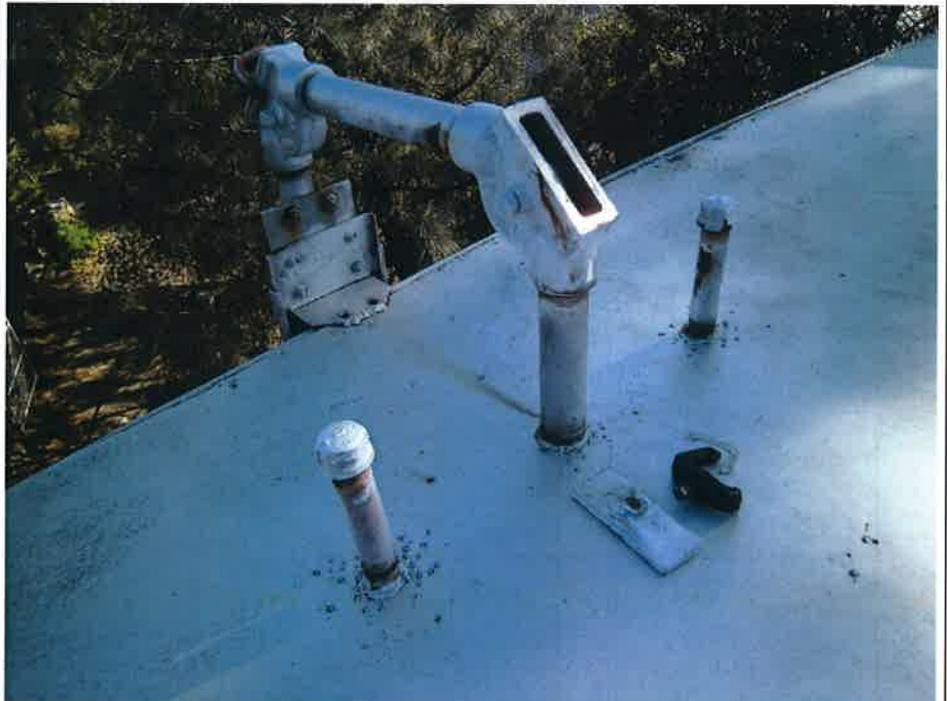
Image #20

*Liquid Level Indicator
Penetration 6:30*

Condition:
Rust Grade! 6.

Description:
Liquid Level Indicator
Penetration appeared to
be in fair condition
with a minor amount of
corrosion. Cap for
pulley needs to be re-
attached.

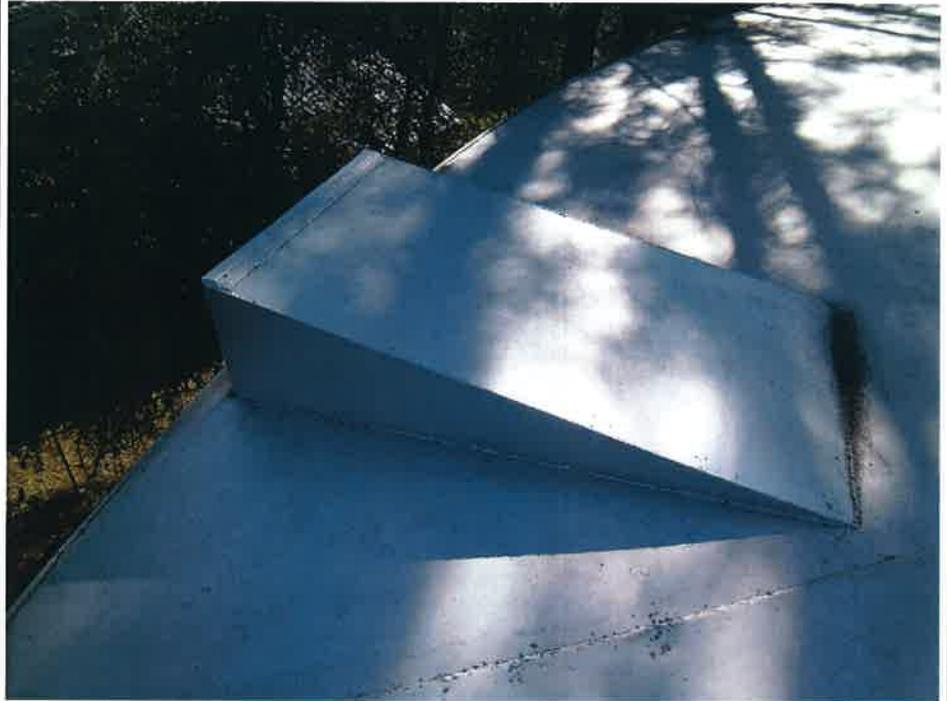
Image #21

Condition:
Rust Grade' 9.

Description:
30"x10" Side Vent
appeared to be in good
condition with a minor
amount of corrosion.

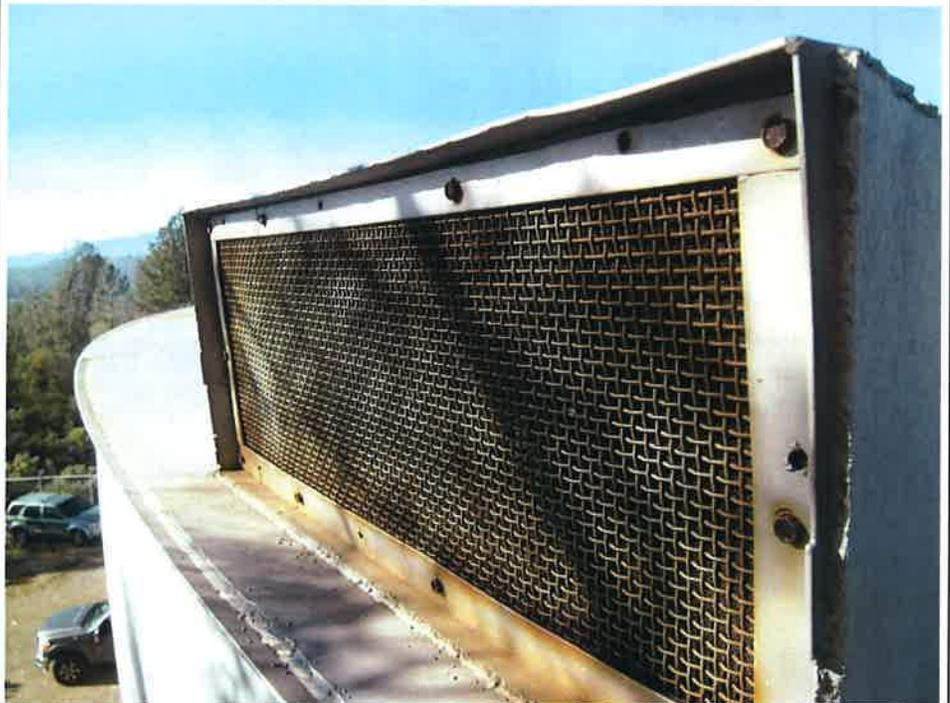
Condition:
Rust Grade' 8.

Description:
Medium Mesh Vent
Screen appeared to be
in good condition with
a minor amount of
corrosion.

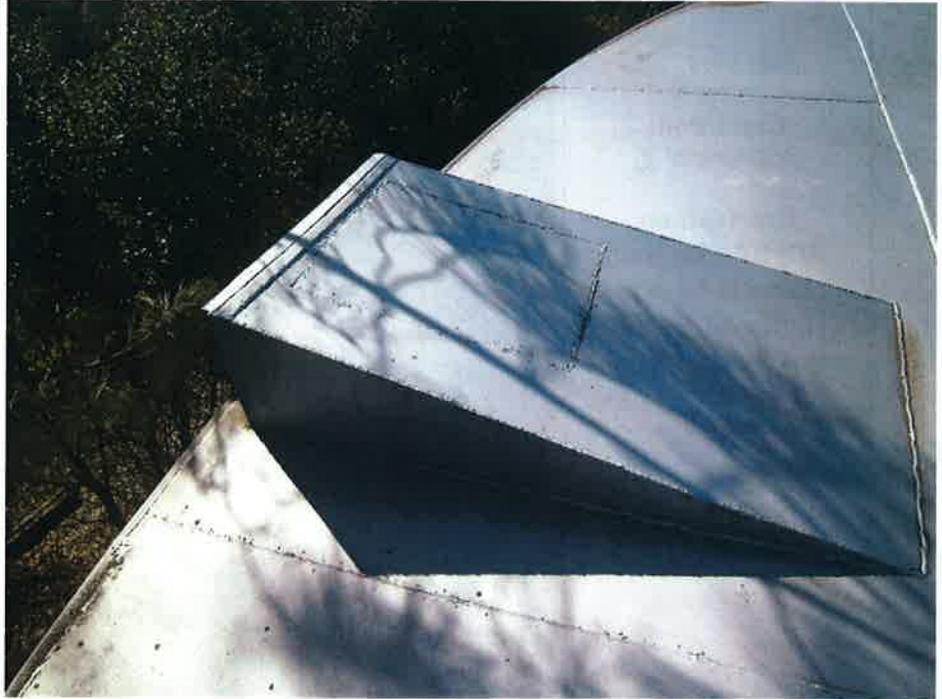
Image #24

Condition:
Rust Grade¹ 9.

Description:
30"x10" Side Vent appeared to be in good condition with a minor amount of corrosion.

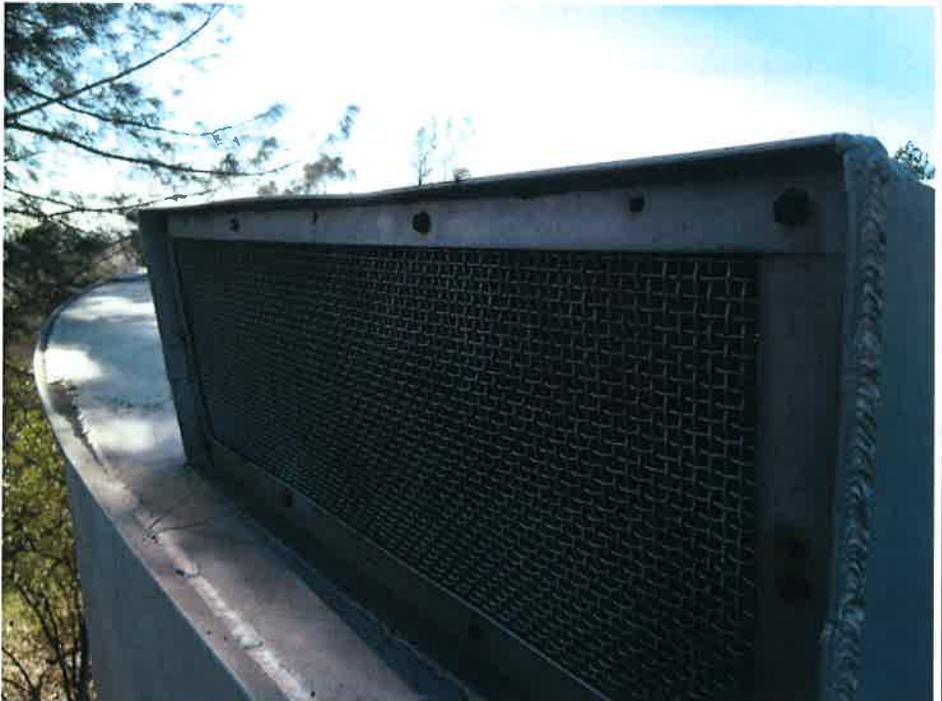
Image #25

Condition:
Rust Grade¹ 9.

Description:
Medium Mesh Vent Screen appeared to be in good condition with a minor amount of corrosion.

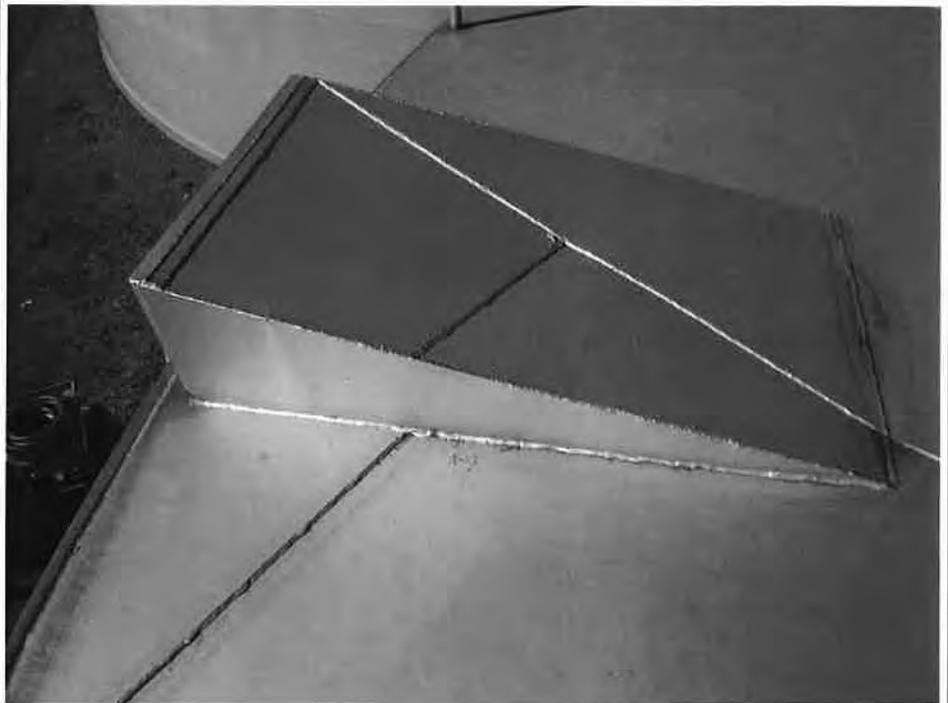
Image #27

Condition:
Rust Grade' 9.

Description:
30"x10" Side Vent appeared to be in good condition with a minor amount of corrosion.

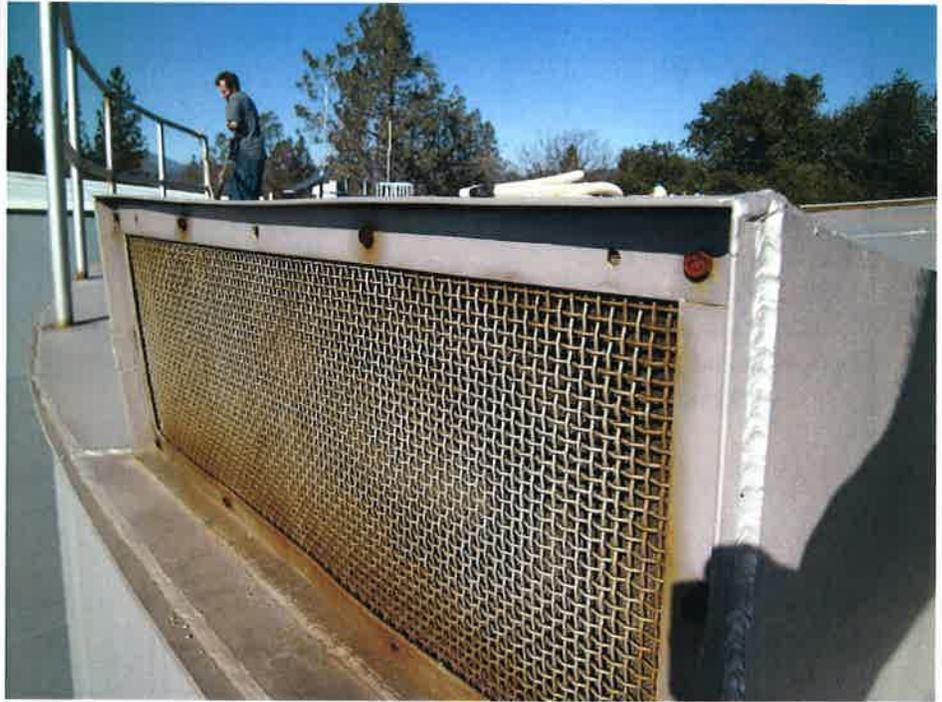
Image #28

Condition:
Rust Grade¹ 8.

Description:
Medium Mesh Vent Screen appeared to be in good condition with a minor amount of corrosion.

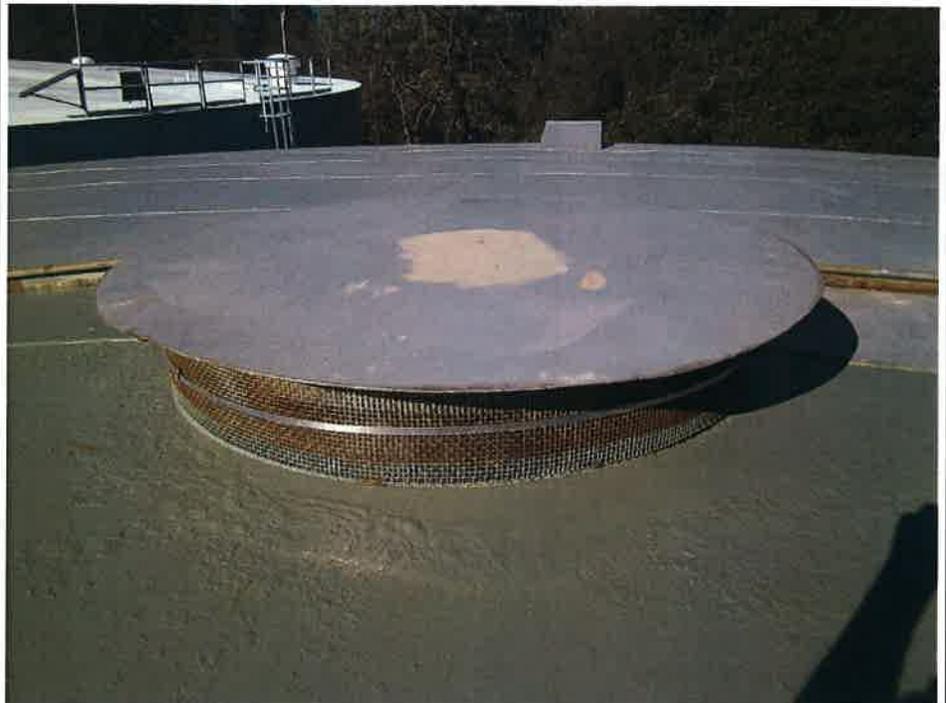
Image #29

Condition:
Rust Grade¹ 9.

Description:
40" Vent appeared to be in good condition with a minor amount of corrosion.

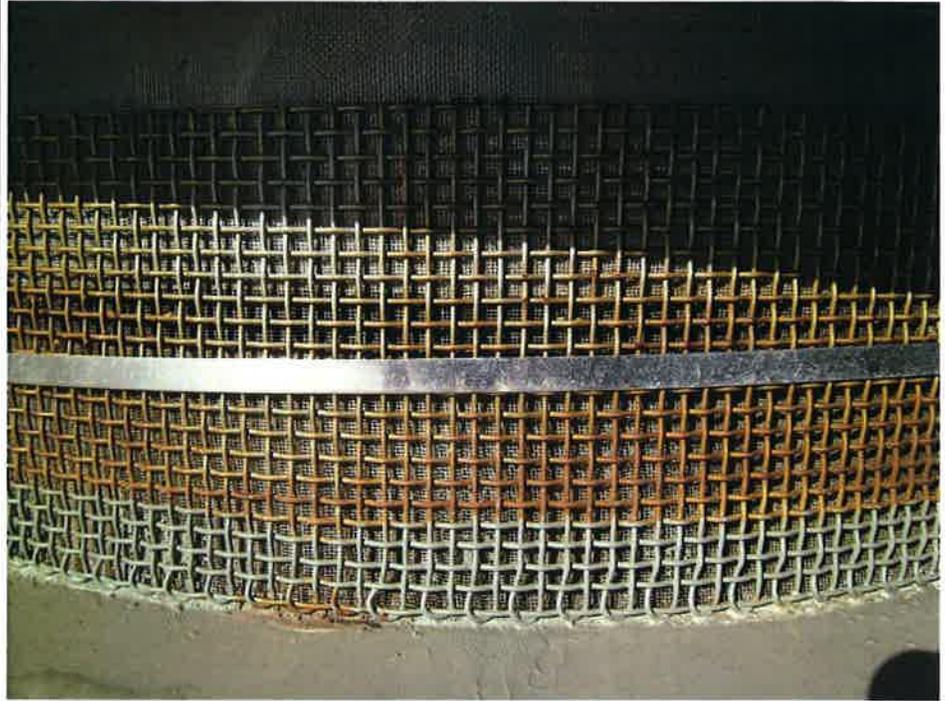
Image #30

Condition:
Rust Grade¹ 8.

Description:
Medium and Fine Mesh Vent Screens appeared to be in good condition with a minor amount of corrosion.

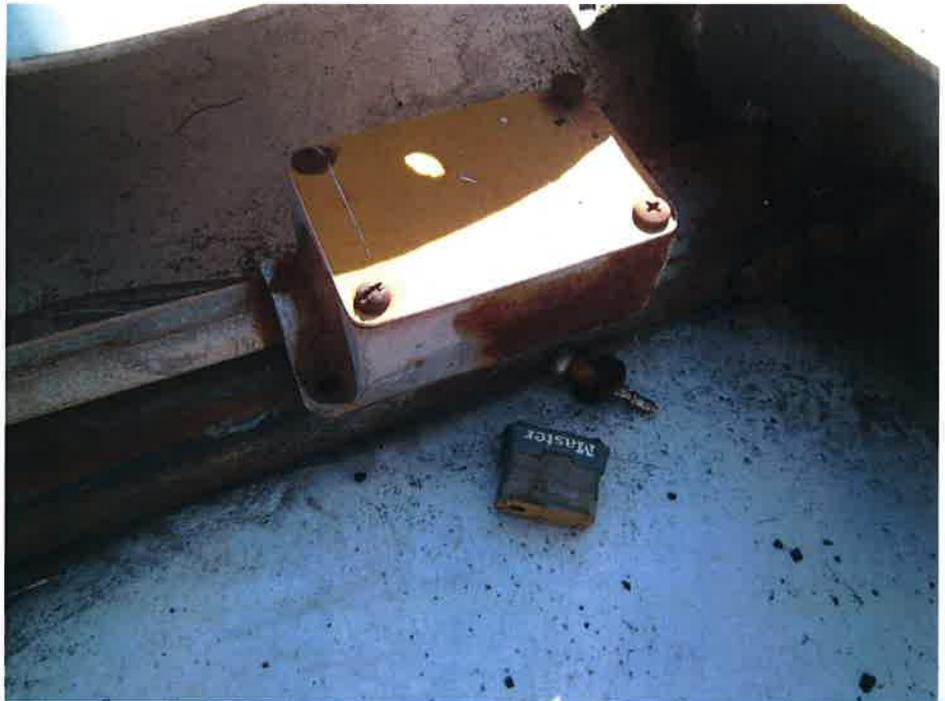
Image #31

Condition:
Rust Grade¹ 7.

Description:
1" Telemetry Penetration appeared to be in good condition with a minor amount of corrosion.

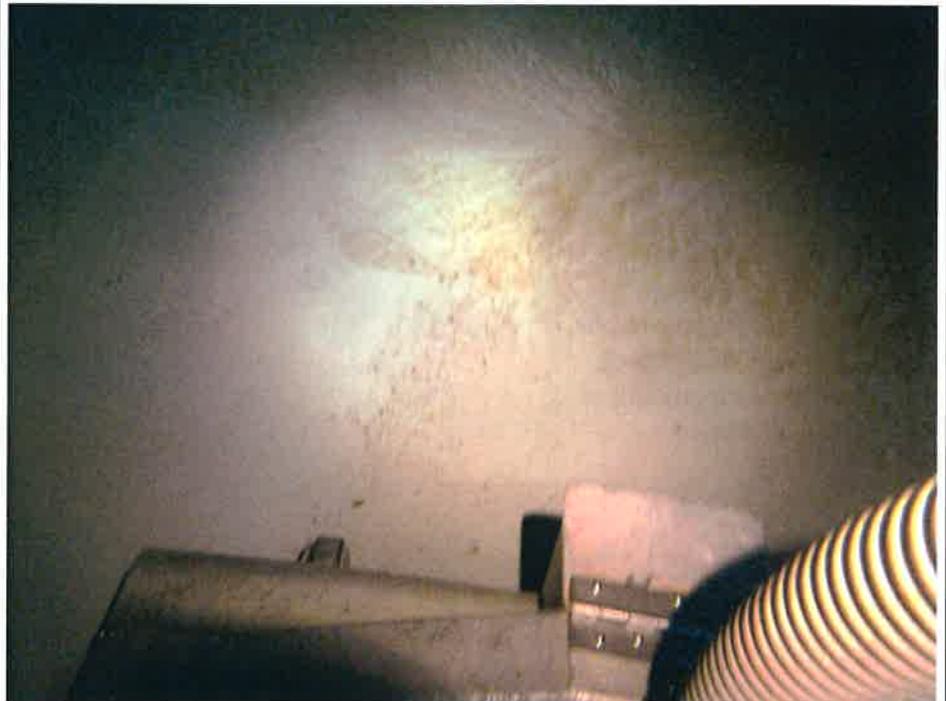
Image #33

Sediment

Description:
1/32" of sediment was removed from reservoir floor.

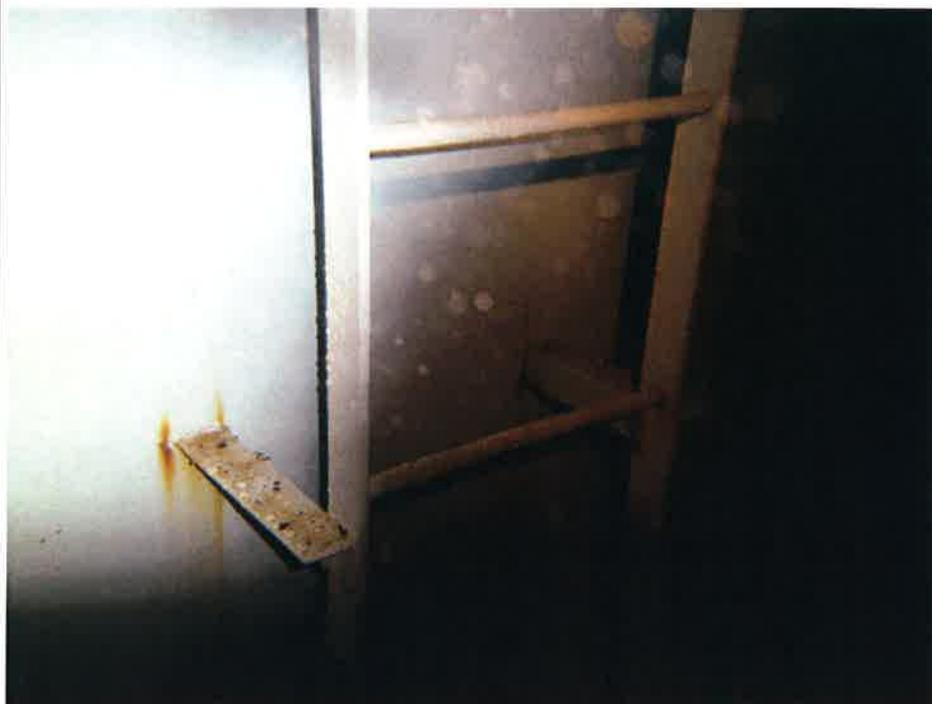
Image #34

Condition:
Rust Grade¹ 7.

Description:
Interior Ladder appeared to be in good condition with a minor amount of corrosion.

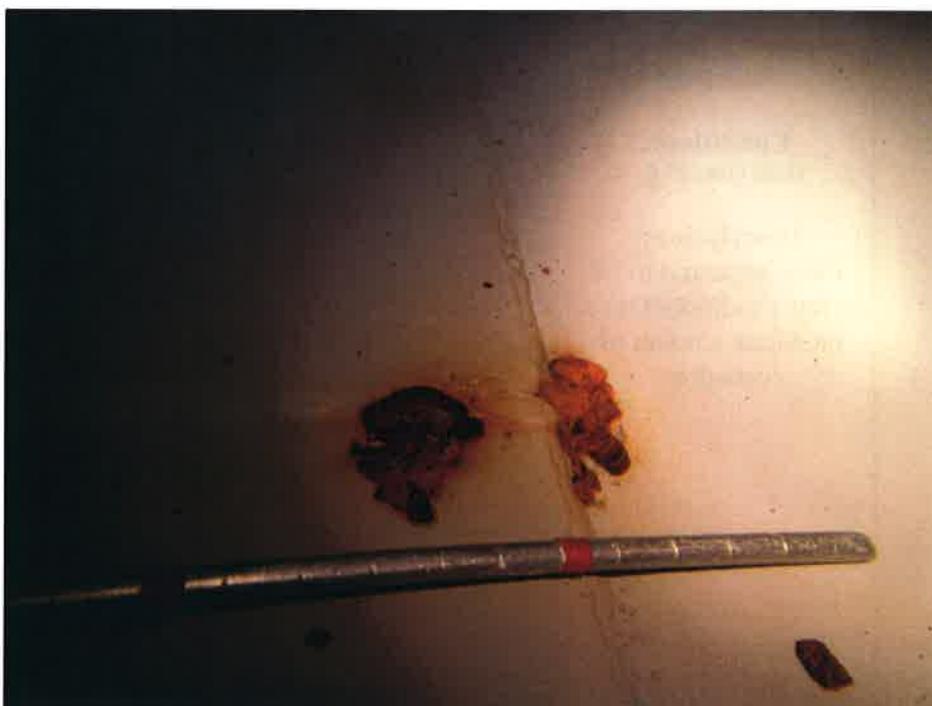
Image #35

Condition:
Rust Grade¹ 6.

Description:
Floor appeared to be in fair condition with a moderate amount of corrosion.

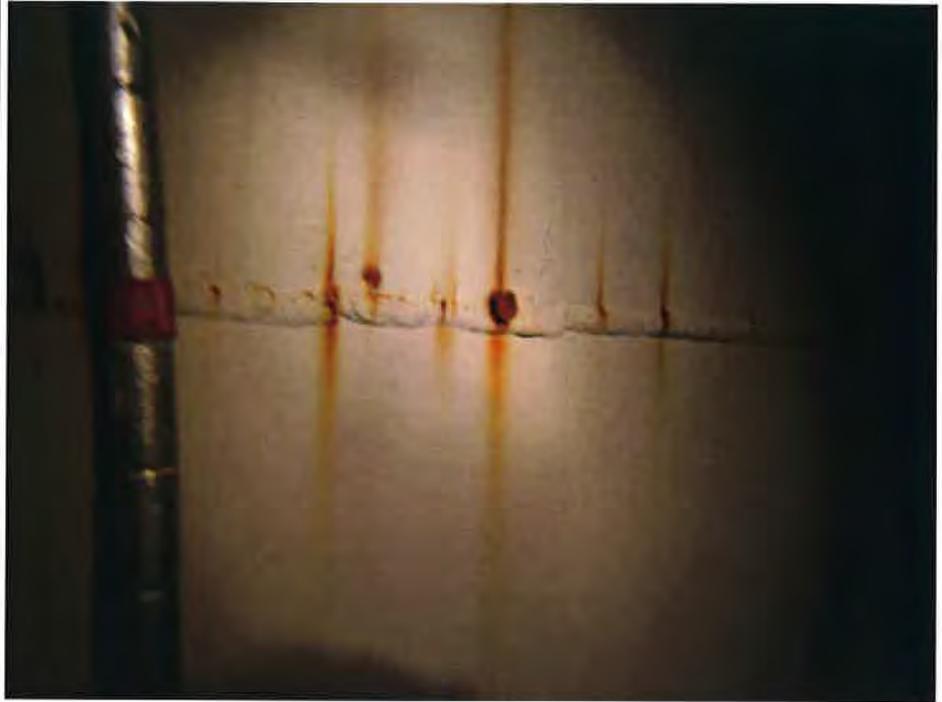
Image #36

Condition:
Rust Grade! 6.

Description:
Wall appeared to be in fair condition with a moderate amount of corrosion.

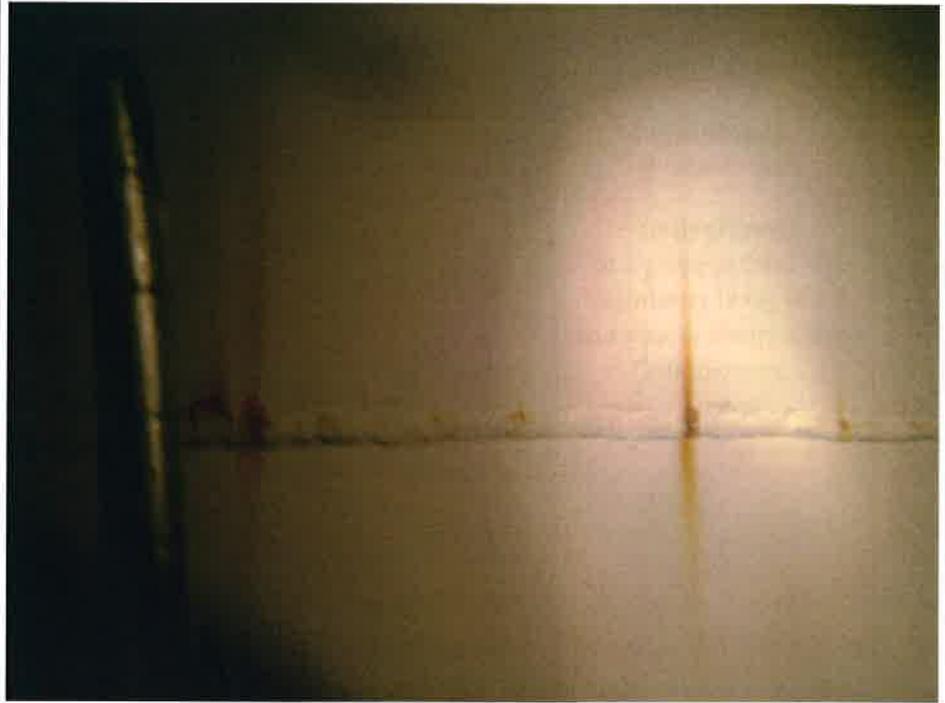
Image #38

Condition:
Rust Grade¹ 6.

Description:
Wall appeared to be in fair condition with a moderate amount of corrosion.

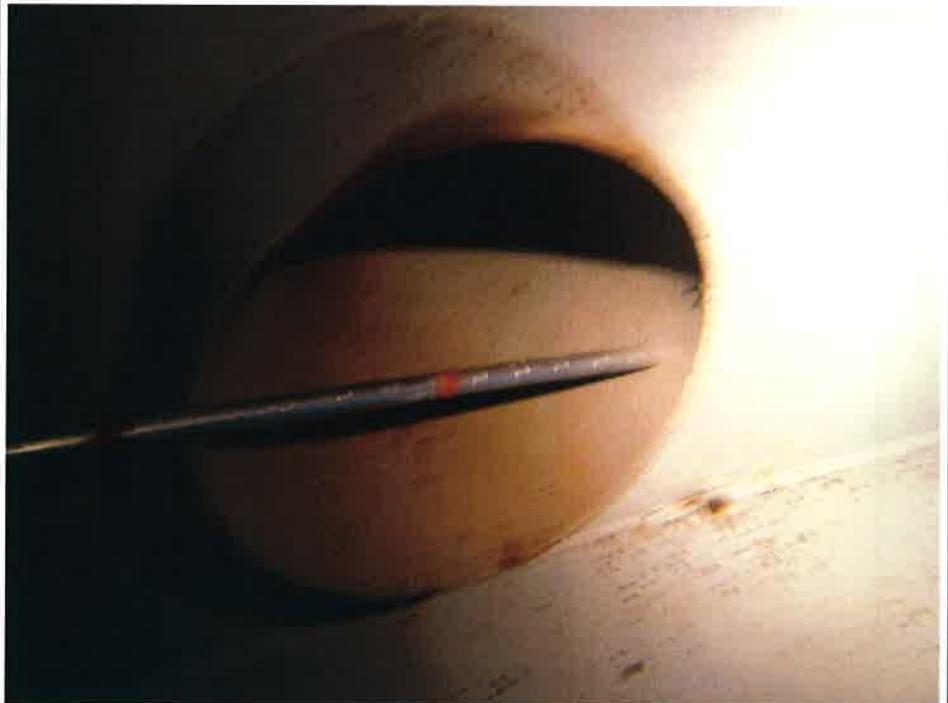
Image #39

Condition:
Rust Grade¹ 7.

Description:
10" Capped Off Penetration appeared to be in good condition with a minor amount of corrosion.

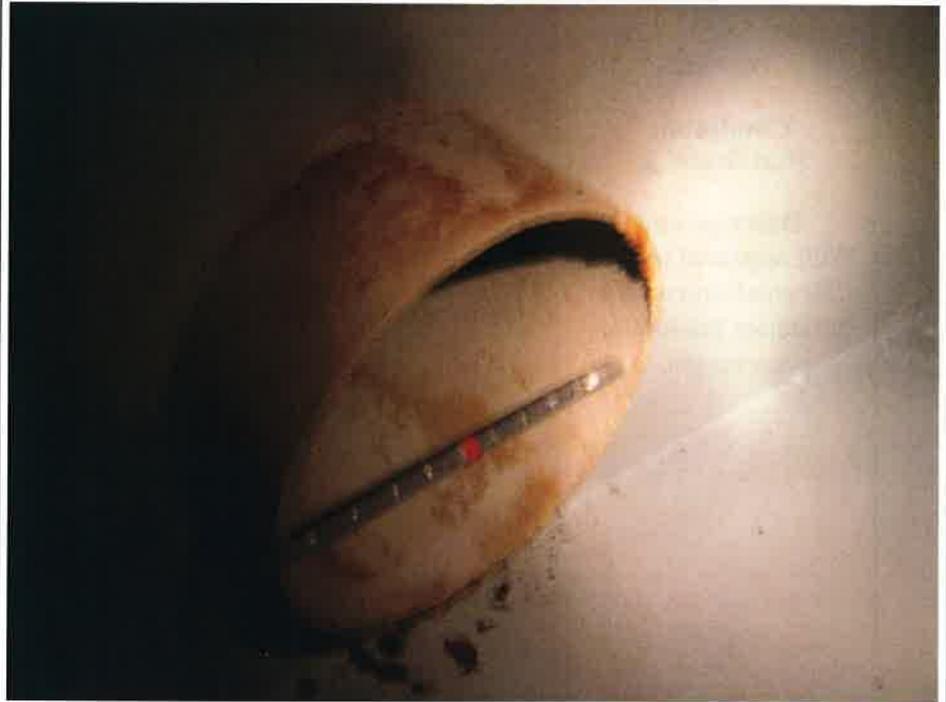
Image #40

Condition:
Rust Grade¹ 9.

Description:
10" Inlet appeared to be in good condition with a minor amount of corrosion.

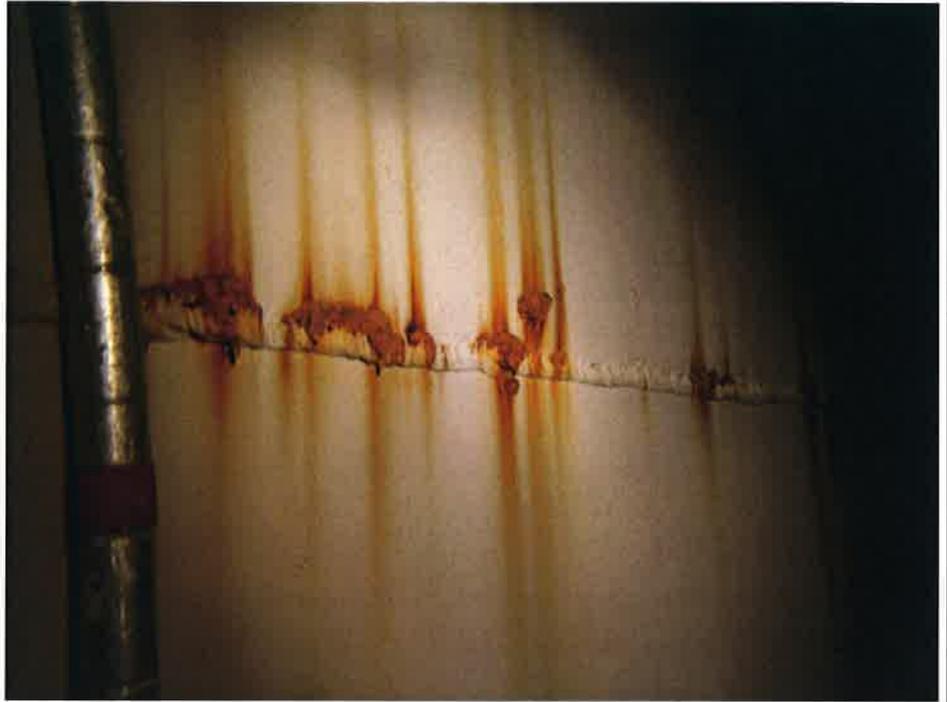
Image #42

Condition:
Rust Grade' 6.

Description:
Wall appeared to be in fair condition with a moderate amount of corrosion.

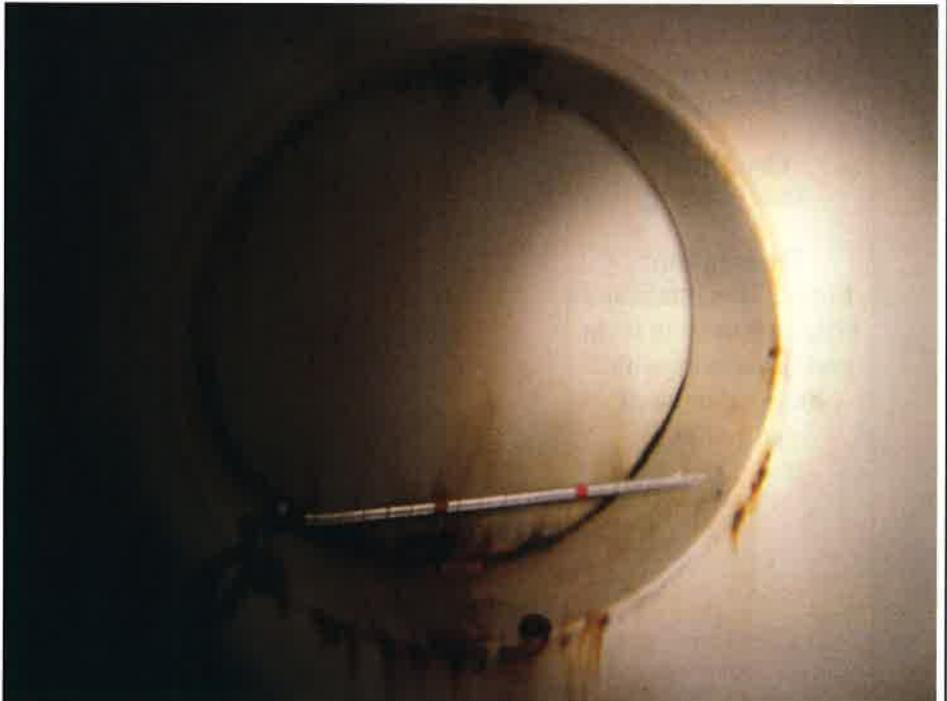
Image #43

Condition:
Rust Grade' 6.

Description:
24" Man Way appeared to be in fair condition with a moderate amount of corrosion.

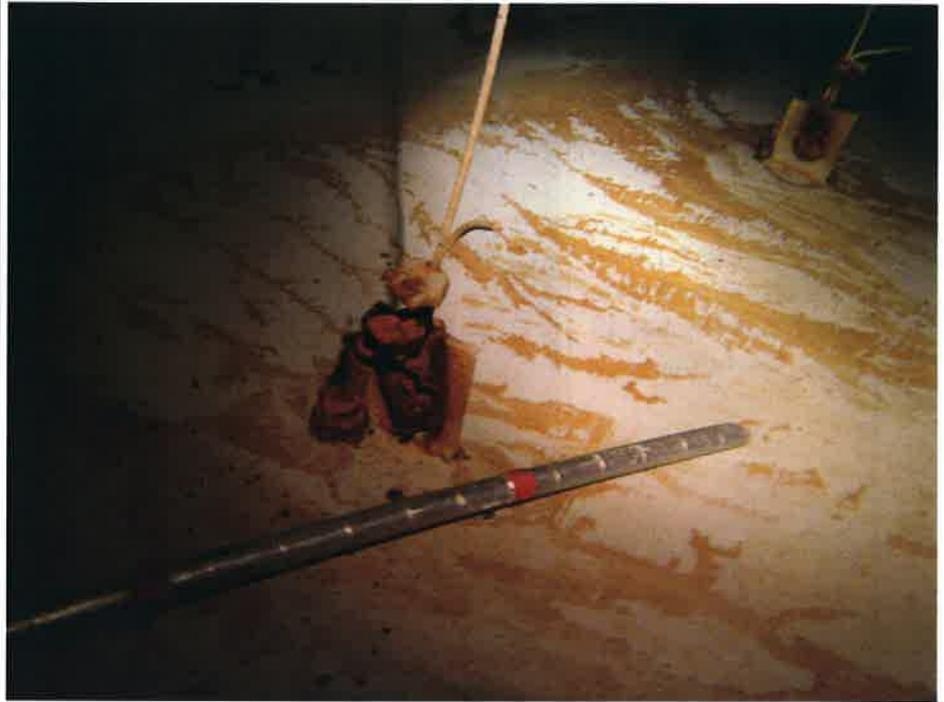
Image #44

Condition:
Rust Grade! 1.

Description:
Liquid Level Indicator
Base appeared to be in
fair condition with a
heavy amount of
corrosion.
