CITY OF SHASTA LAKE

2016-2026 WATER MASTER PLAN

FINAL • OCTOBER 2016

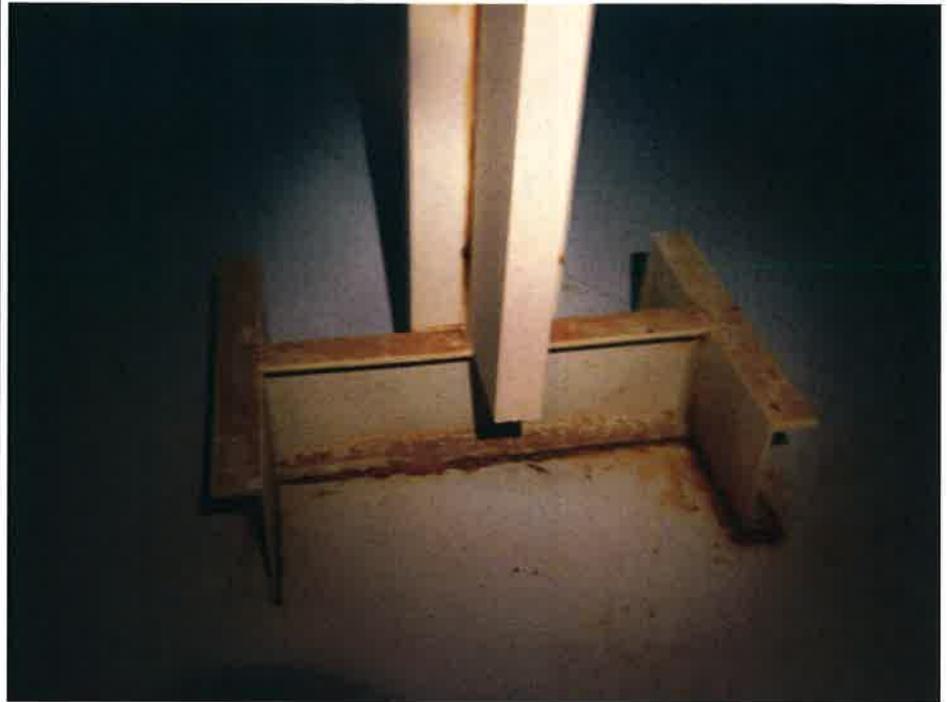
Image #46

Condition:
Rust Grade 7.

Description:
8" Column appeared to be in good condition with a minor amount of corrosion.

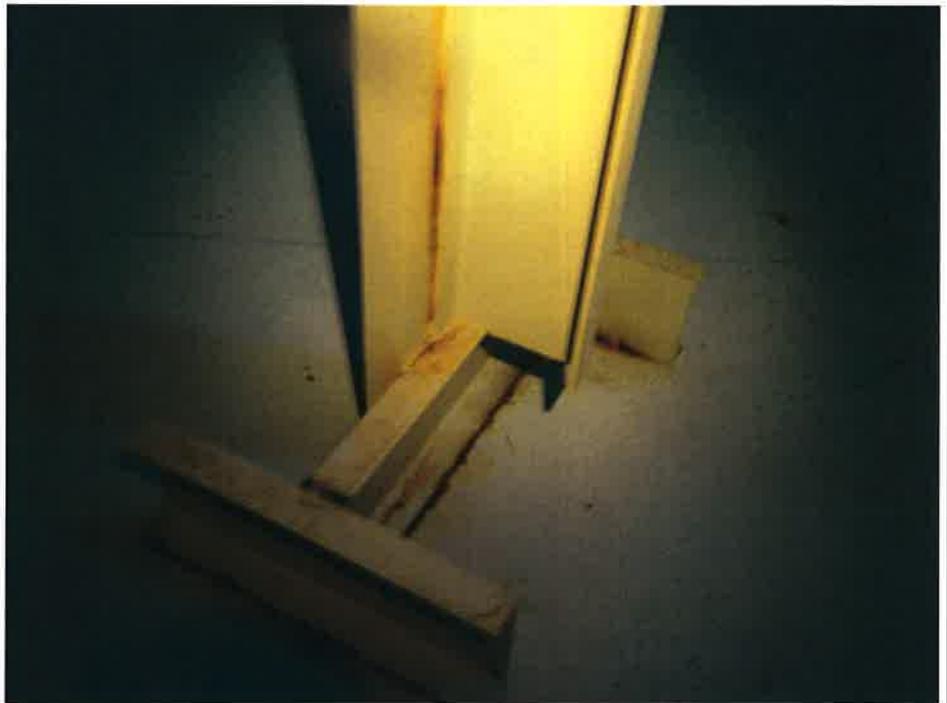
Image #47

Condition:
Rust Grade 7.

Description:
8" Column appeared to be in good condition with a minor amount of corrosion.

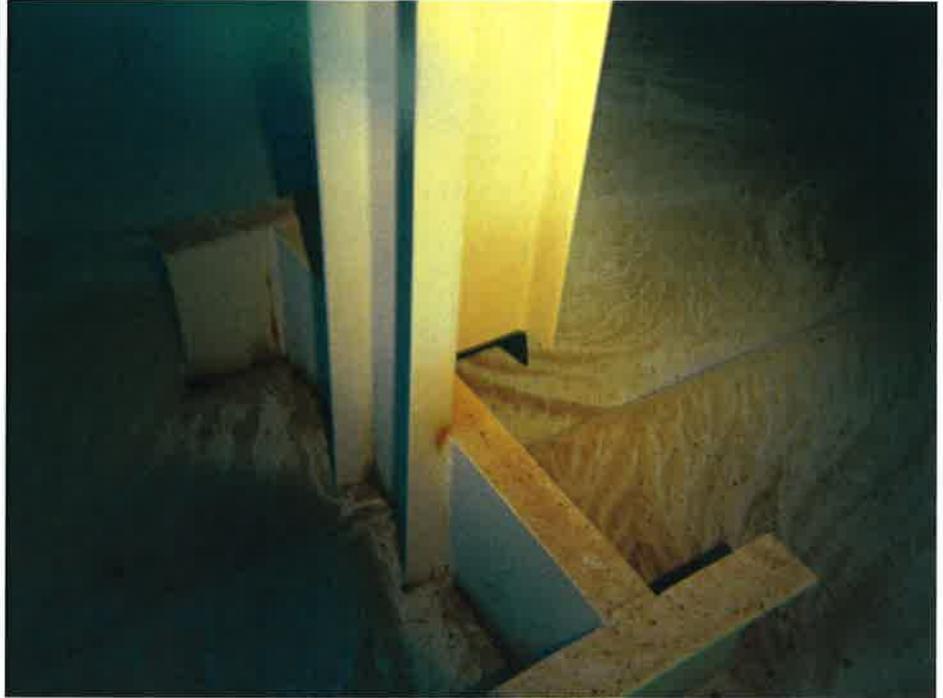
Image #48

Condition:
Rust Grade¹ 7.

Description:
8" Column appeared to be in good condition with a minor amount of corrosion.

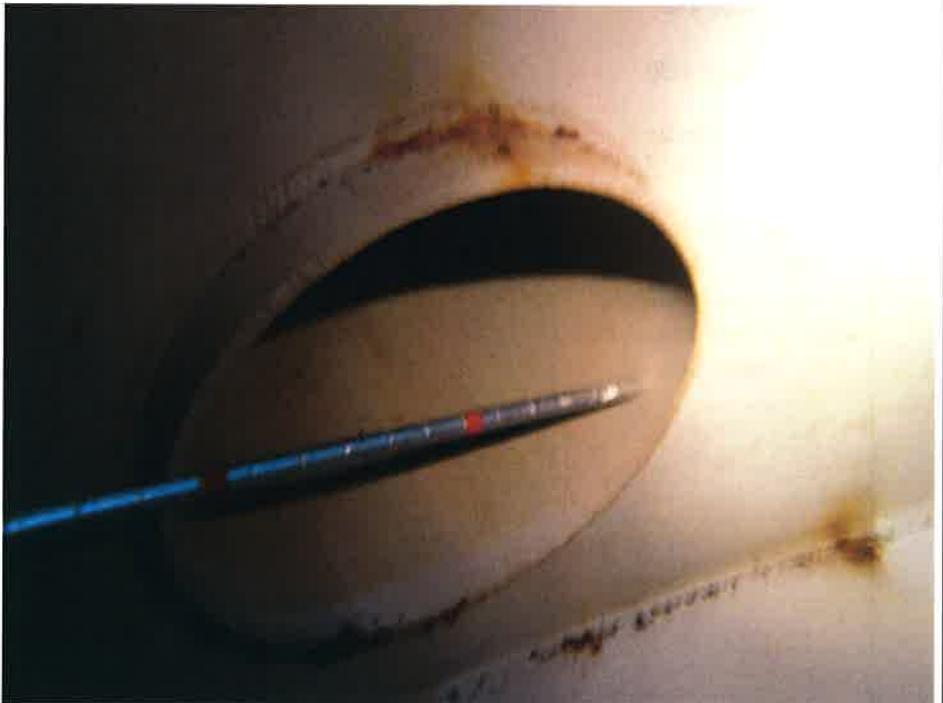
Image #49

Condition:
Rust Grade¹ 7.

Description:
12" Outlet appeared to be in good condition with a minor amount of corrosion.

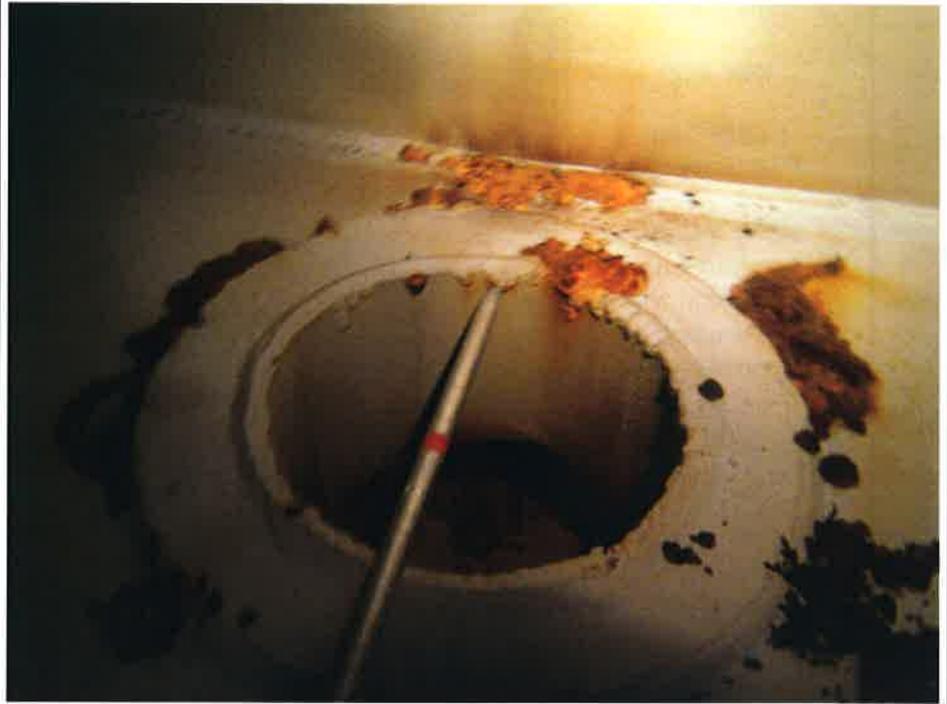
Image #50

Condition:
Rust Grade¹ 6.

Description:
8" Drain appeared to be in good condition with a moderate amount of corrosion.

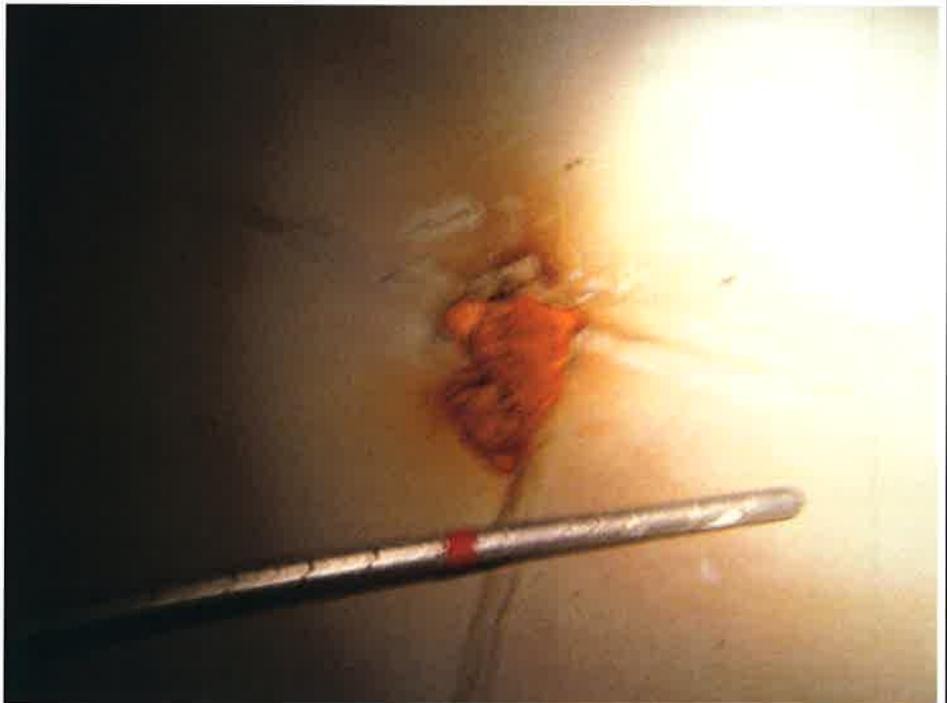
Image #51

Condition:
Rust Grade¹ 6.

Description:
Floor appeared to be in fair condition with a moderate amount of corrosion.

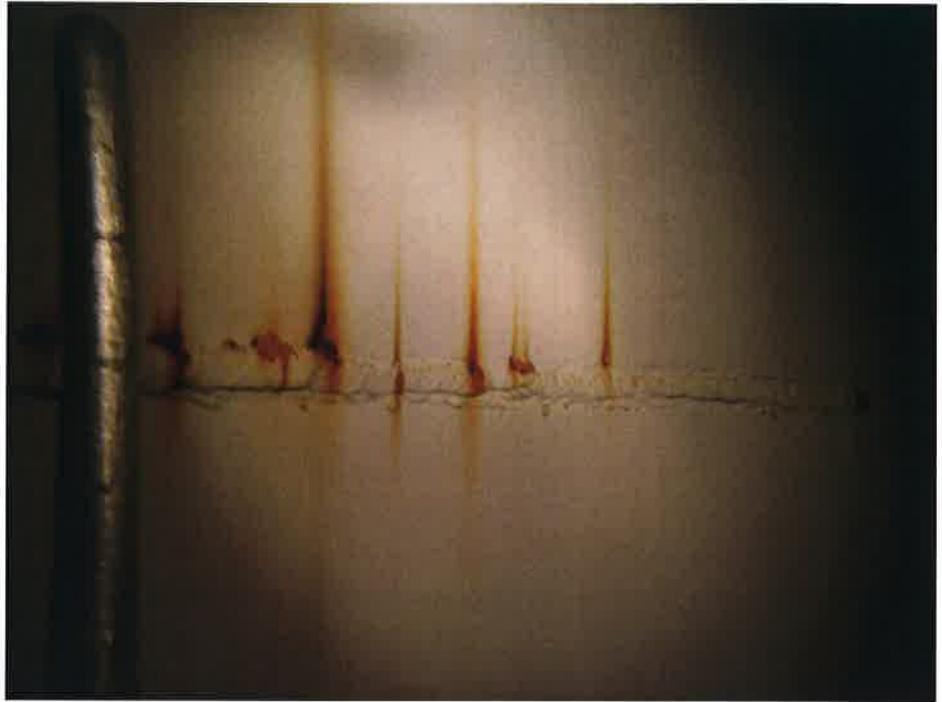
Image #52

Condition:
Rust Grade' 6.

Description:
Wall appeared to be in fair condition with a moderate amount of corrosion.

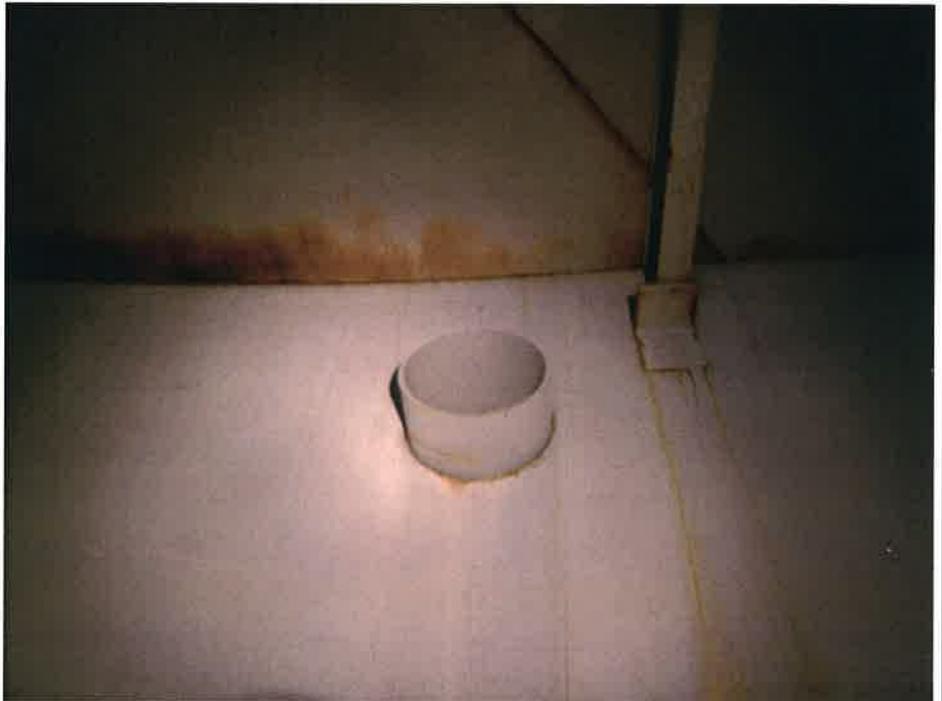
Condition:
Rust Grade' 7.

Description:
8'' Overflow appeared to be in good condition with a minor amount of corrosion.

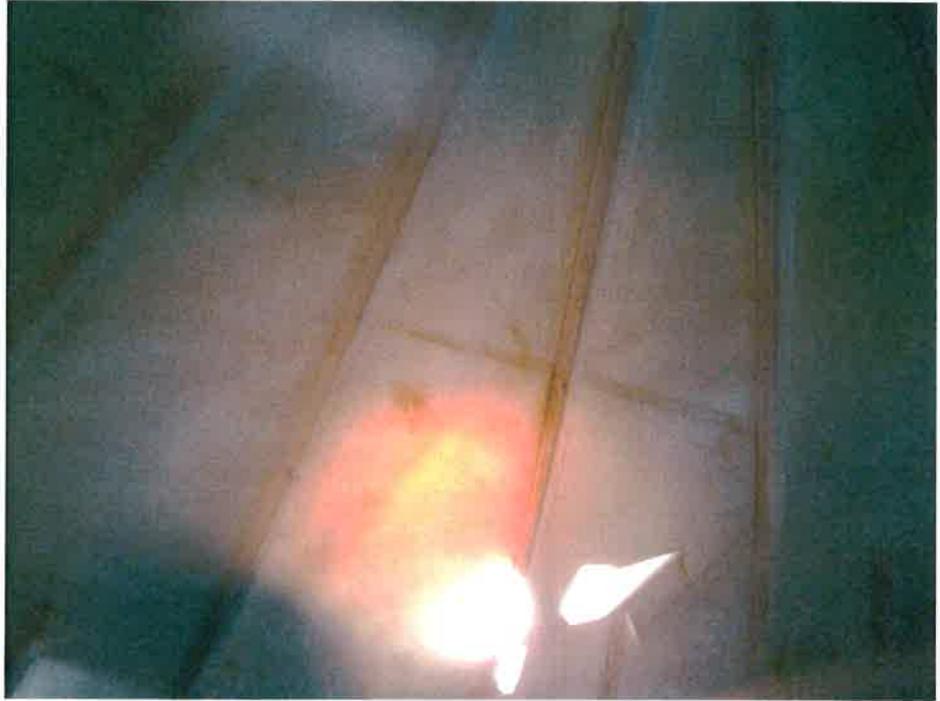
Image #54

Condition:
Rust Grade¹ 6.

Description:
Ceiling appeared to be in fair condition with a minor amount of corrosion.

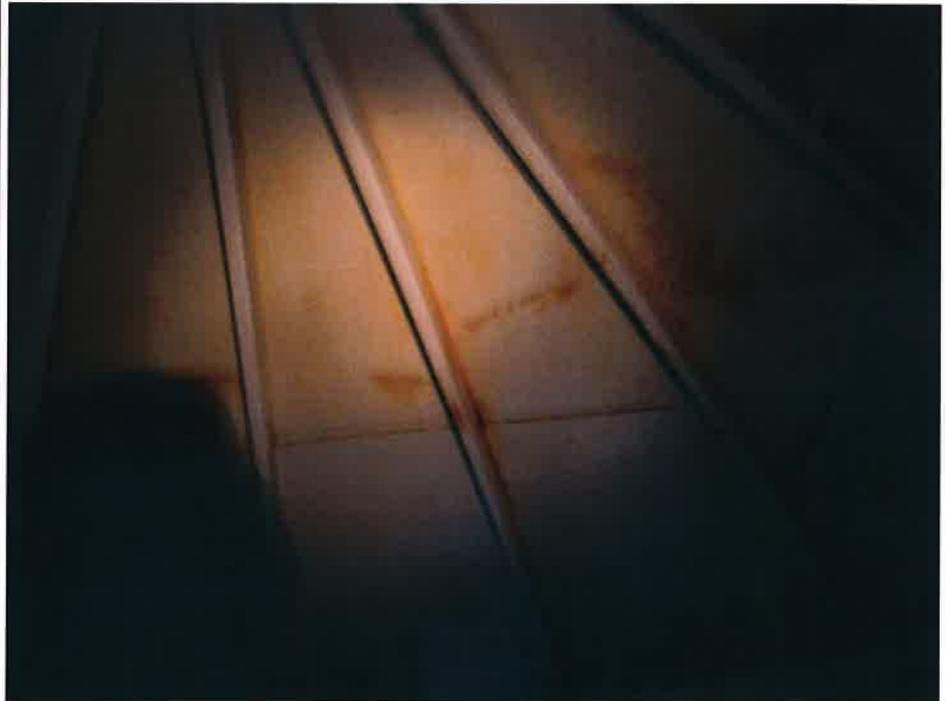
Image #55

Condition:
Rust Grade¹ 6.

Description:
Ceiling appeared to be in fair condition with a minor amount of corrosion.

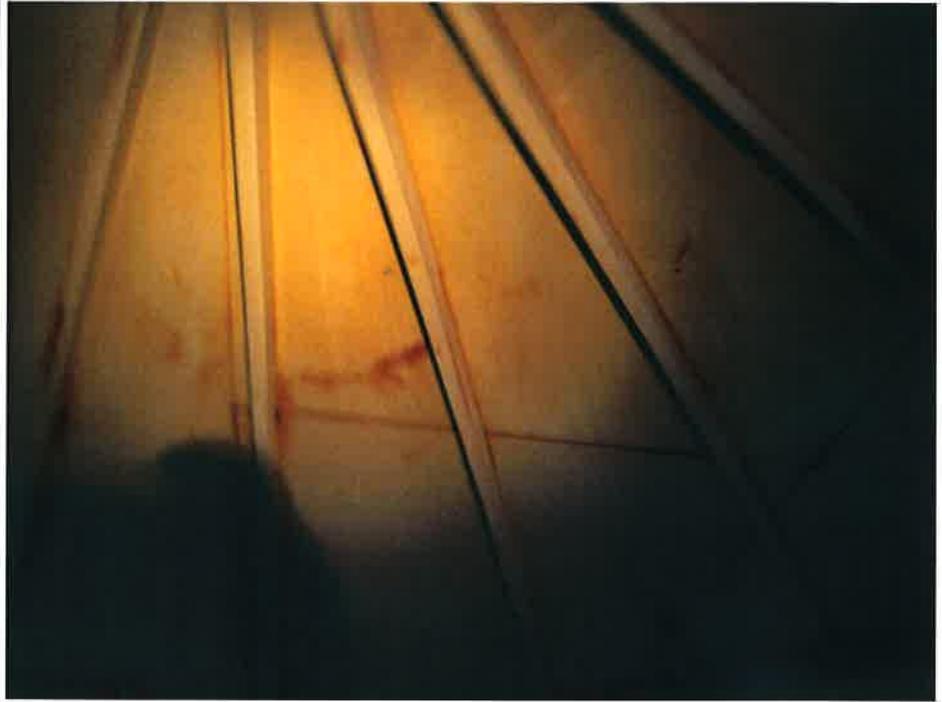
Image #56

Condition:
Rust Grade¹ 6.

Description:
Ceiling appeared to be in fair condition with a minor amount of corrosion.

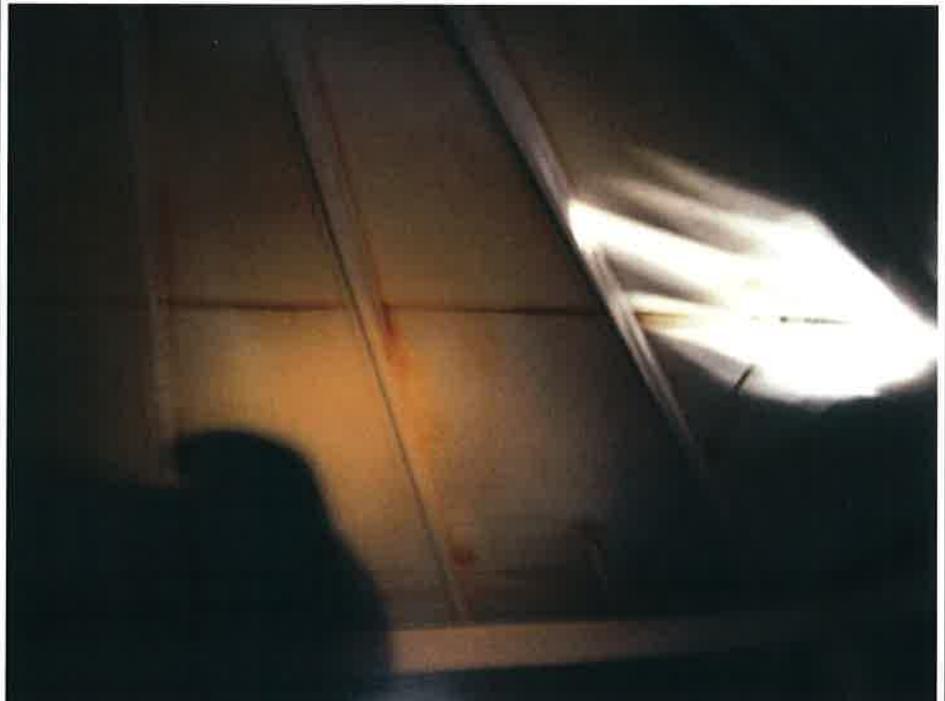
Condition:
Rust Grade¹ 6.

Description:
Ceiling appeared to be in fair condition with a minor amount of corrosion.

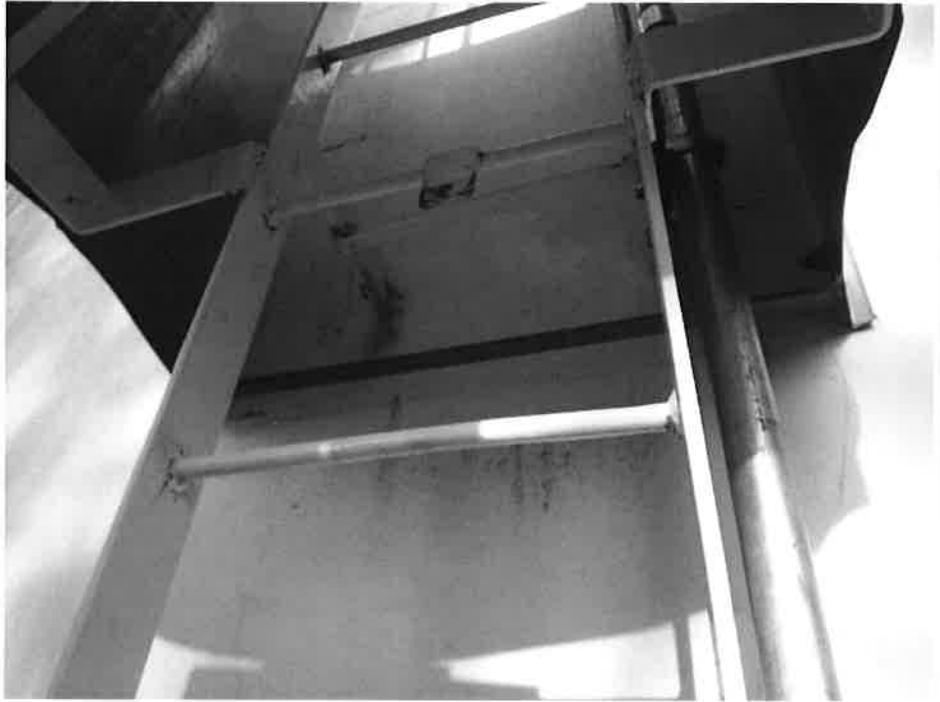
Image #2

Condition:
Rust Grade¹ 9.

Description:
Exterior Ladder appeared to be in good condition with a minor amount of corrosion.

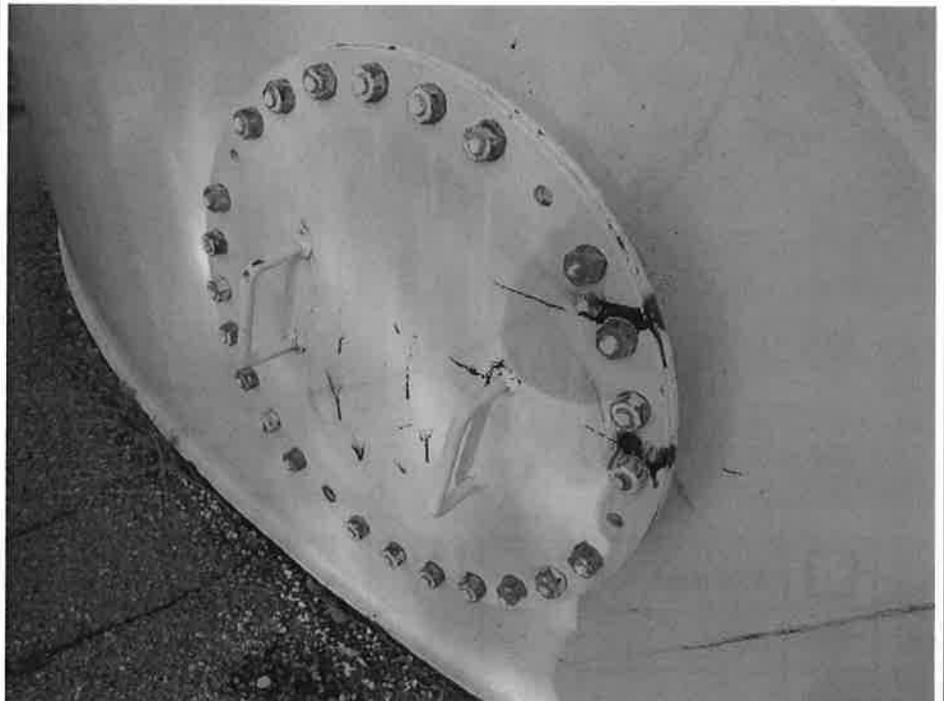
Image #3

Condition:
Rust Grade¹ 8.

Description:
24" Man Way appeared to be in good condition with a minor amount of corrosion.

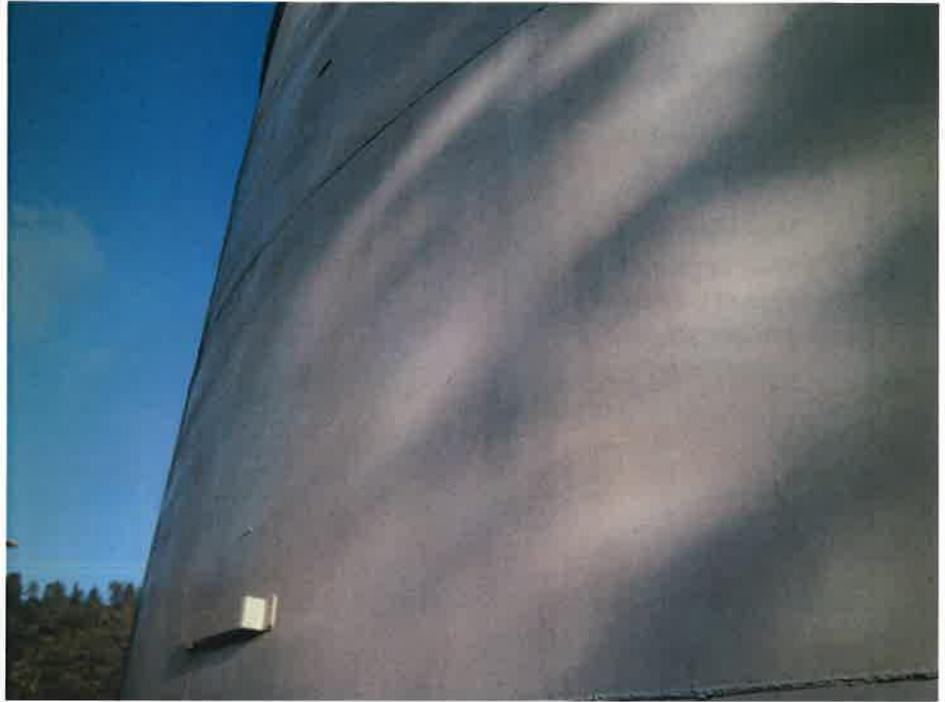
Image #4

Condition:
Rust Grade¹ 9.

Description:
Exterior Wall
appeared to be in good
condition with a minor
amount of corrosion.

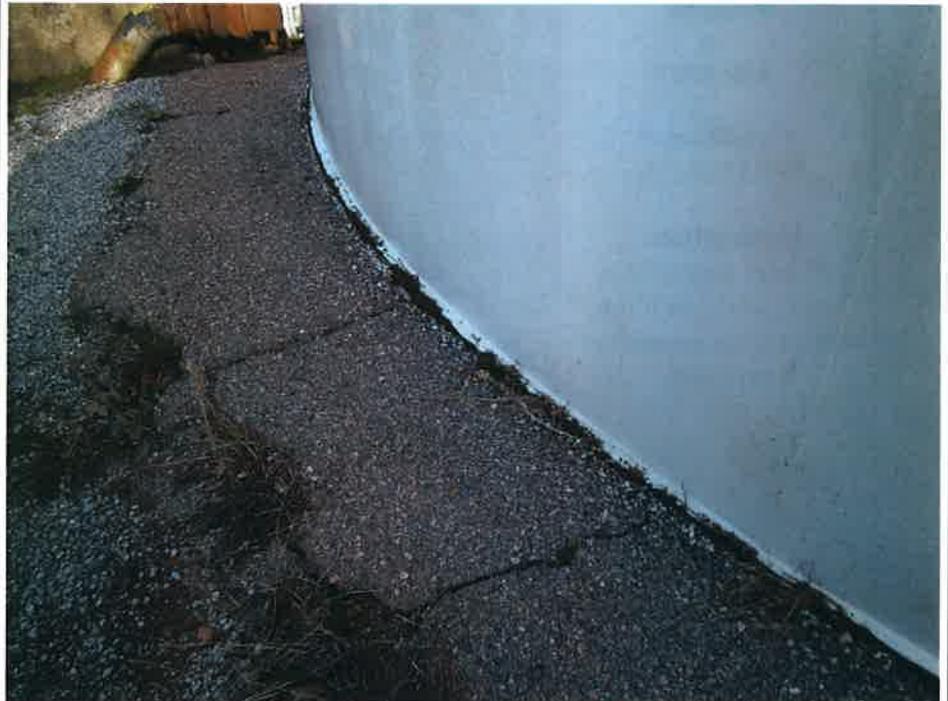
Image #5

Condition:
Concrete Deform³ CK.

Description:
Exterior Base
appeared to be in fair
condition with a
moderate amount of
cracking.

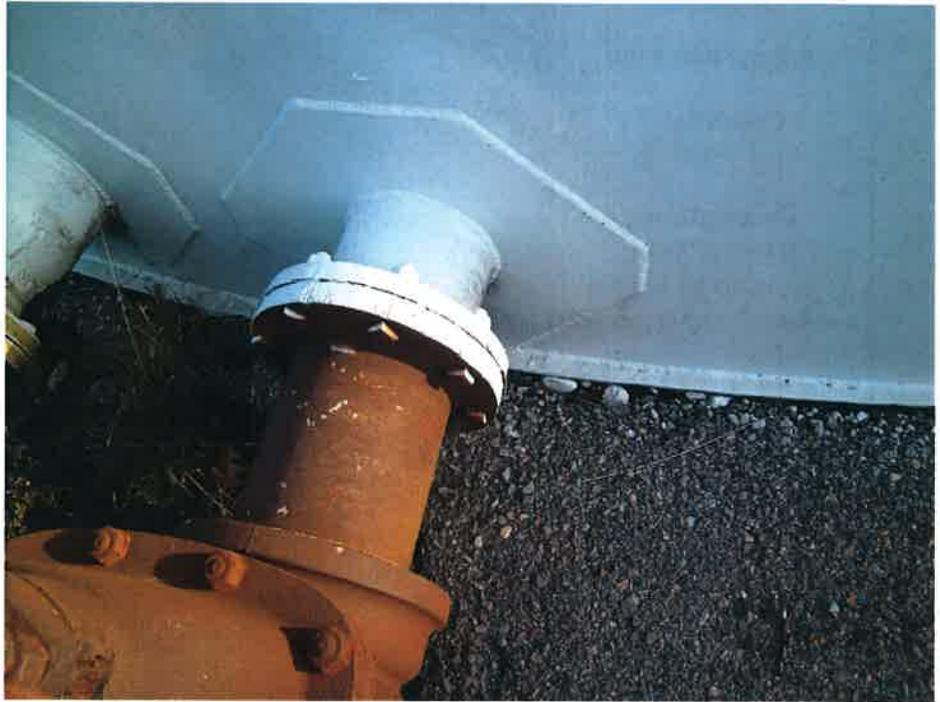
Image #6

Condition:
Rust Grade 9.

Description:
10" Inlet appeared to be in good condition with a minor amount of corrosion.

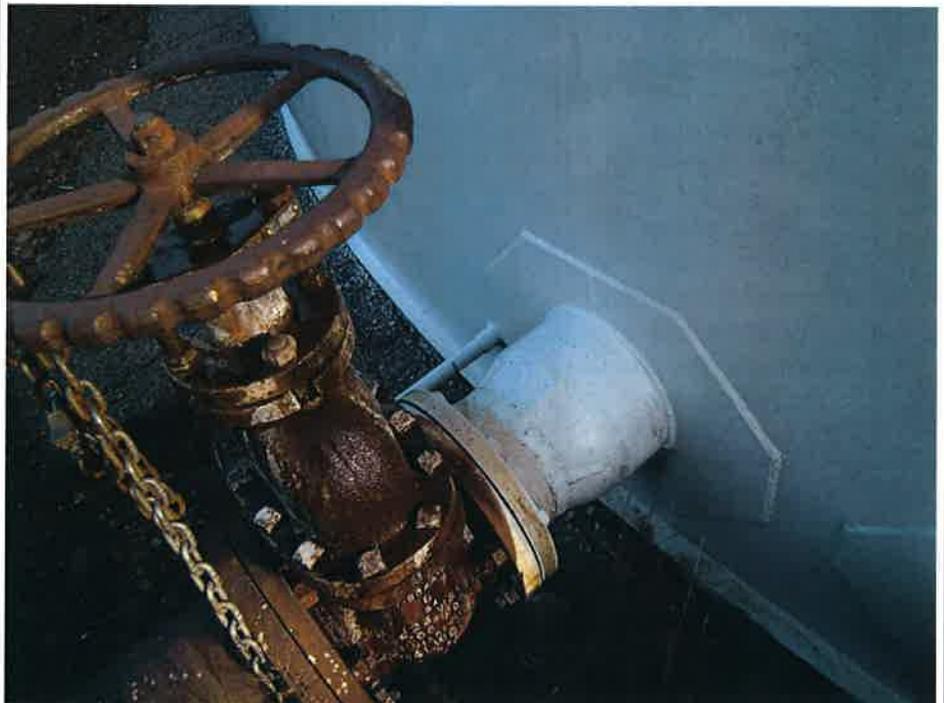
Image #7

Condition:
Rust Grade' 7.

Description:
6" Drain appeared to be in good condition with a minor amount of corrosion.

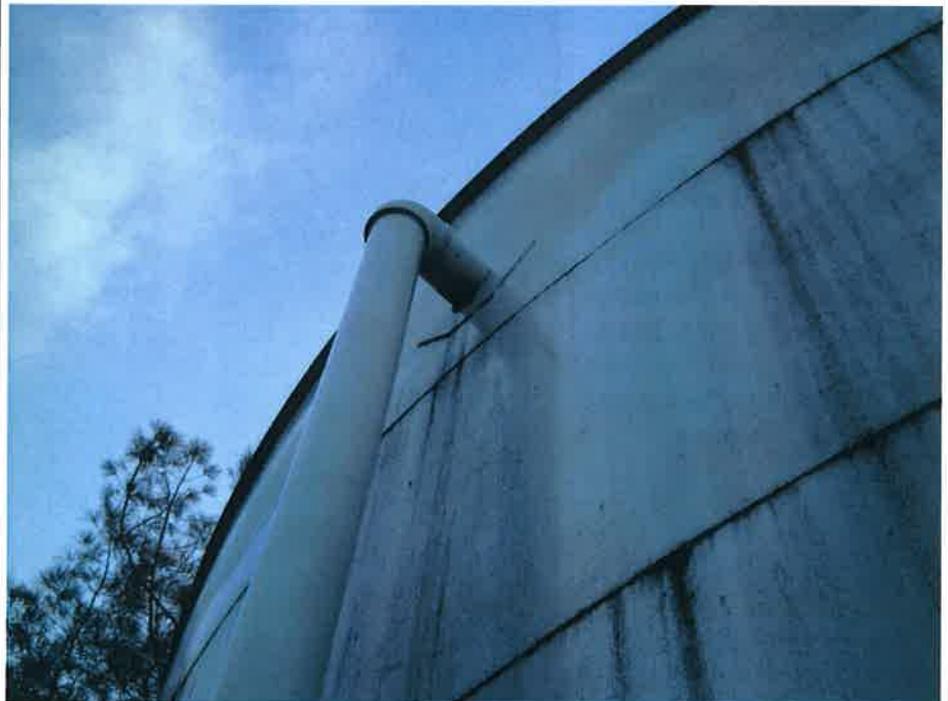
Image #9

Condition:
Rust Grade¹ 6.

Description:
Medium Mesh
Overflow Screen
appeared to be in good
condition with a
moderate amount of
corrosion.

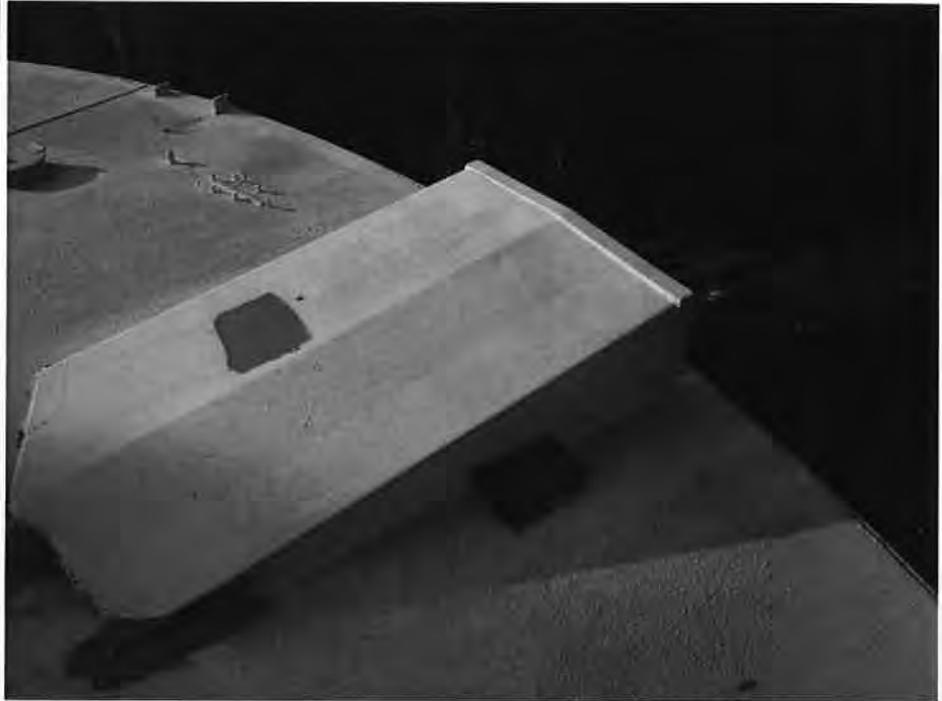
Image #16

Condition:
Rust Grade' 8.

Description:
Fine Mesh Vent Screen
appeared to be in good
condition with a minor
amount of corrosion.

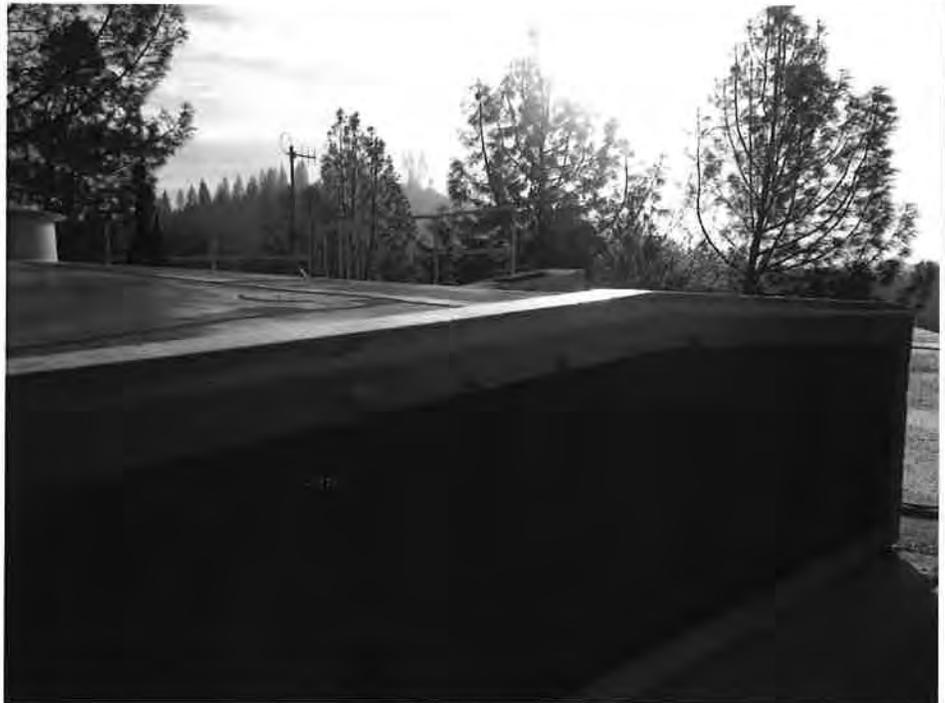
Image #17

Condition:
Rust Grade' 8.

Description:
40" Vent appeared to be sealed and no longer in working condition.

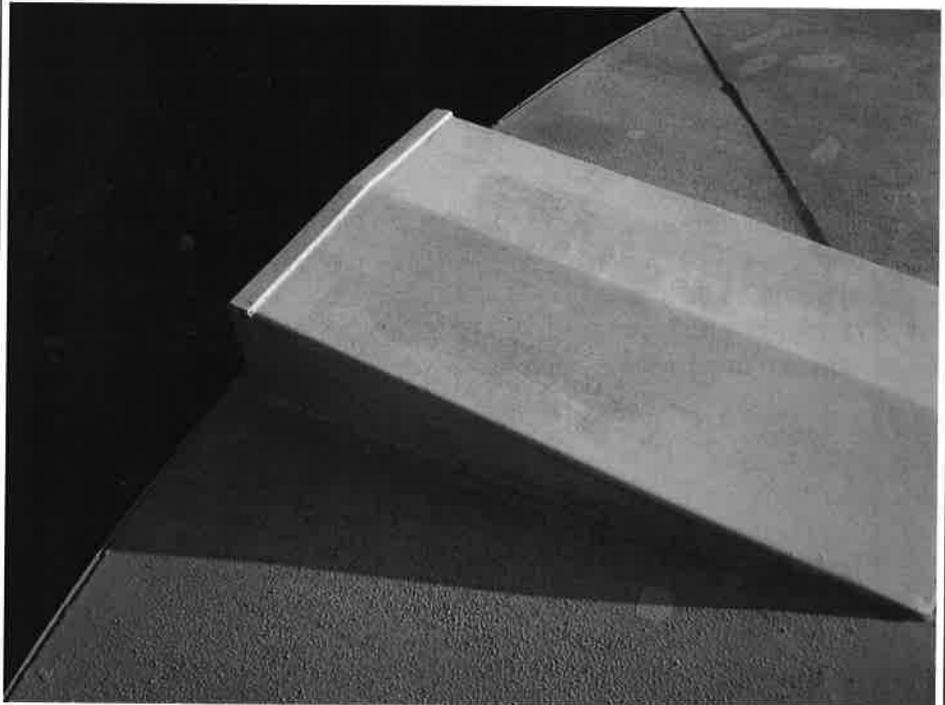
Image #19

Condition:
Rust Grade' 9.

Description:
Fine Mesh Vent Screen appeared to be in good condition with a minor amount of corrosion.

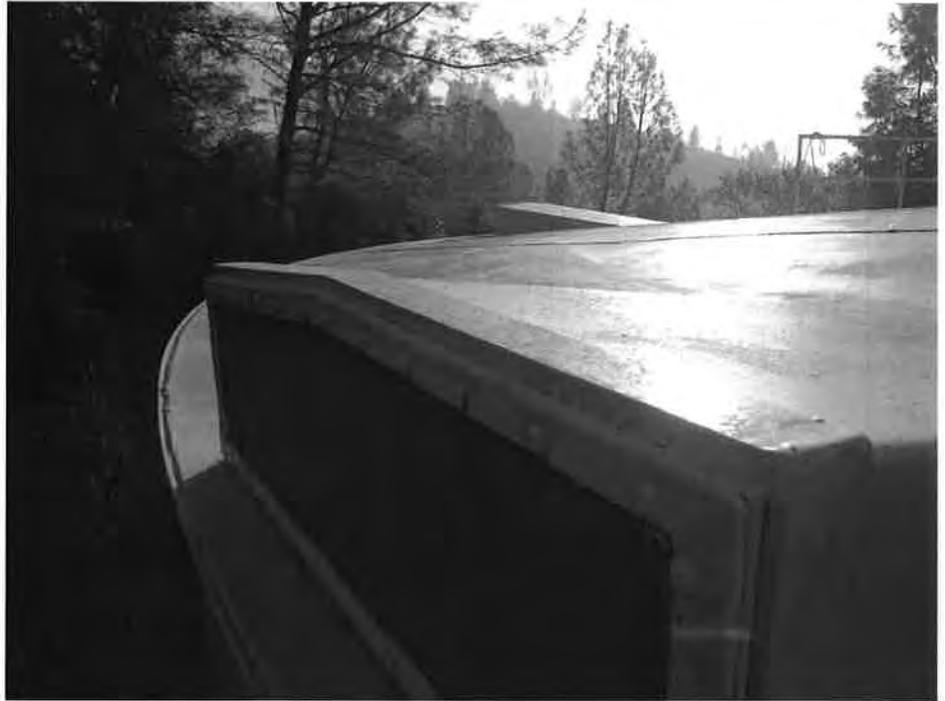
Image #20

Condition:
Rust Grade' 9.

Description:
Roof appeared to be in good condition with a minor amount of corrosion and chalking observed.

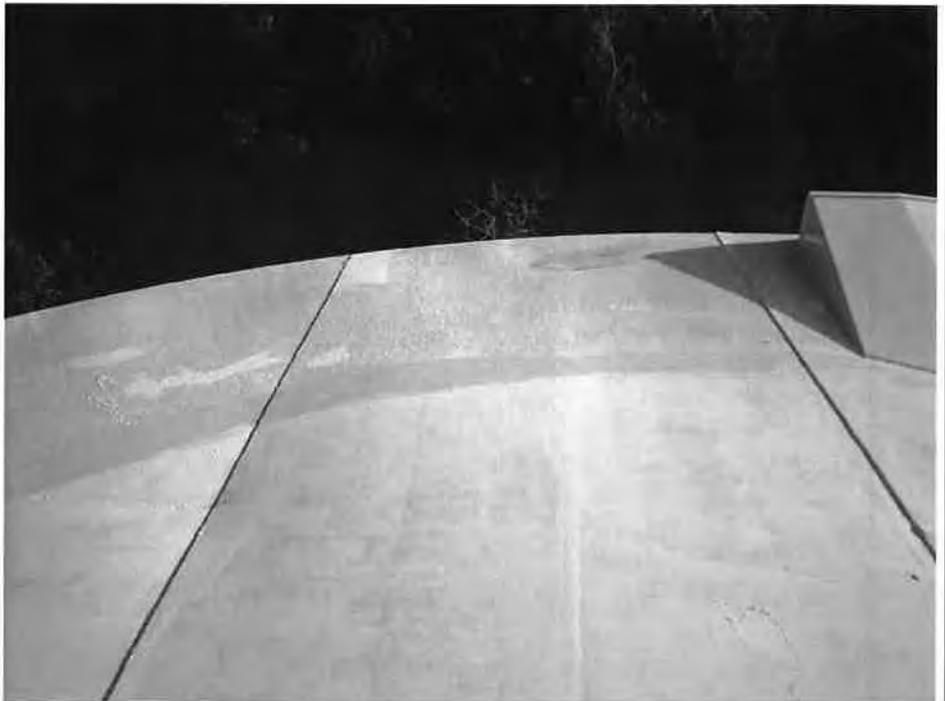
Image #21

Condition:
Rust Grade' 9.

Description:
24"x6" Side Vent
appeared to be in good
condition with a minor
amount of corrosion.

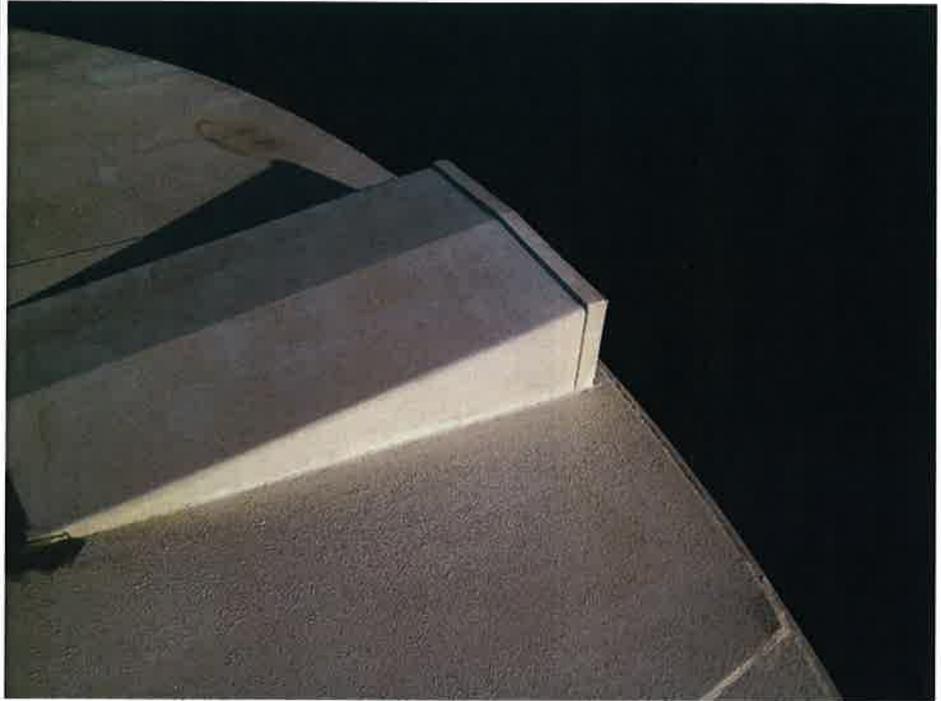
Image #22

Condition:
Rust Grade' 8.

Description:
Fine Mesh Vent Screen
appeared to be in good
condition with a minor
amount of corrosion.

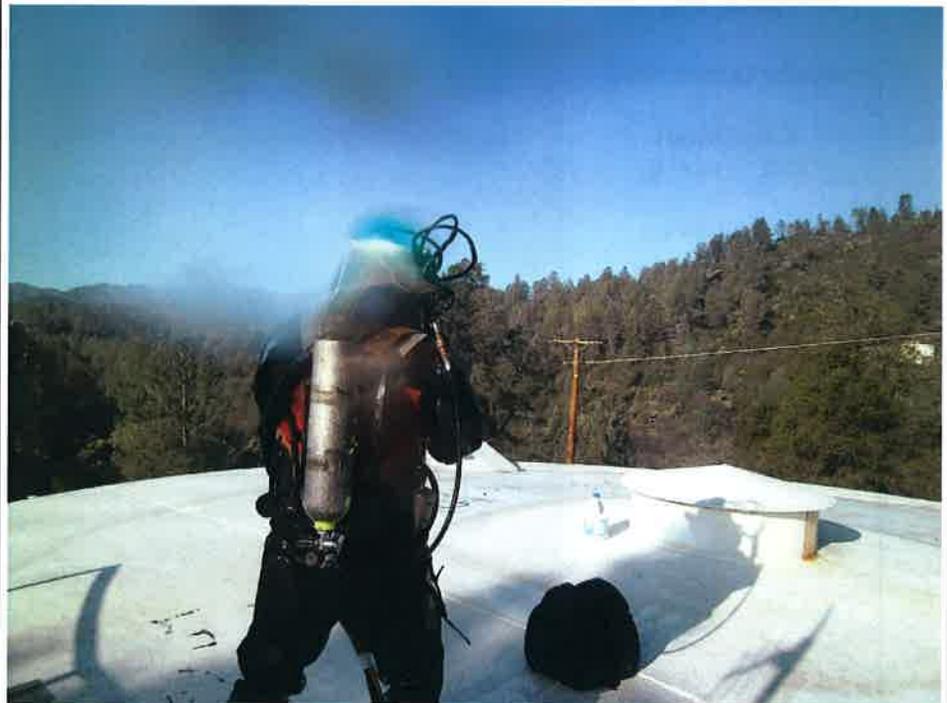
Image #25

Description:
1/32" of sediment was removed from reservoir floor.

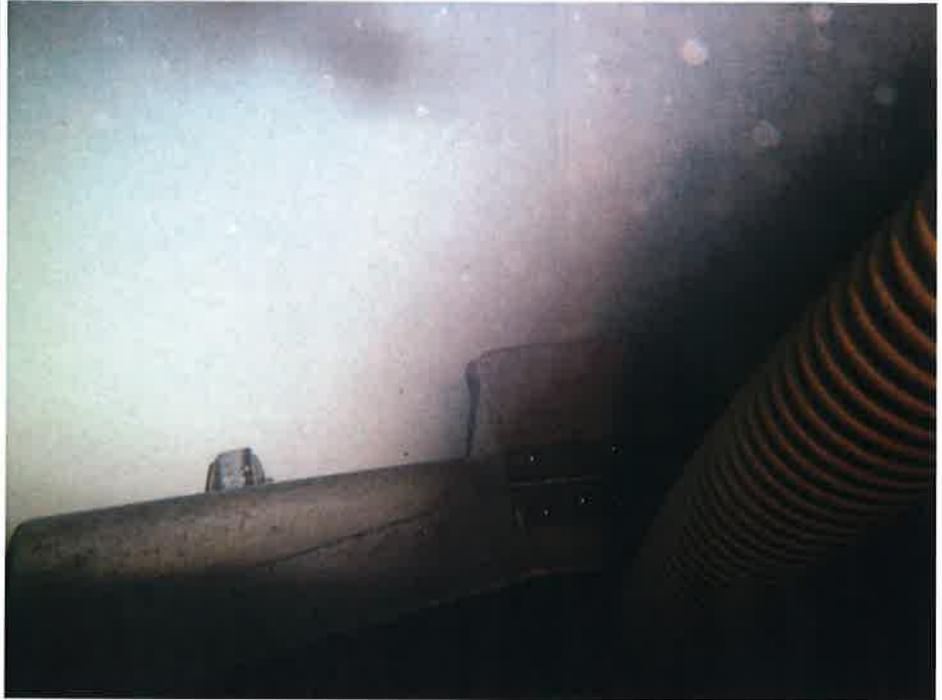
Image #26

Condition:
Rust Grade¹ 6.

Description:
Interior Ladder appeared to be in good condition with a moderate amount of corrosion.

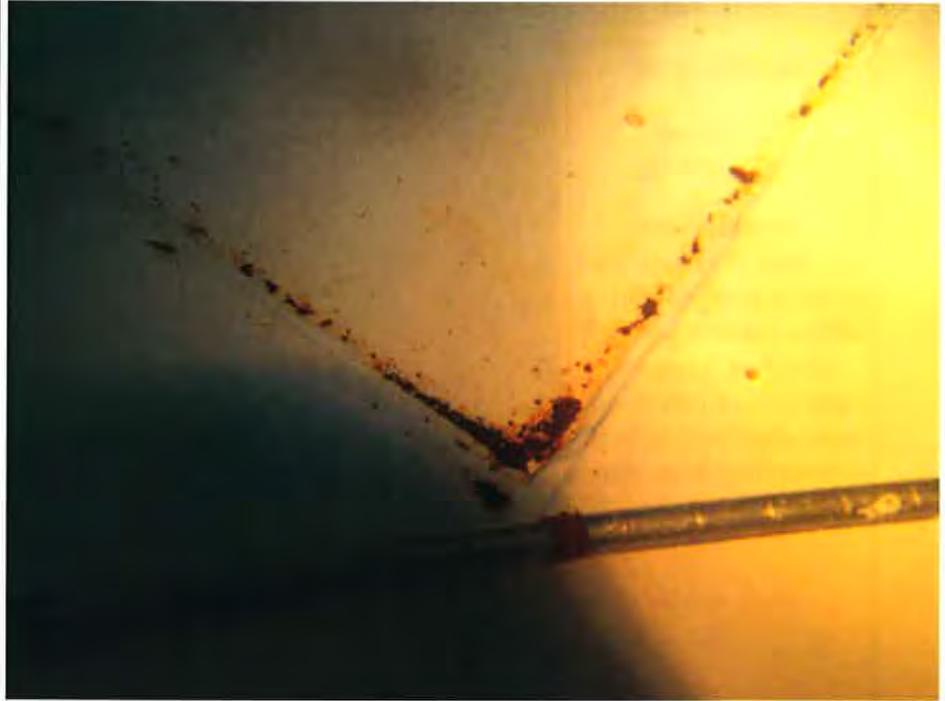
Image #28

Condition:
Rust Grade' 8.

Description:
Wall appeared to be in fair condition with a minor amount of corrosion and heavy chalking.

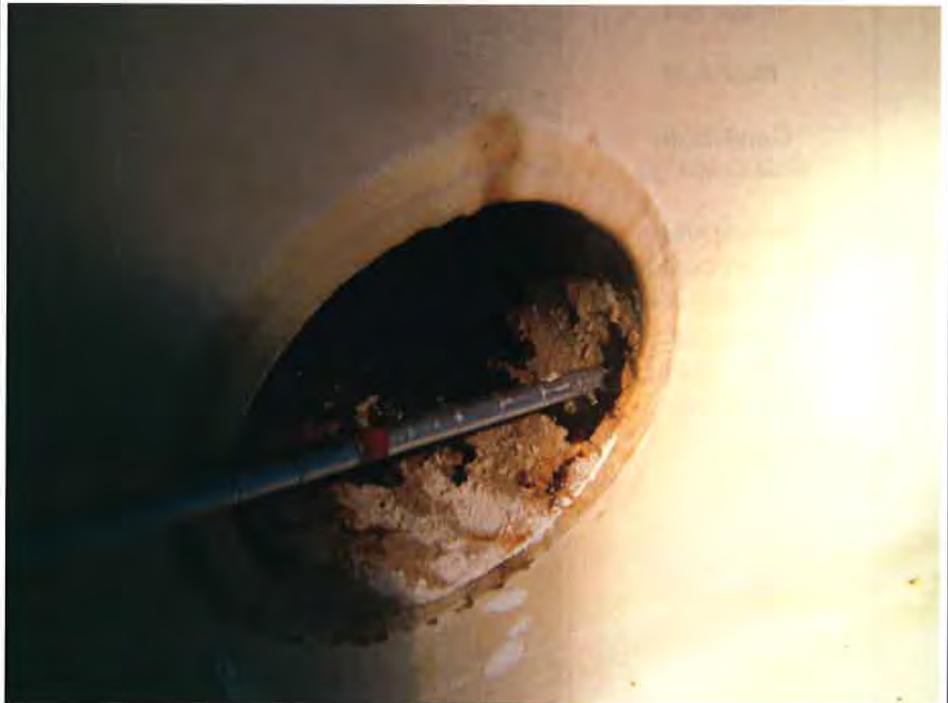
Image #33

Condition:
Rust Grade' 7.

Description:
10" Inlet appeared to be in good condition with a minor amount of corrosion.

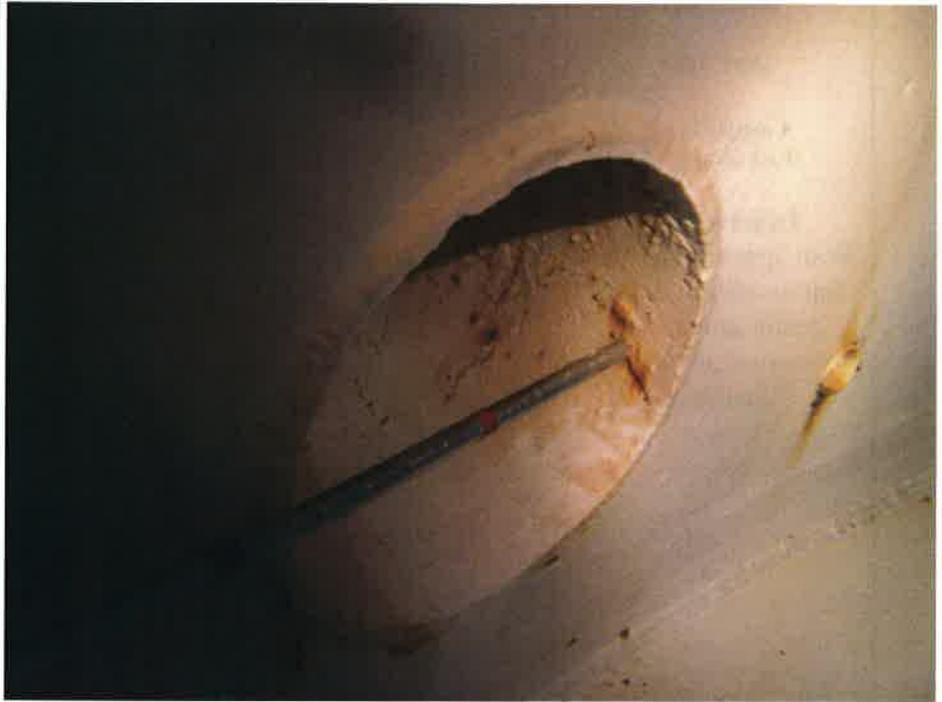
Image #34

Condition:
Rust Grade' 7.

Description:
Floor appeared to be in fair condition with a minor amount of corrosion and heavy chalking.

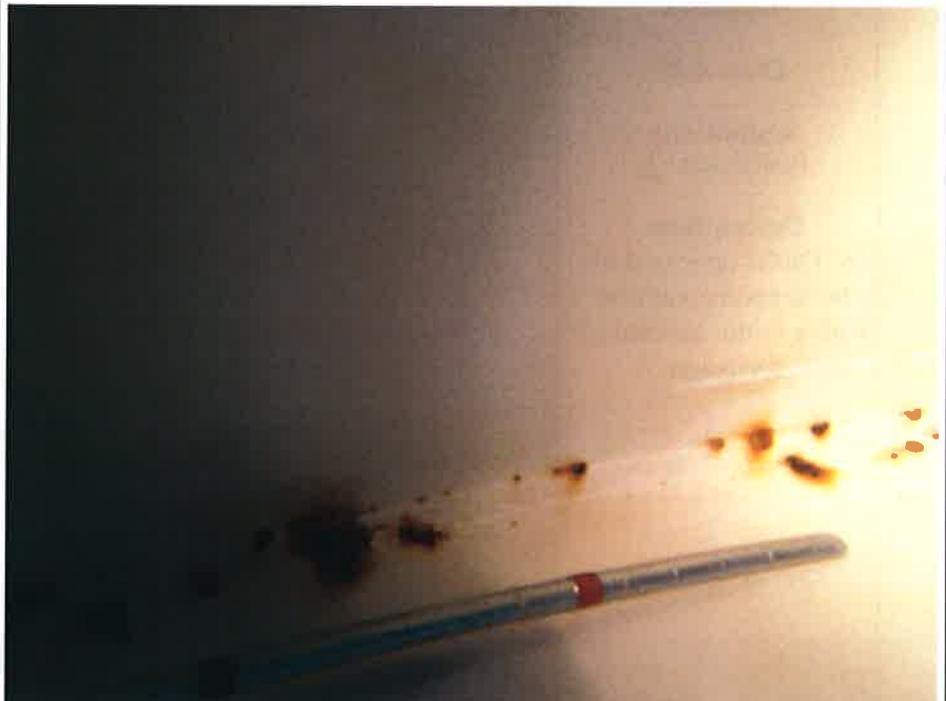
Image #35

Condition:
Rust Grade' 7.

Description:
Wall appeared to be in fair condition with a minor amount of corrosion and heavy chalking.

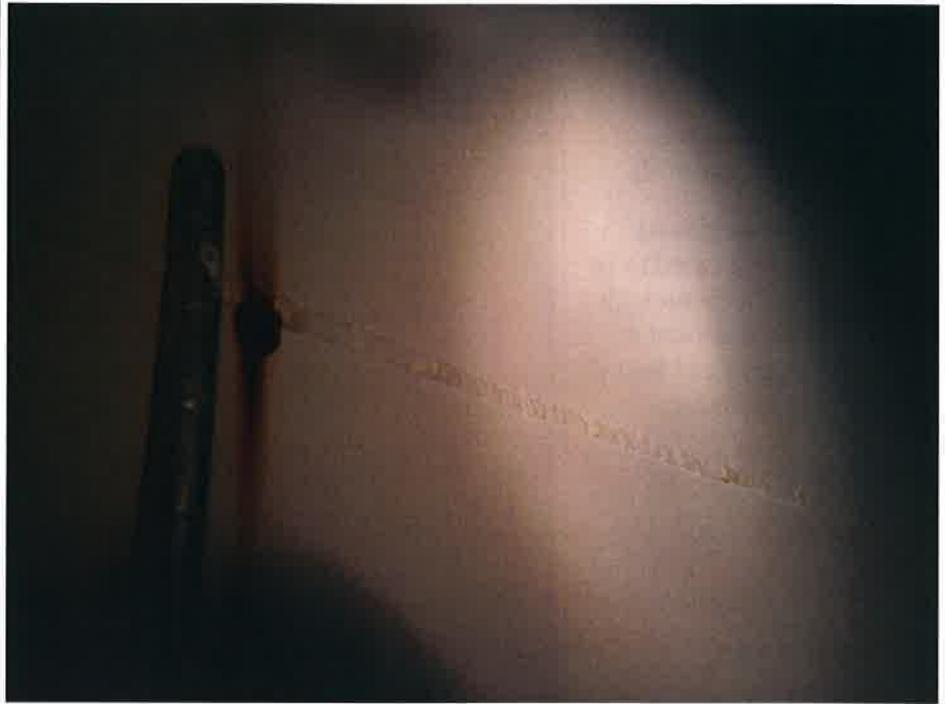
Image #36

Condition:
Rust Grade' 1.

Description:
6" Drain appeared to be in fair condition with a heavy amount of corrosion.

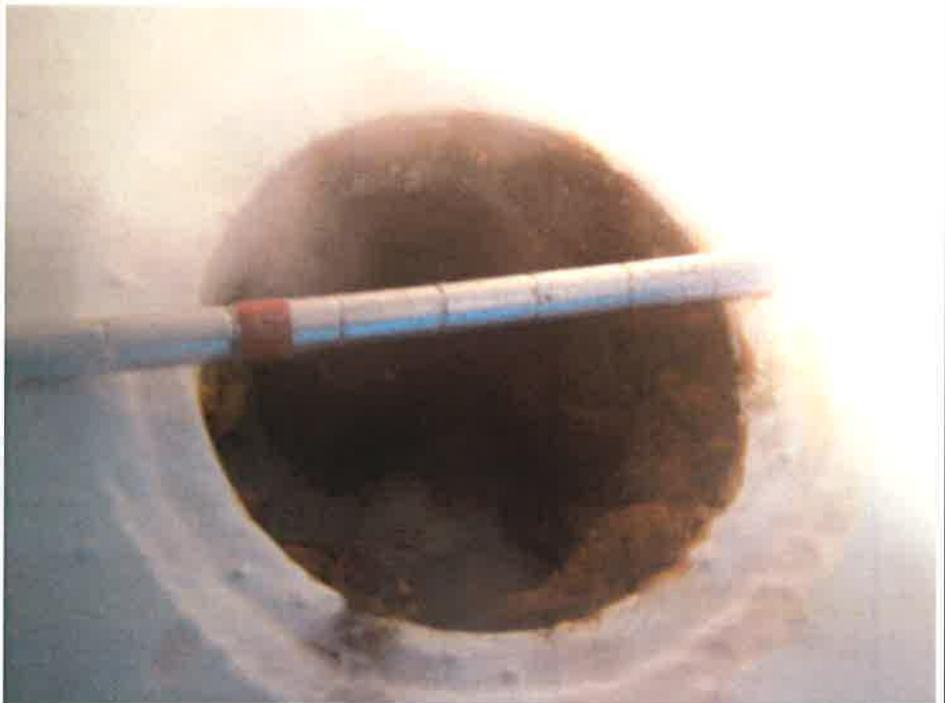
Image #37

Condition:
Rust Grade¹ 7.

Description:
Floor appeared to be in fair condition with a minor amount of corrosion and heavy chalking.
