CITY OF SHASTA LAKE

2016-2026 WATER MASTER PLAN

FINAL • OCTOBER 2016

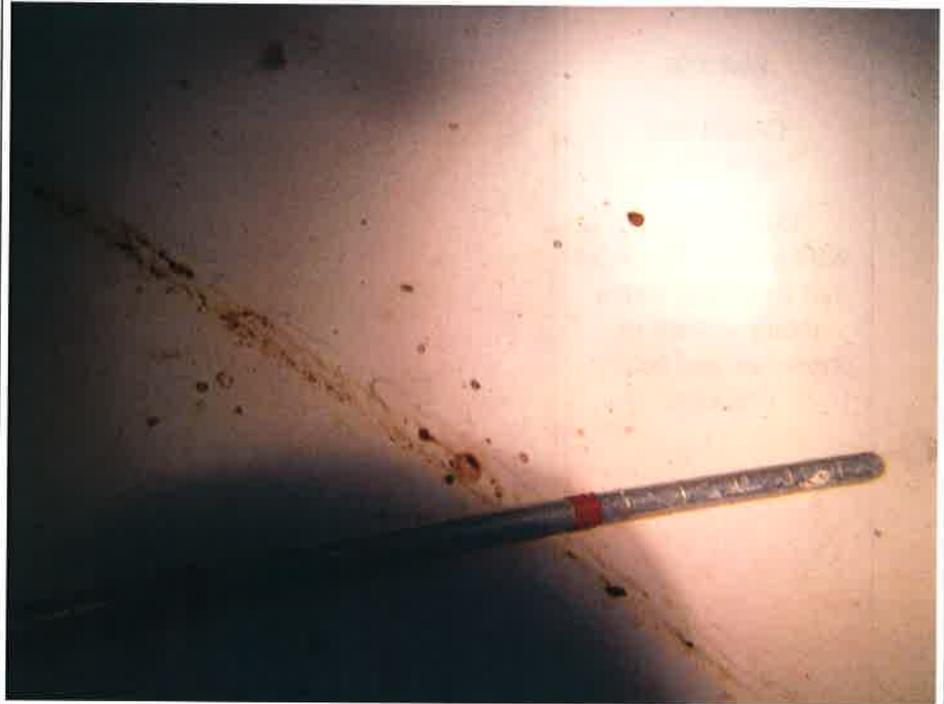
Image #38

Condition:
Rust Grade¹ 8.

Description:
Wall appeared to be in fair condition with a minor amount of corrosion and heavy chalking.

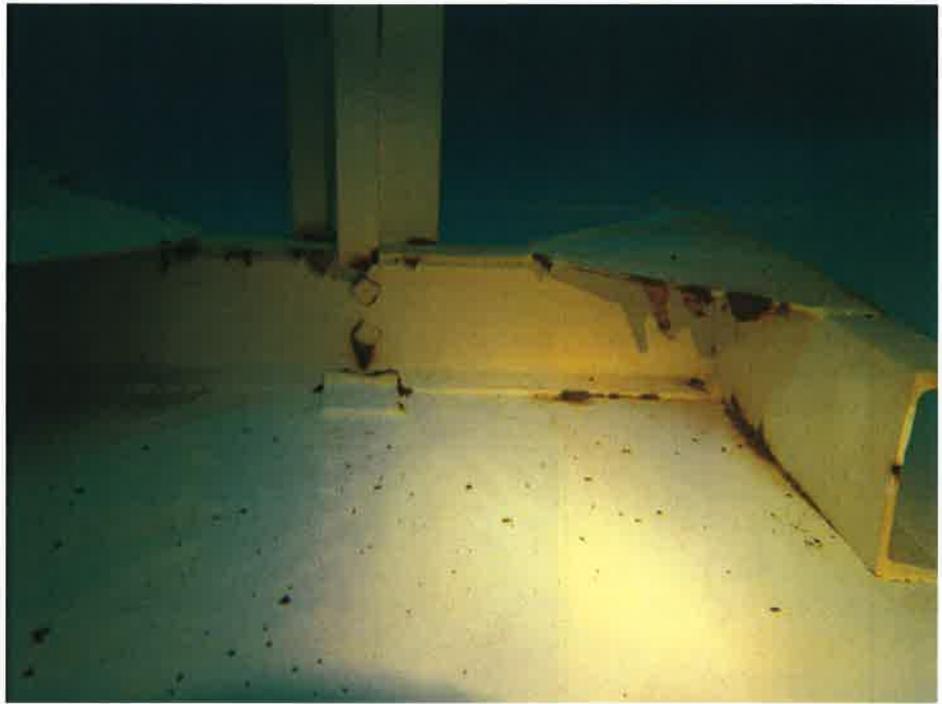
Image #40

Condition:
Rust Grade¹ 1.

Description:
Ceiling appeared to be in poor condition with a heavy amount of corrosion and moderate delamination observed.

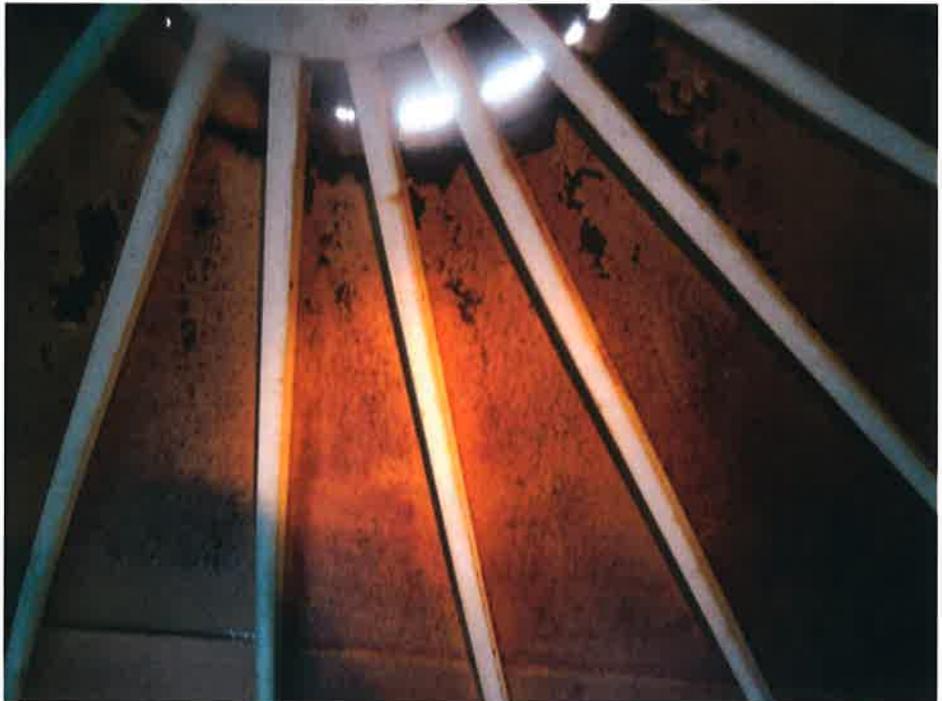
Image #41

Condition:
Rust Grade¹ 1.

Description:
Ceiling appeared to be in poor condition with a heavy amount of corrosion and moderate delamination observed.

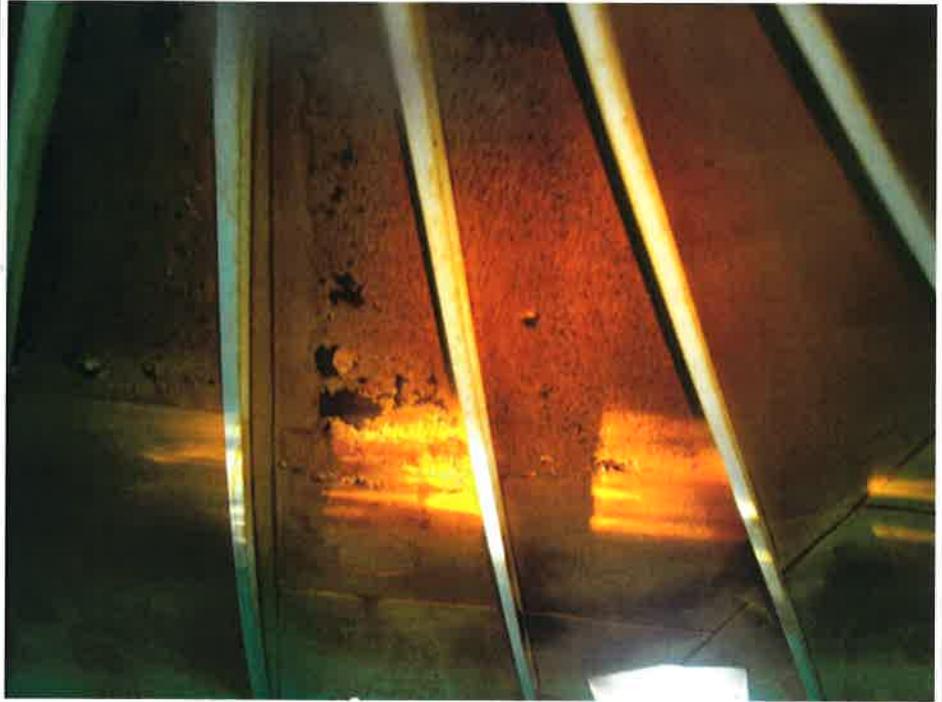
Image #42

Condition:
Rust Grade¹ 1.

Description:
Ceiling appeared to be in poor condition with a heavy amount of corrosion and moderate delamination observed.

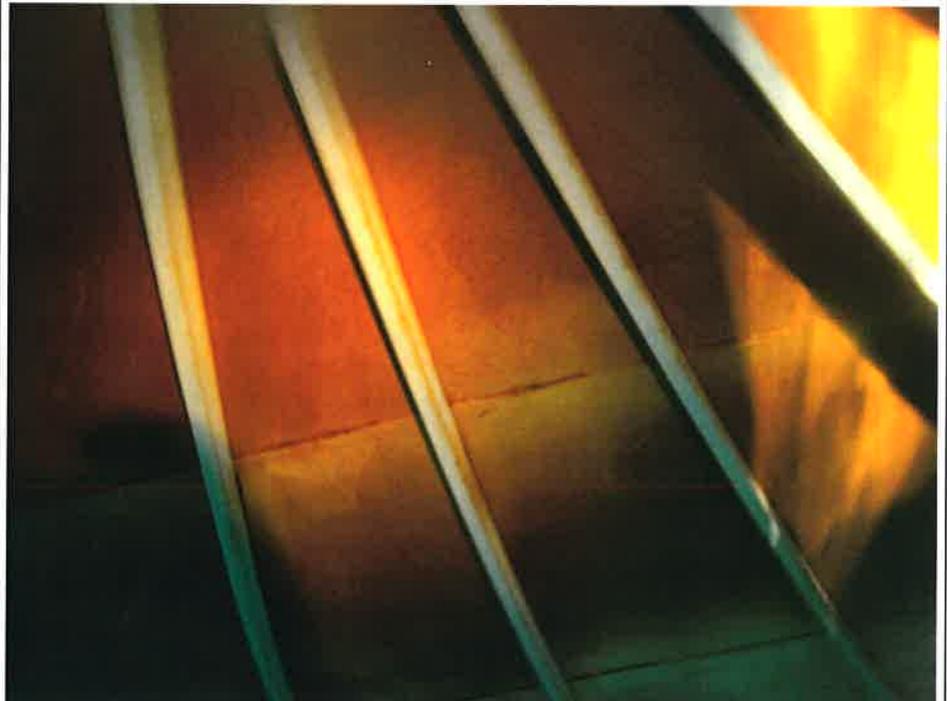
Image #43

Condition:
Rust Grade' 1.

Description:
Ceiling appeared to be in poor condition with a heavy amount of corrosion and moderate delamination observed.

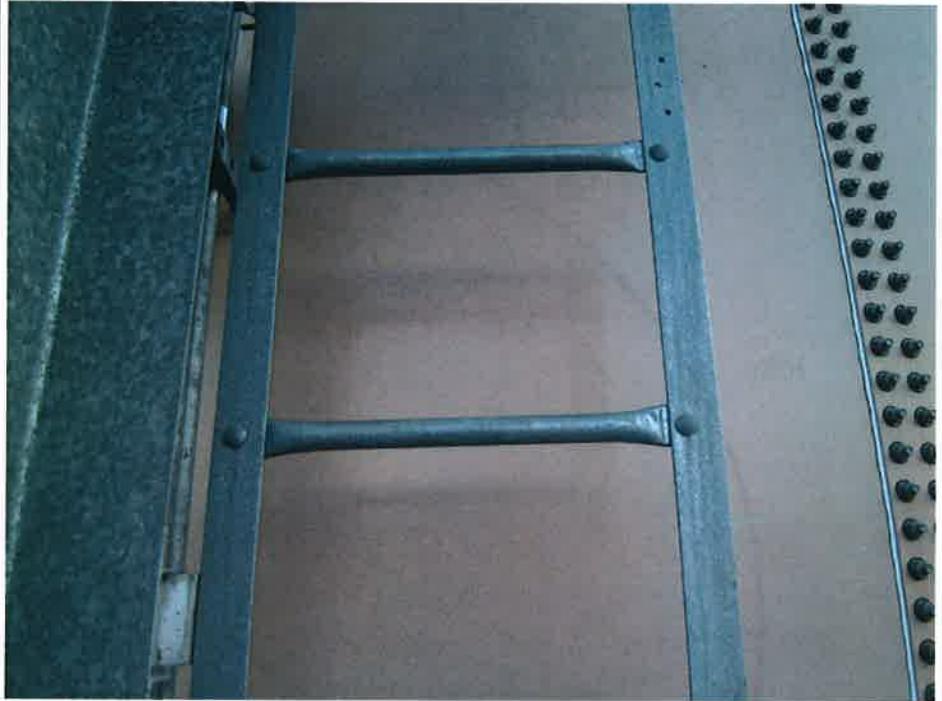
Condition:
Rust Grade' 10.

Description:
Exterior Ladder appeared to be in good condition with no signs of corrosion.

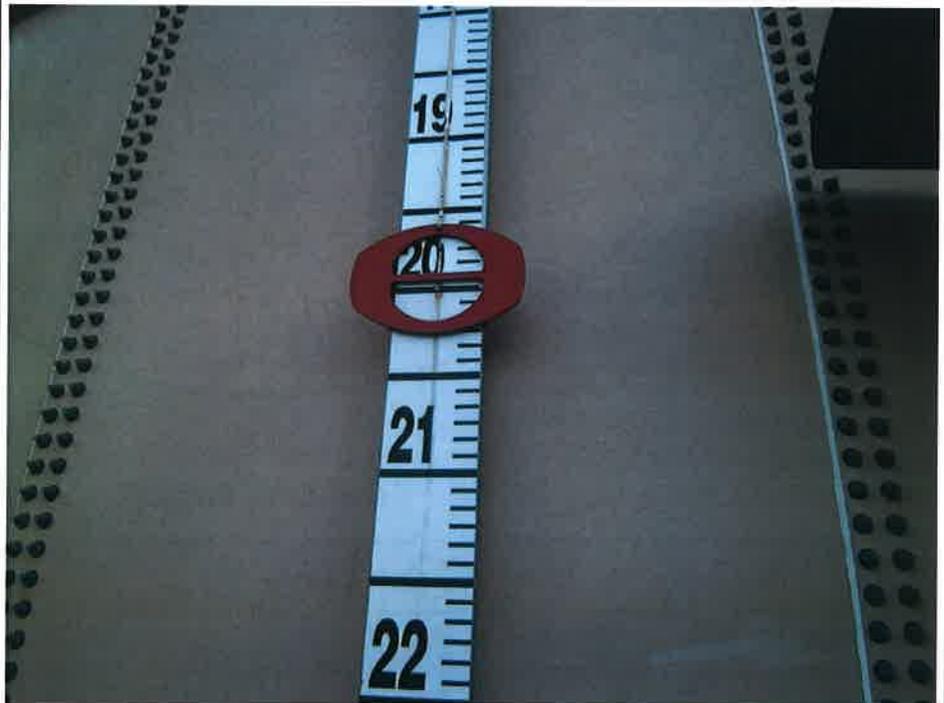
Image #2

Condition:
Rust Grade' 9.

Description:
Liquid Level Indicator Reader Board appeared to be in good condition with a minor amount of corrosion.

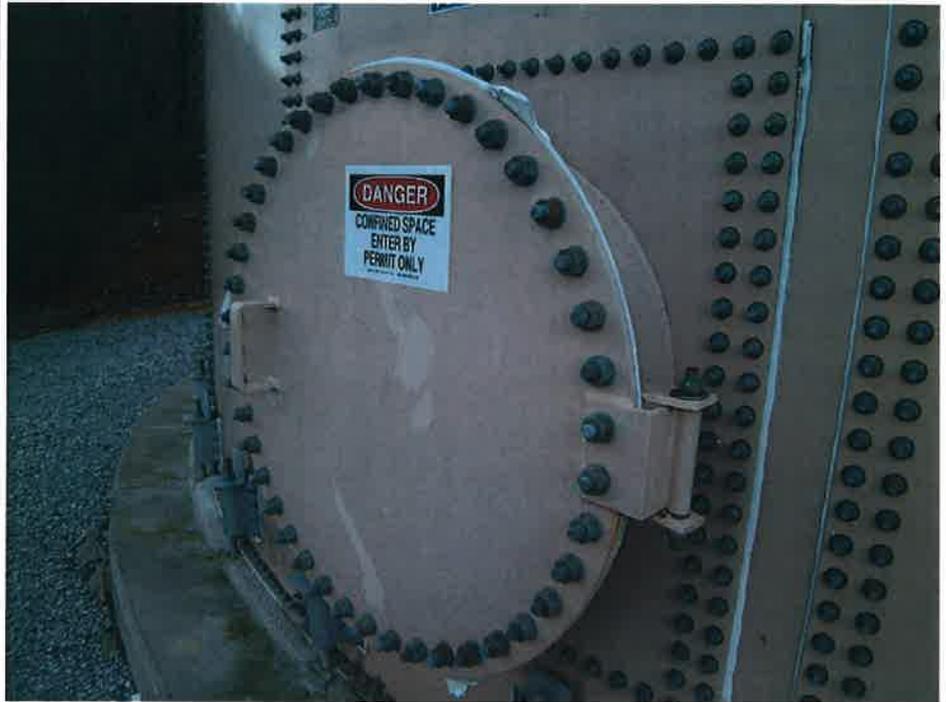
Image #3

Condition:
Rust Grade¹ 9.

Description:
30" Man Way appeared to be in good condition with a minor amount of corrosion.

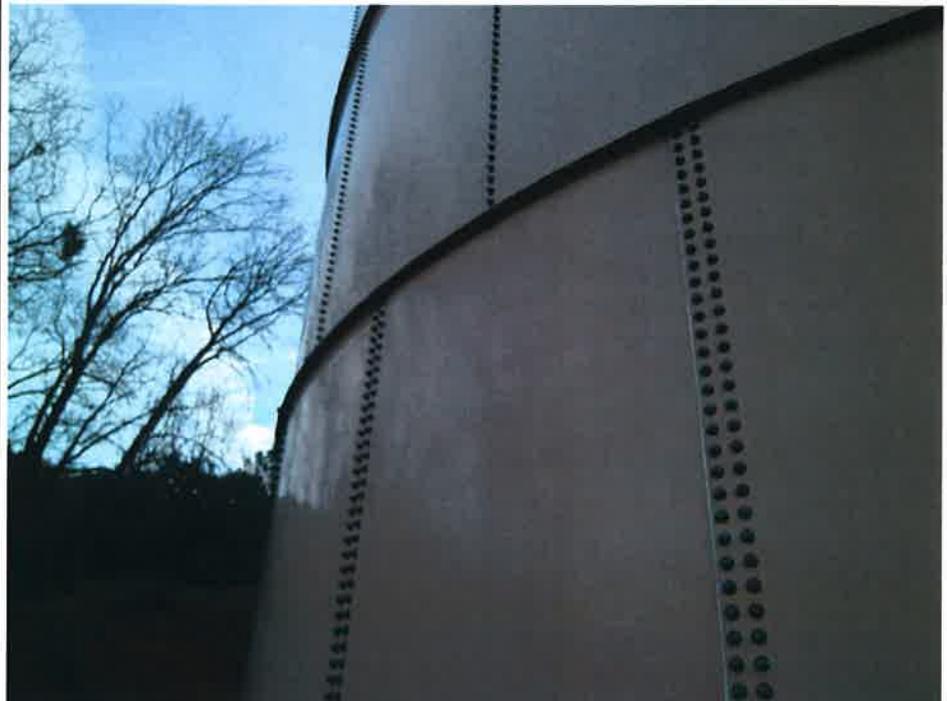
Image #4

Condition:
Rust Grade¹ 9.

Description:
Exterior Wall appeared to be in good condition with a minor amount of corrosion.

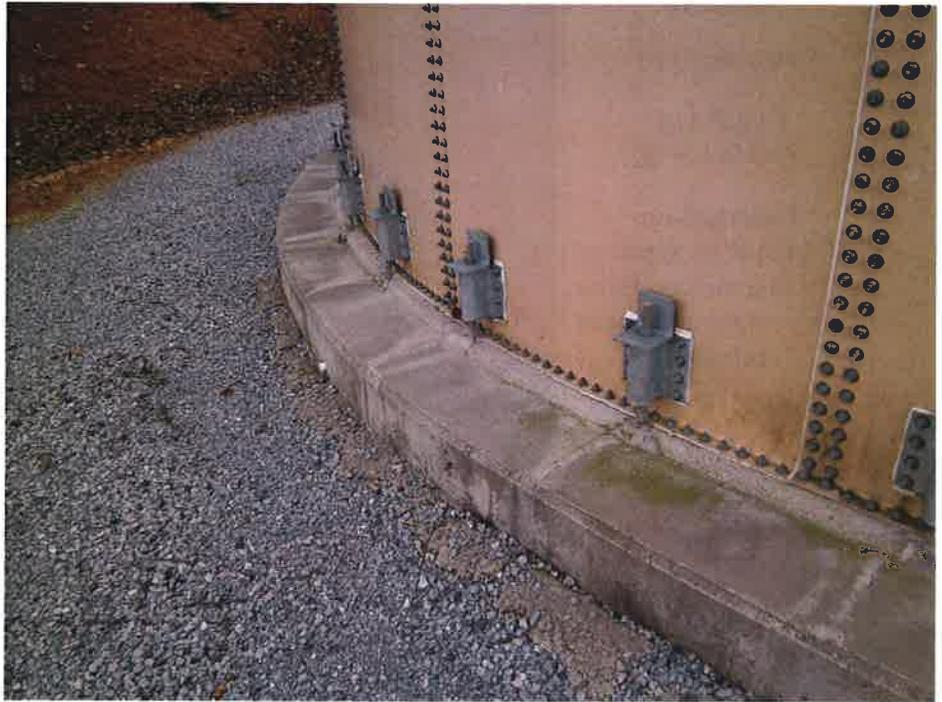
Image #5

Condition:
Concrete Deform³ GC.

Description:
Exterior Base appeared to be in good condition with no concrete problems.

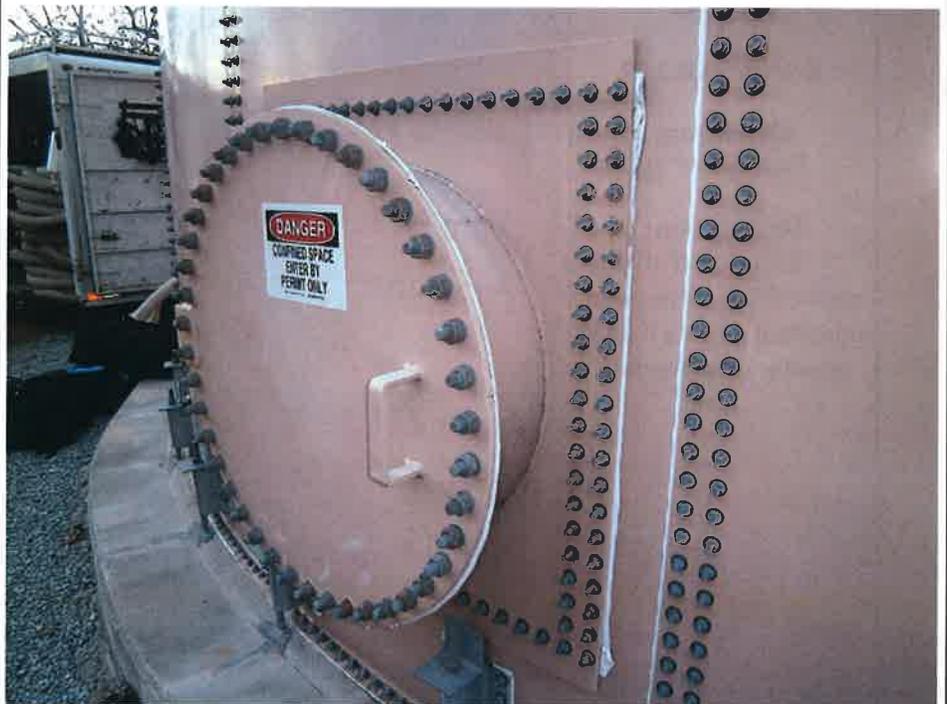
Image #6

Condition:
Rust Grade¹ 9.

Description:
30" Man Way appeared to be in good condition with a minor amount of corrosion.

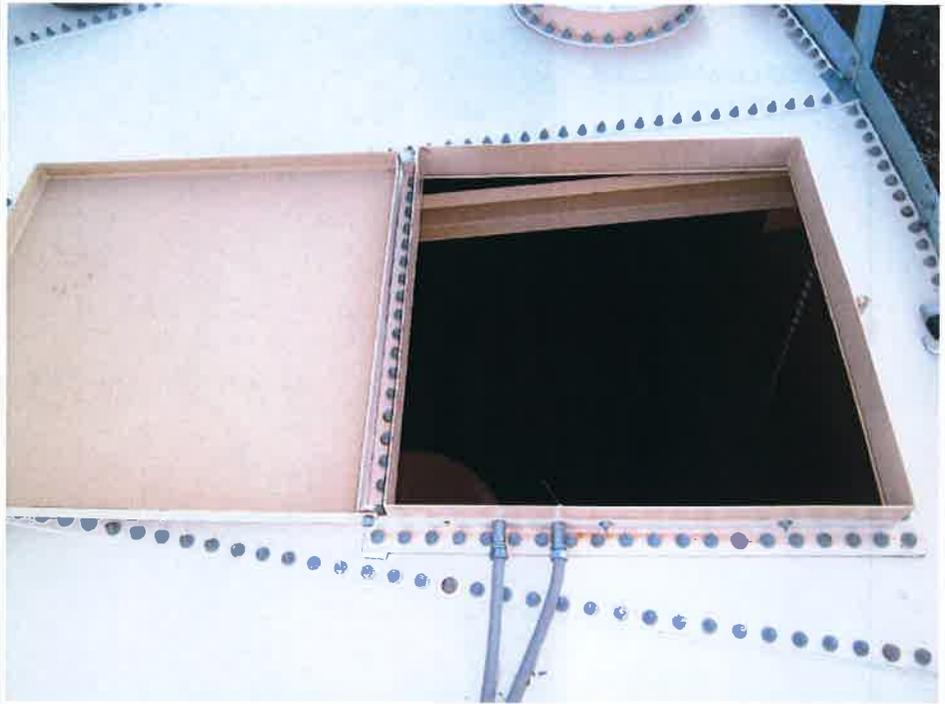
Image #7

Condition:
Rust Grade¹ 9.

Description:
36"x36" Entry Hatch appeared to be in good condition with a minor amount of corrosion.

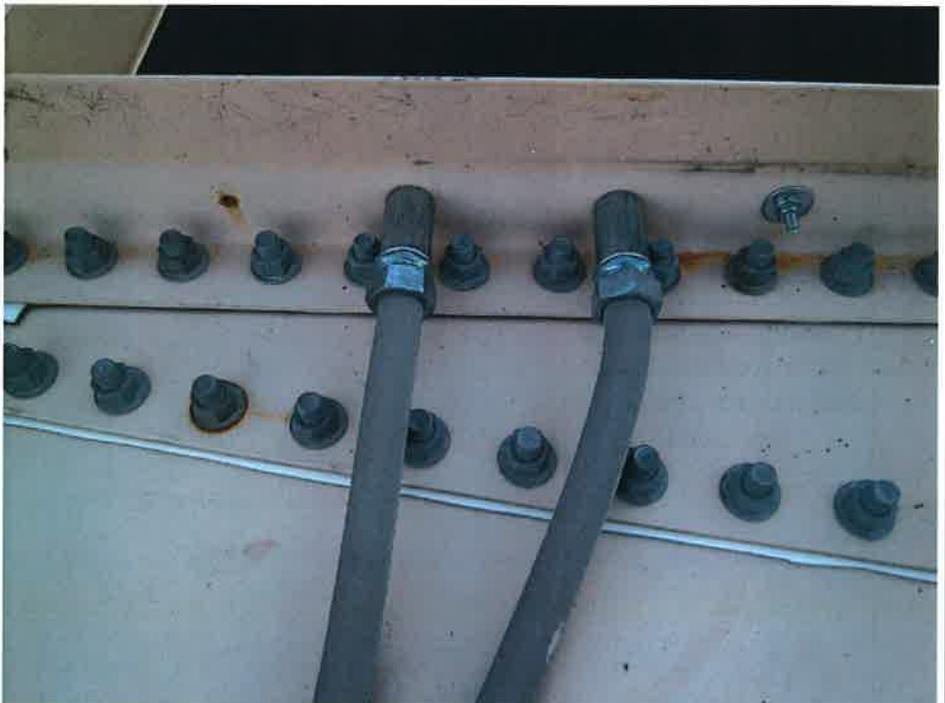
Image #8

Condition:
Rust Grade¹ 10.

Description:
1" Telemetry Penetration appeared to be in good condition with no signs of corrosion.

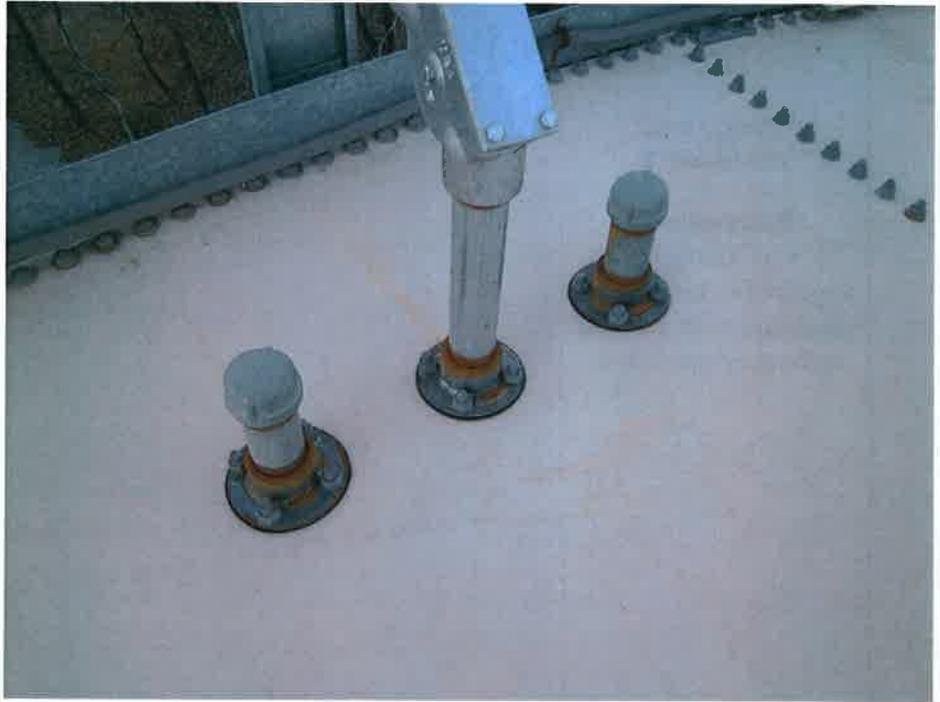
Image #9

Condition:
Rust Grade¹ 7.

Description:
2" Liquid Level
Indicator Penetration
appeared to be in good
condition with a minor
amount of corrosion.

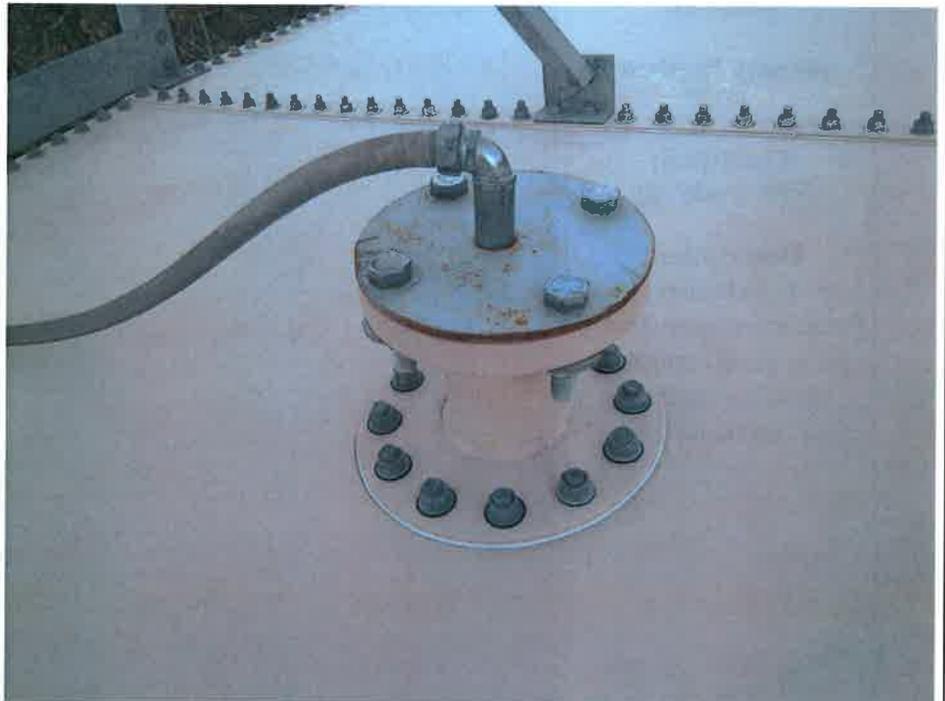
Image #10

Condition:
Rust Grade¹ 9.

Description:
3" Telemetry
Penetration appeared to
be in good condition
with a minor amount of
corrosion.

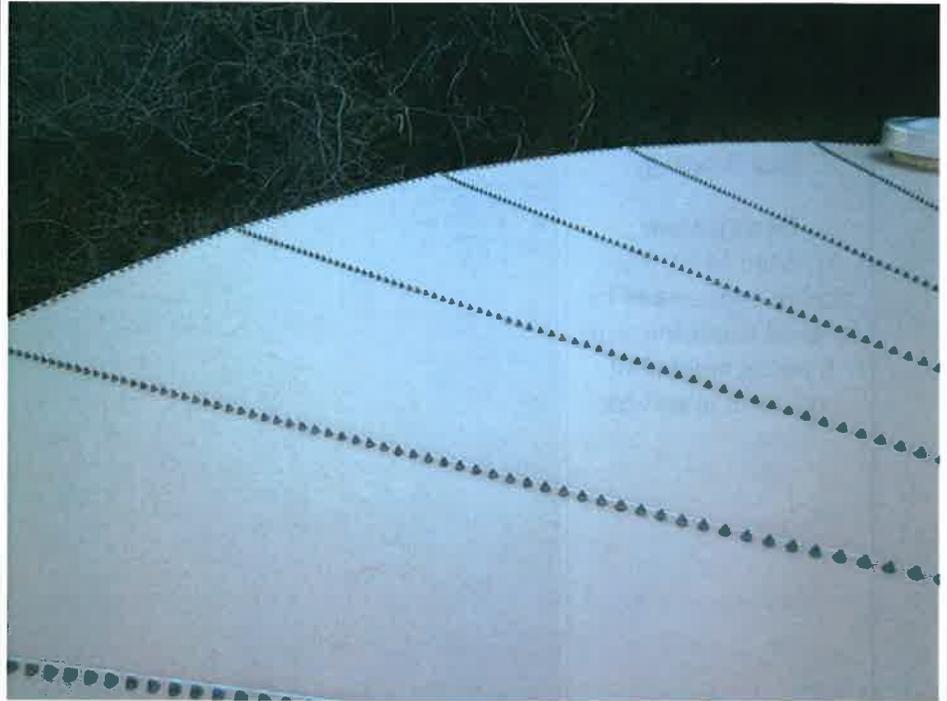
Image #11

Condition:
Rust Grade' 9.

Description:
Roof appeared to be in good condition with a minor amount of corrosion.

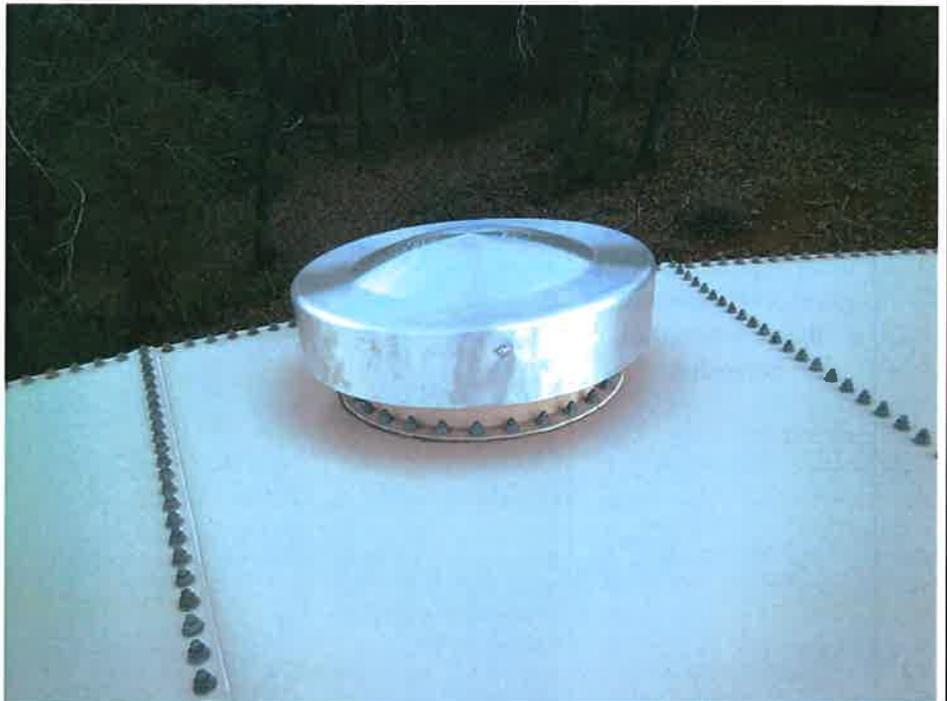
Image #12

Condition:
Rust Grade' 10.

Description:
18" Side Vent appeared to be in good condition with no signs of corrosion.

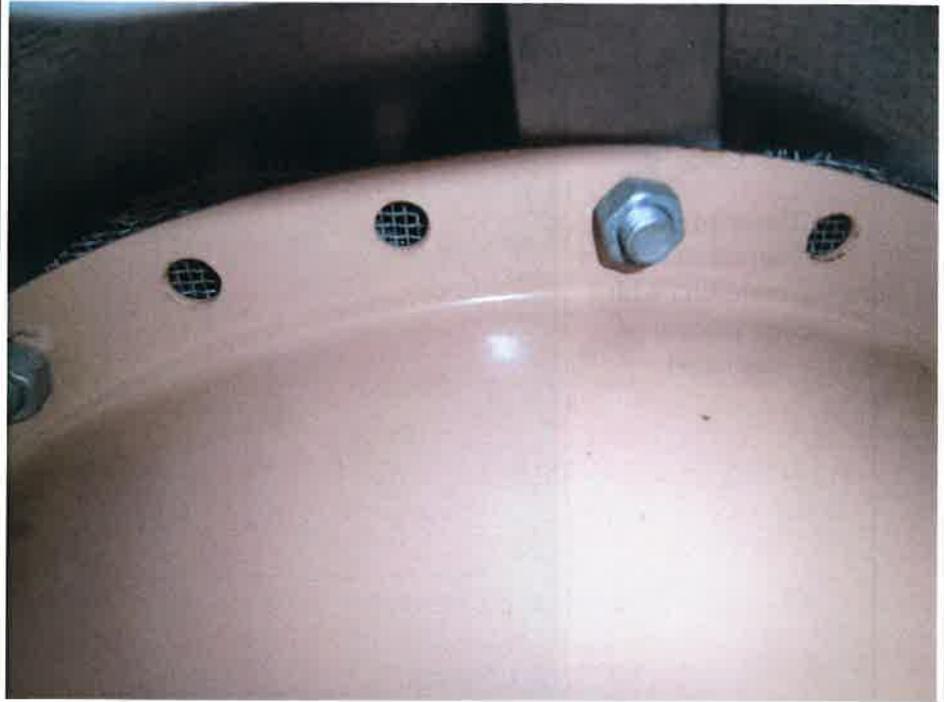
Image #13

Condition:
Rust Grade! 9.

Description:
Medium Mesh Vent Screen appeared to be in good condition with a minor amount of corrosion observed.

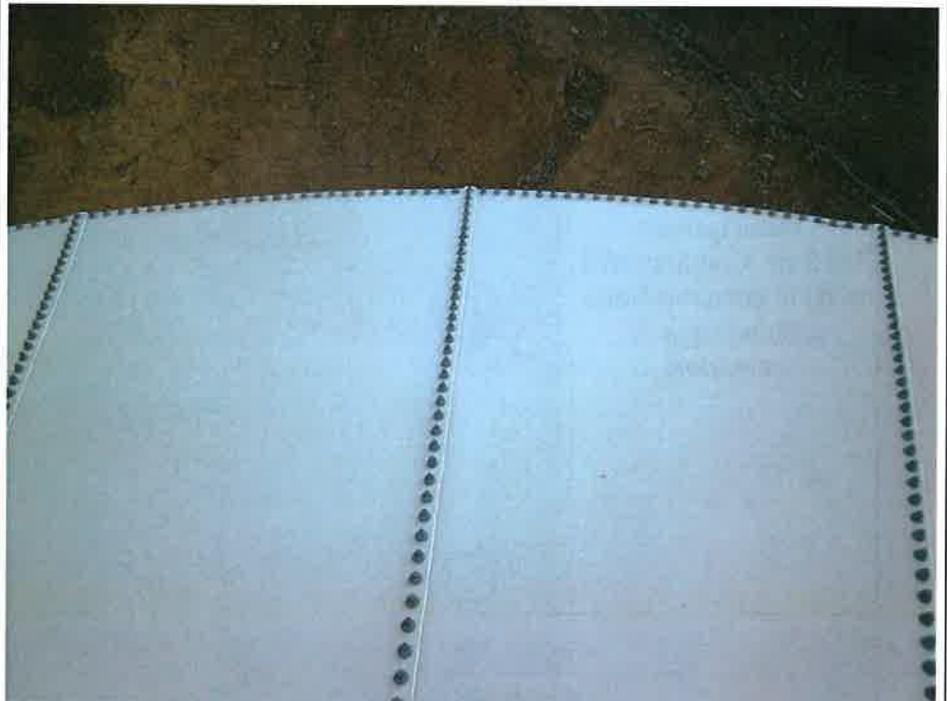
Image #14

Condition:
Rust Grade! 9.

Description:
Roof appeared to be in good condition with a minor amount of corrosion.

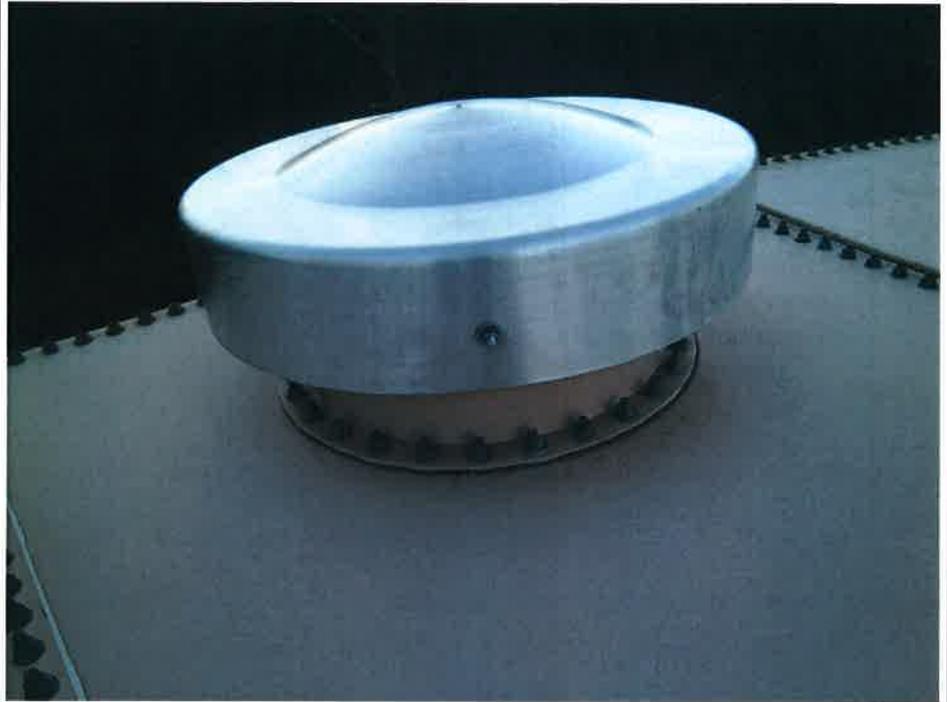
Image #15

Condition:
Rust Grade 9.

Description:
18" Side Vent appeared to be in good condition with a minor amount of corrosion.

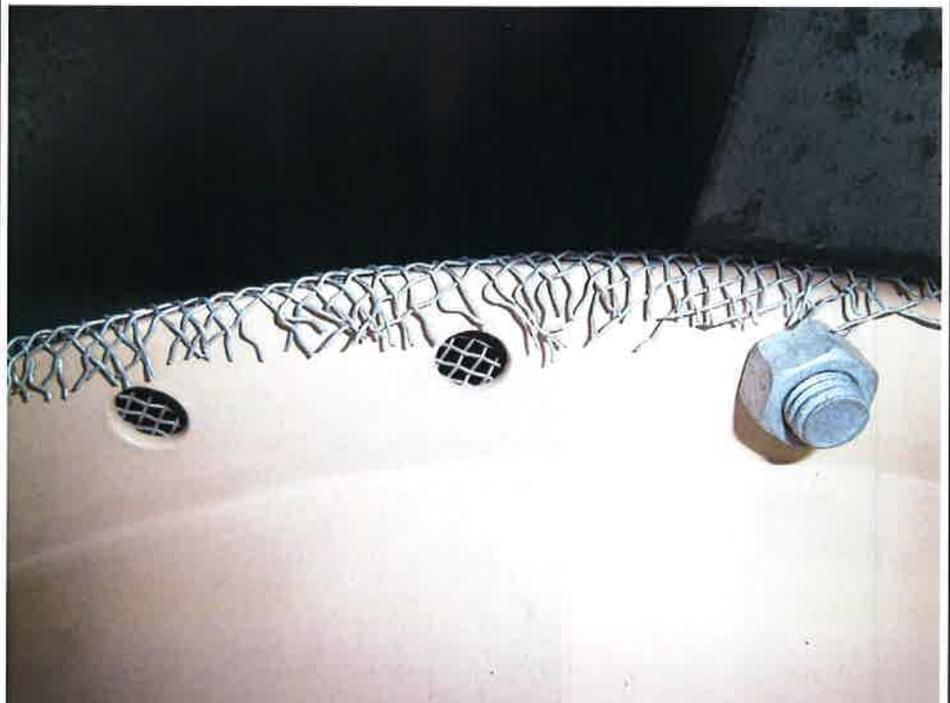
Image #16

Condition:
Rust Grade 9.

Description:
Medium Mesh Vent Screen appeared to be in good condition with a minor amount of corrosion observed.

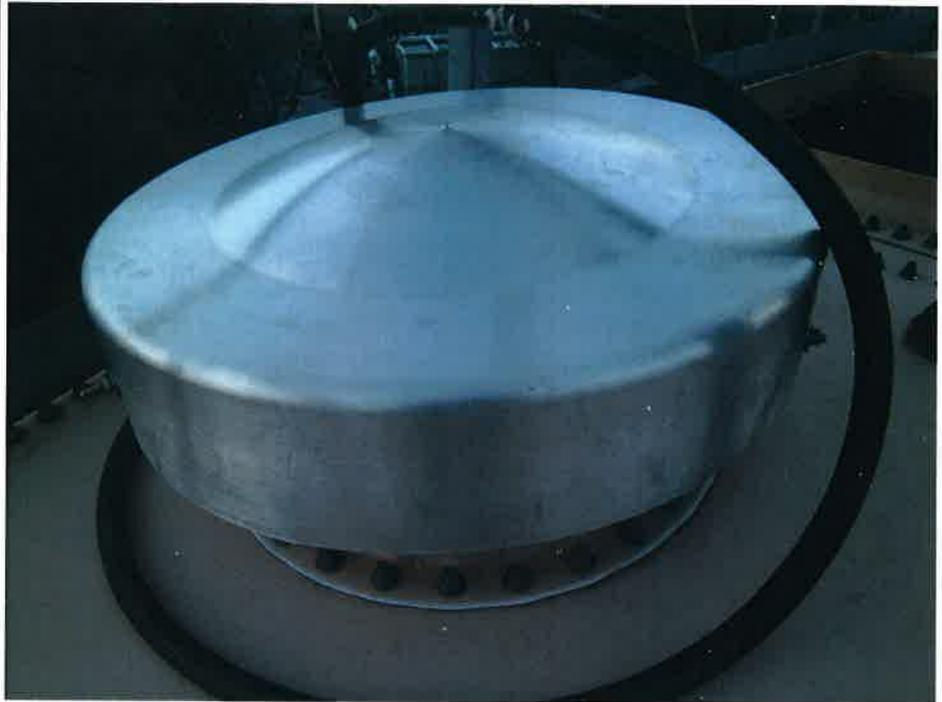
Image #17

Condition:
Rust Grade¹ 9.

Description:
18" Side Vent appeared to be in good condition with a minor amount of corrosion.

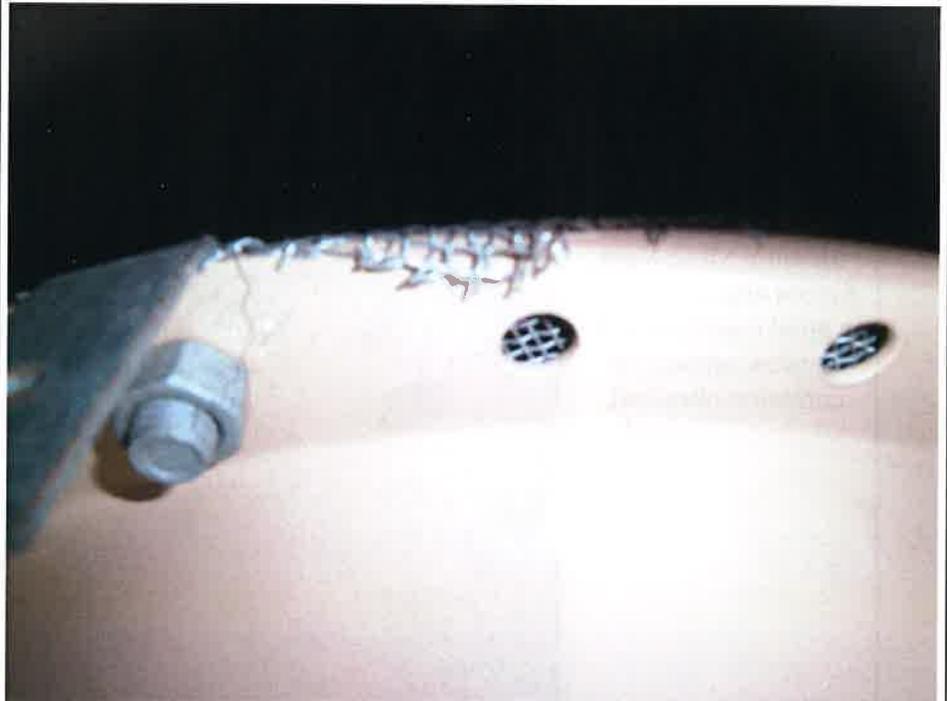
Image #18

Condition:
Rust Grade¹ 9.

Description:
Medium Mesh Vent Screen appeared to be in good condition with a minor amount of corrosion observed.

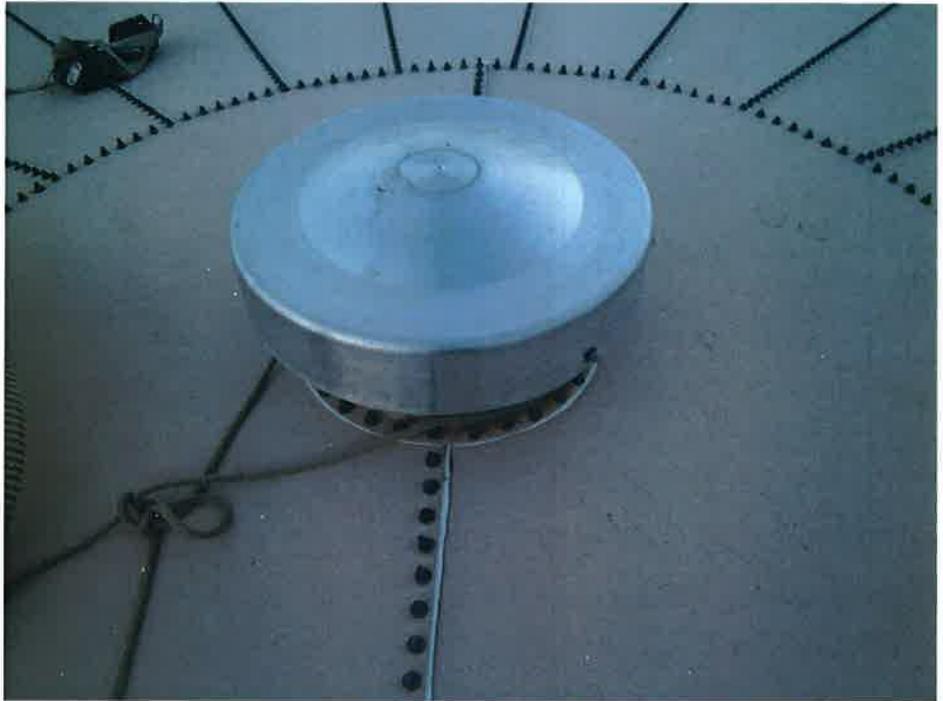
Image #19

Condition:
Rust Grade¹ 9.

Description:
18" Vent appeared to be in good condition with a minor amount of corrosion.

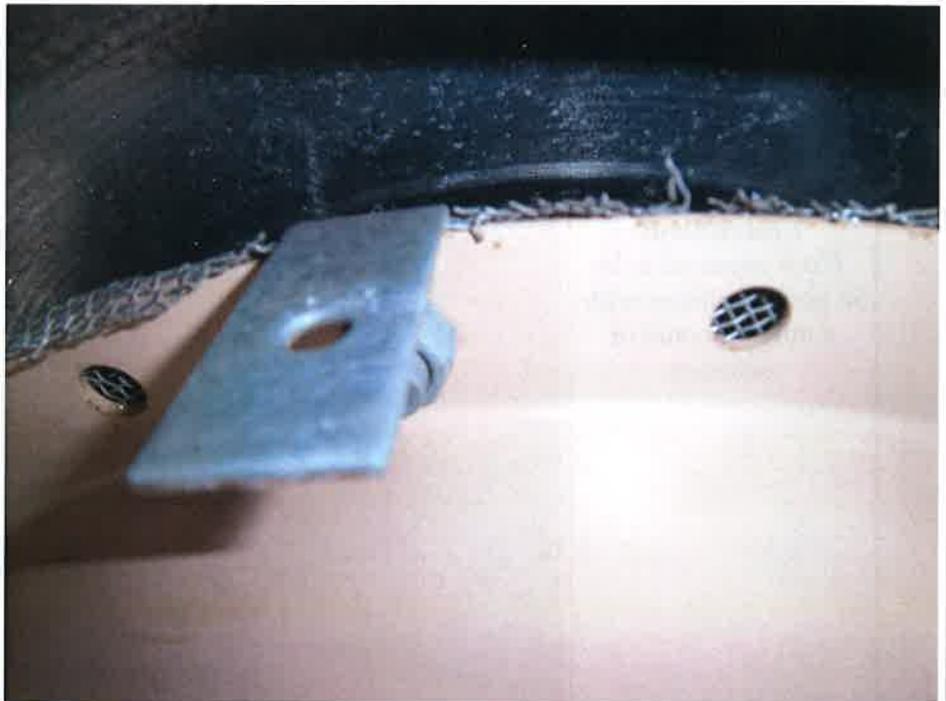
Image #20

Condition:
Rust Grade¹ 9.

Description:
Medium Mesh Vent Screen appeared to be in good condition with a minor amount of corrosion observed.

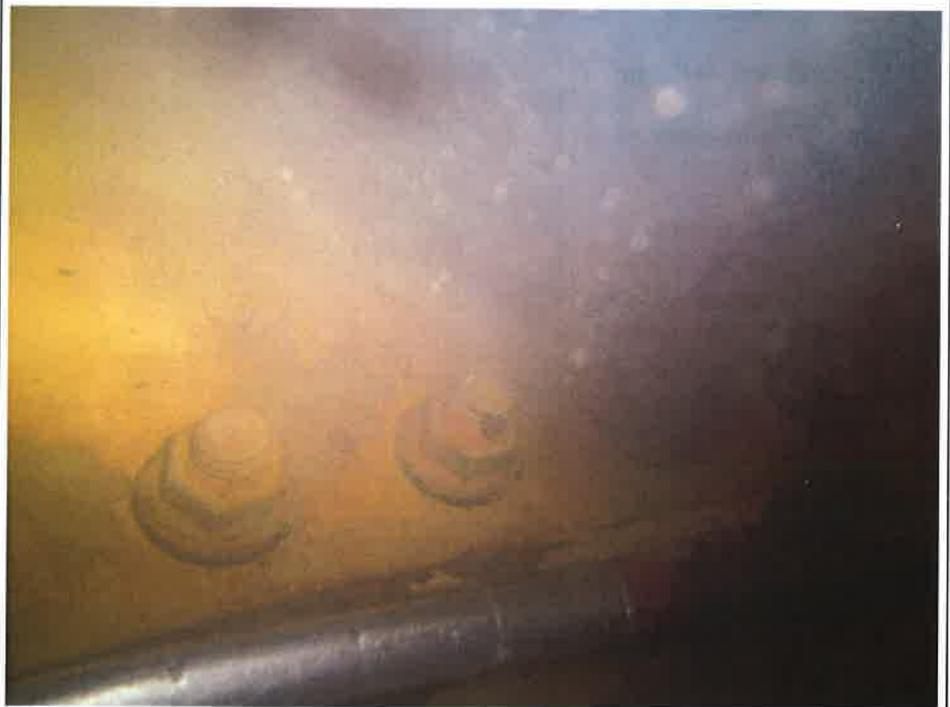
Image #22

Condition:
Rust Grade! 8.

Description:
Floor appeared to be in good condition with a minor amount of corrosion.

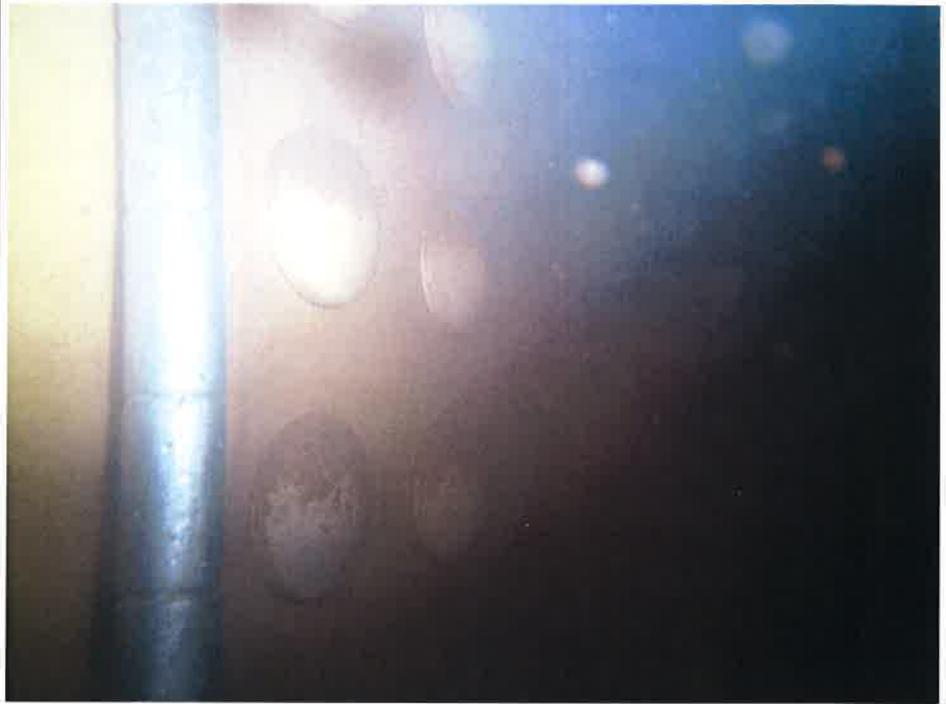
Image #23

Condition:
Rust Grade 7.

Description:
Wall appeared to be in good condition with a minor amount of corrosion.

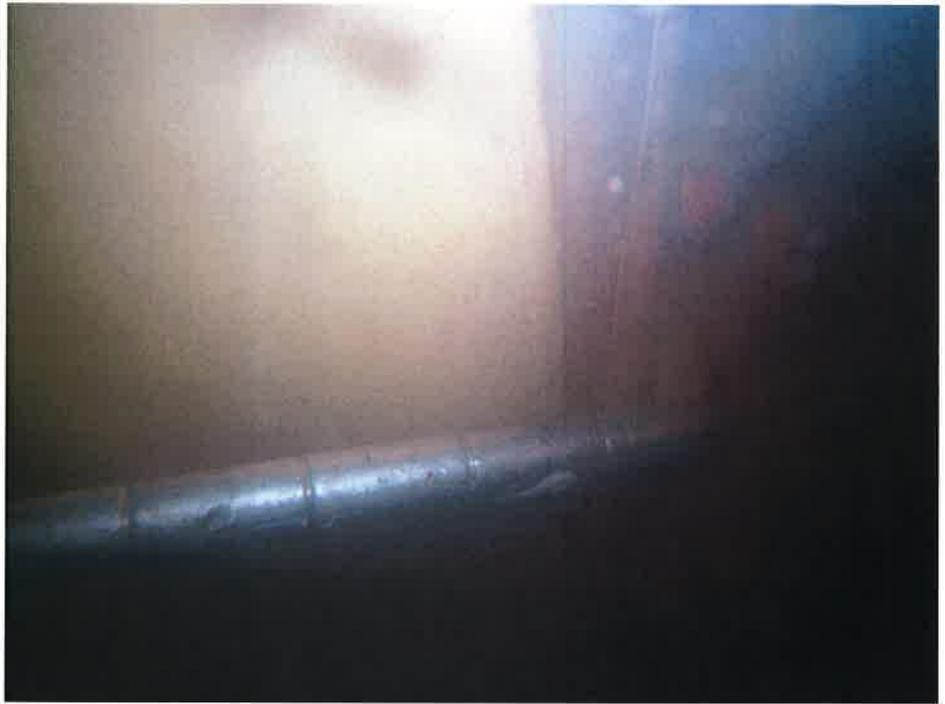
Image #27

Condition:
Rust Grade¹ 10.

Description:
30" Man Way appeared to be in good condition with no signs of corrosion.

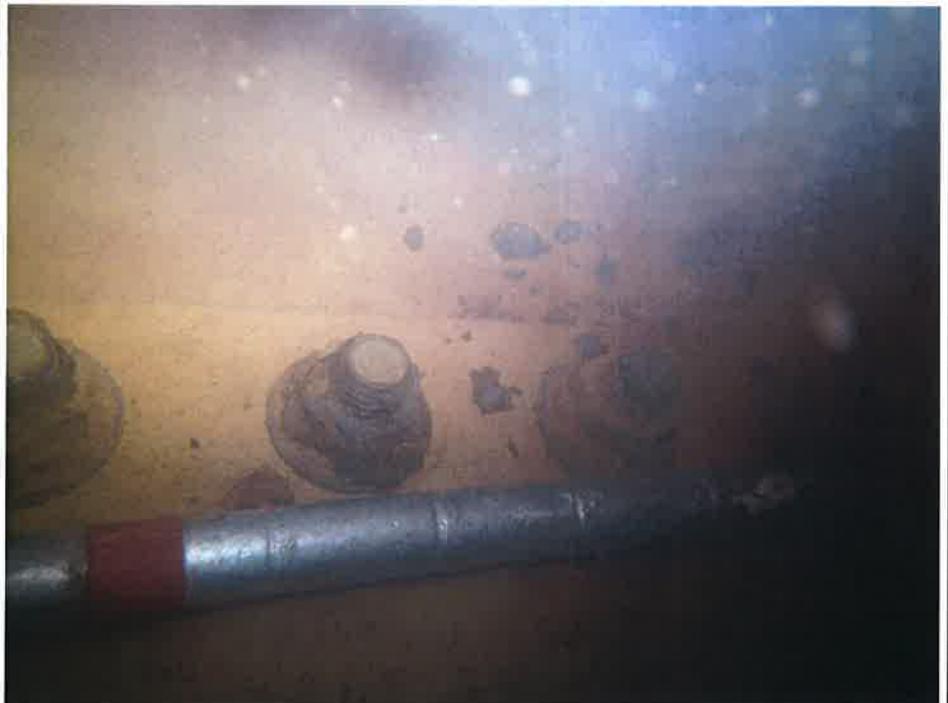
Image #28

Condition:
Rust Grade¹ 9.

Description:
Floor appeared to be in good condition with a minor amount of corrosion.

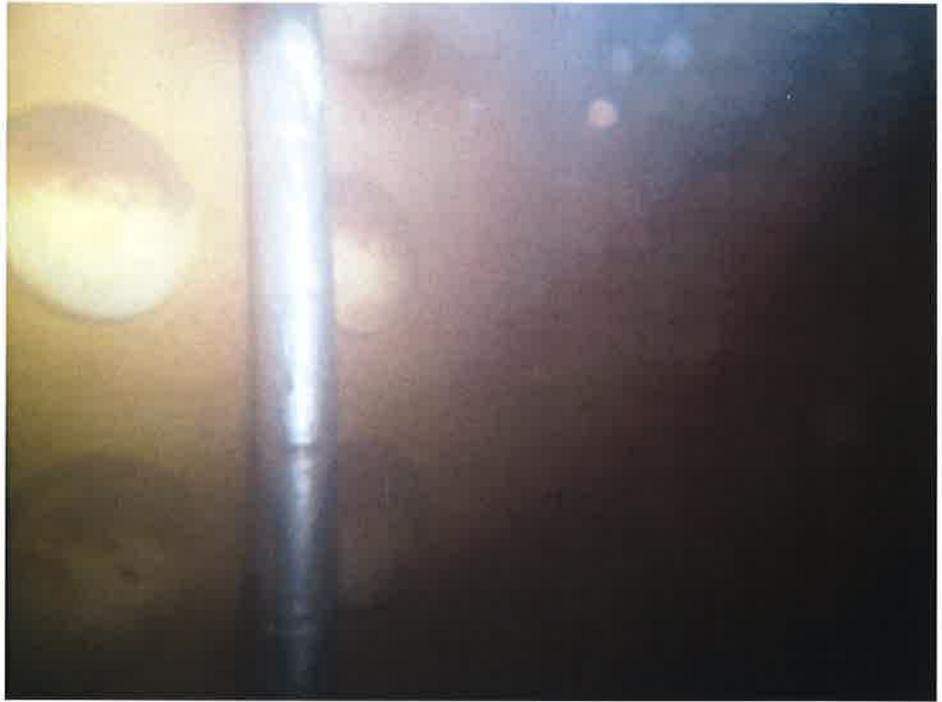
Image #29

Condition:
Rust Grade¹ 9.

Description:
Wall appeared to be in good condition with a minor amount of corrosion.

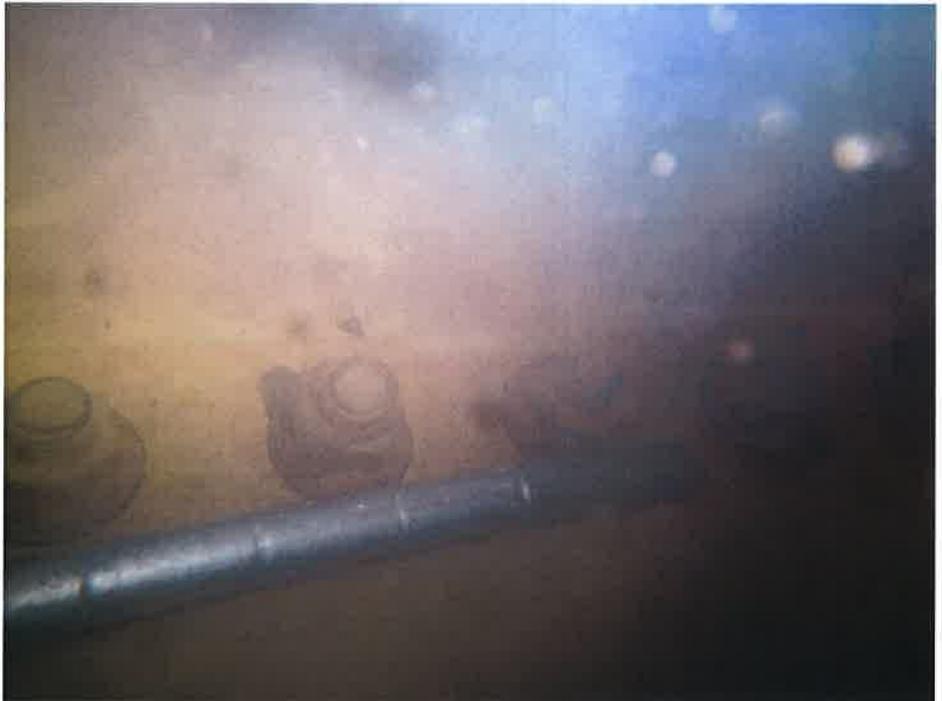
Image #30

Condition:
Rust Grade¹ 8.

Description:
Floor appeared to be in good condition with a minor amount of corrosion.

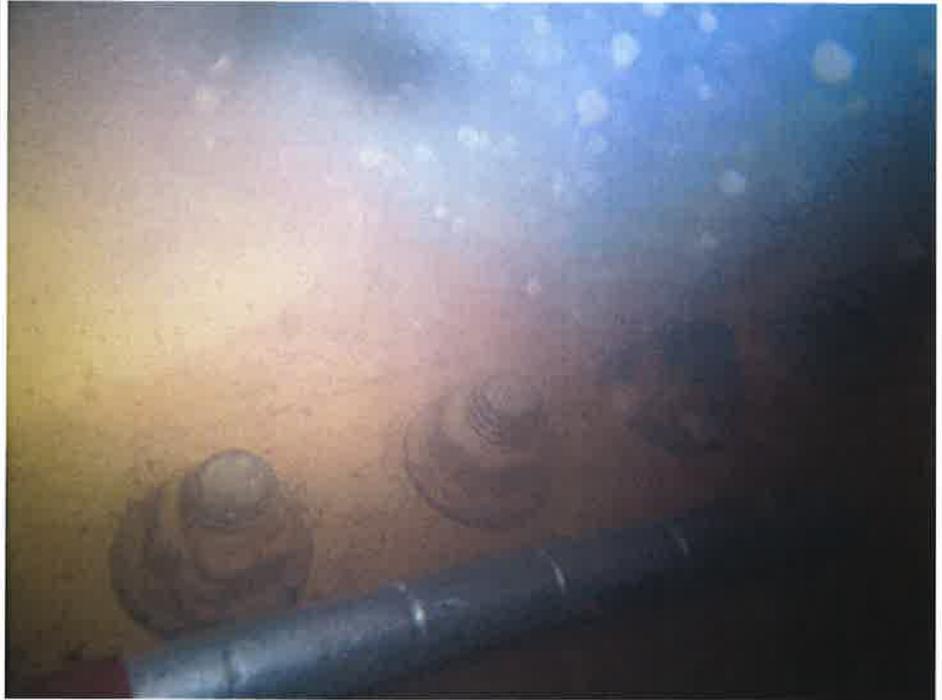
Image #33

Condition:
Rust Grade¹ 8.

Description:
Floor appeared to be in good condition with a minor amount of corrosion.

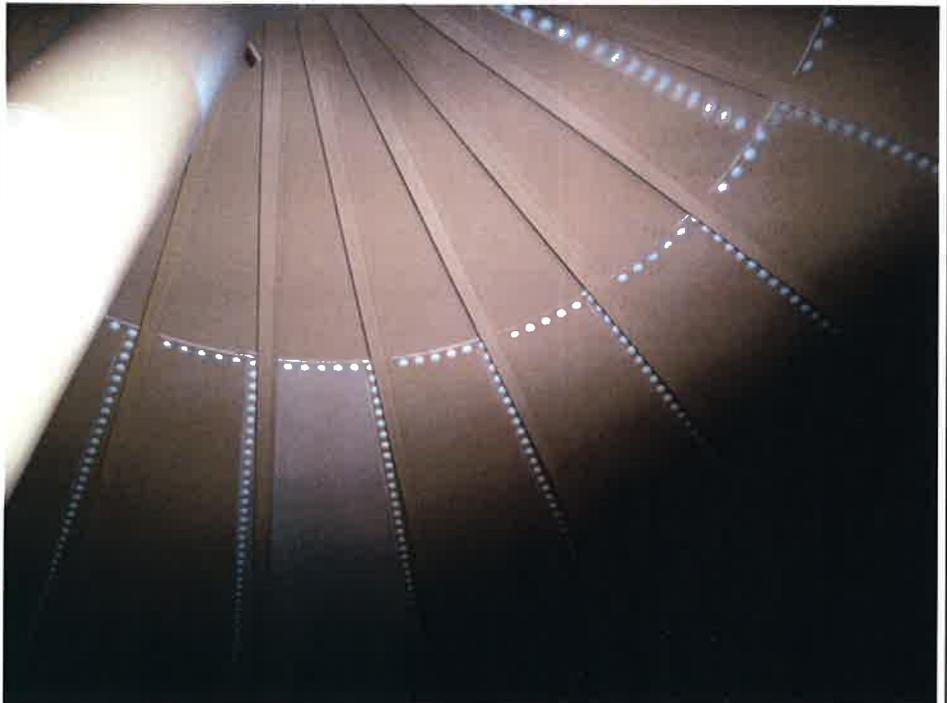
Image #36

Condition:
Rust Grade¹ 9.

Description:
Ceiling appeared to be in good condition with a minor amount of corrosion.
