CITY OF SHASTA LAKE

2016-2026 WATER MASTER PLAN

FINAL • OCTOBER 2016

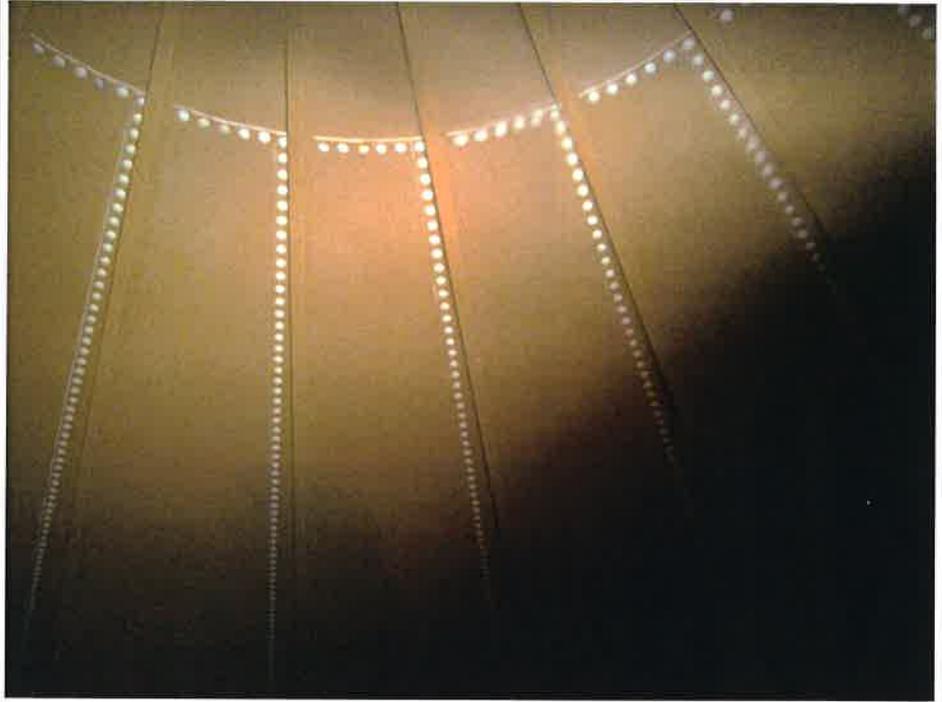
Image #37

Condition:
Rust Grade¹ 10.

Description:
Ceiling appeared to be in good condition with no signs of corrosion.

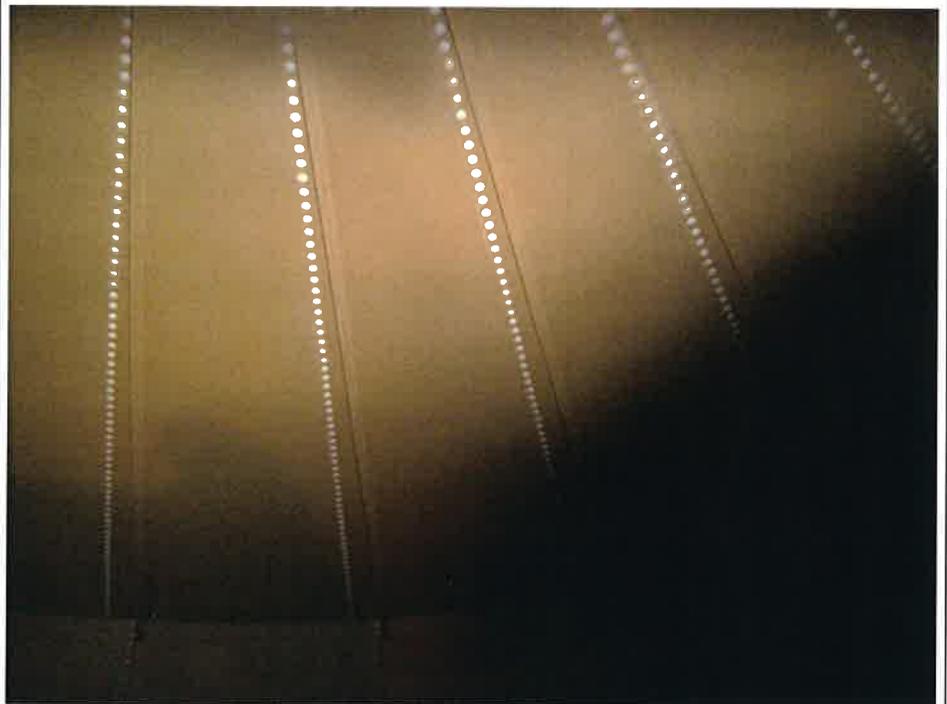
Image #38

Condition:
Rust Grade¹ 10.

Description:
Ceiling appeared to be in good condition with no signs of corrosion.

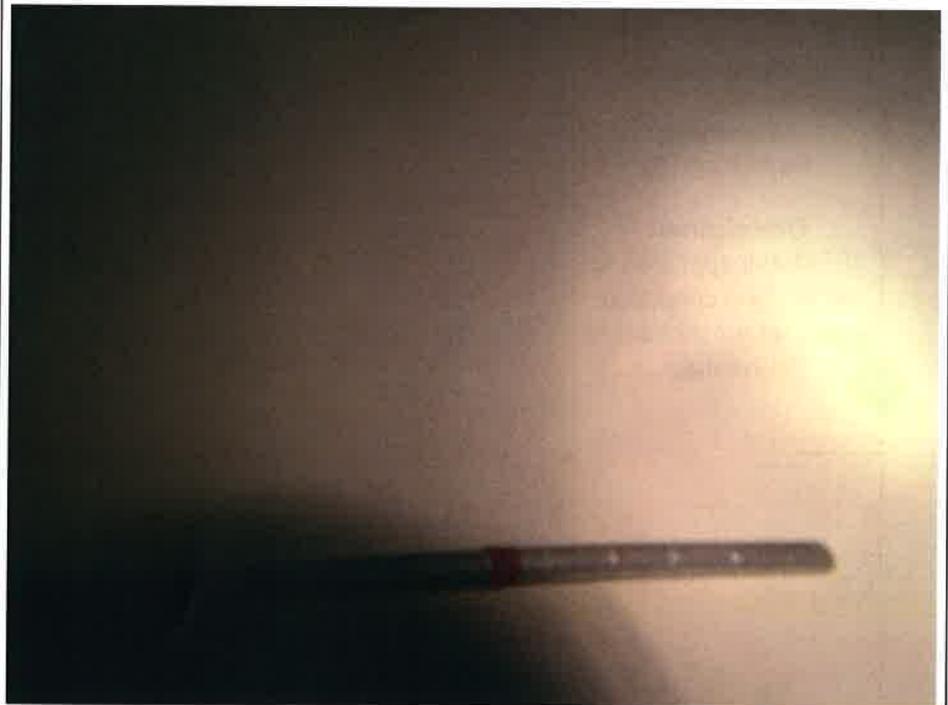
Condition:
Rust Grade¹ 9.

Description:
Floor appeared to be in good condition with a minor amount of corrosion.

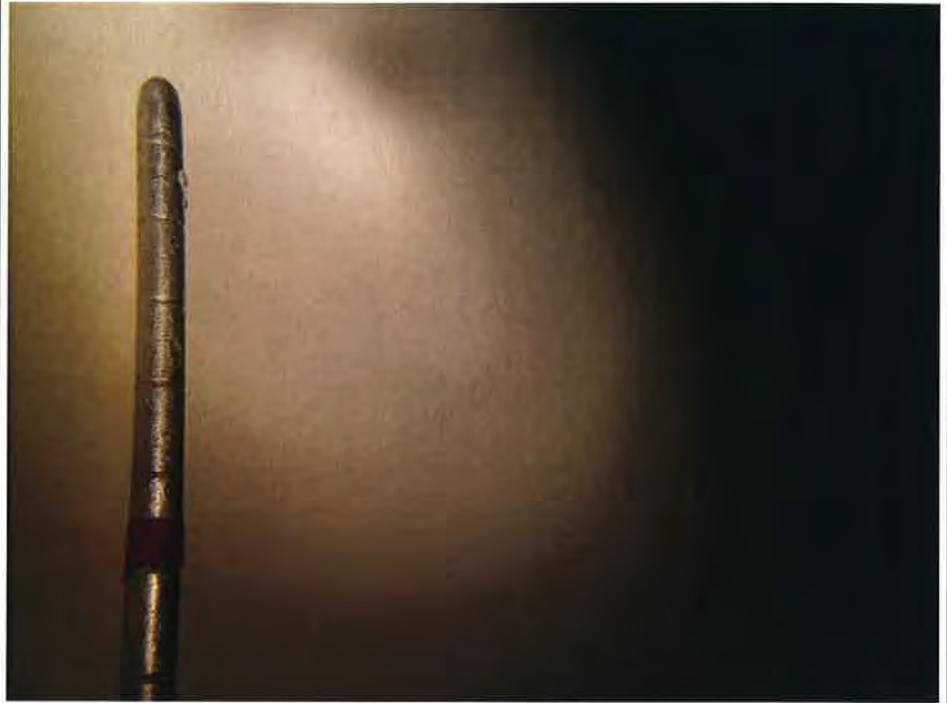
Image #37

Condition:
Rust Grade' 9.

Description:
Wall appeared to be in good condition with a minor amount of corrosion.

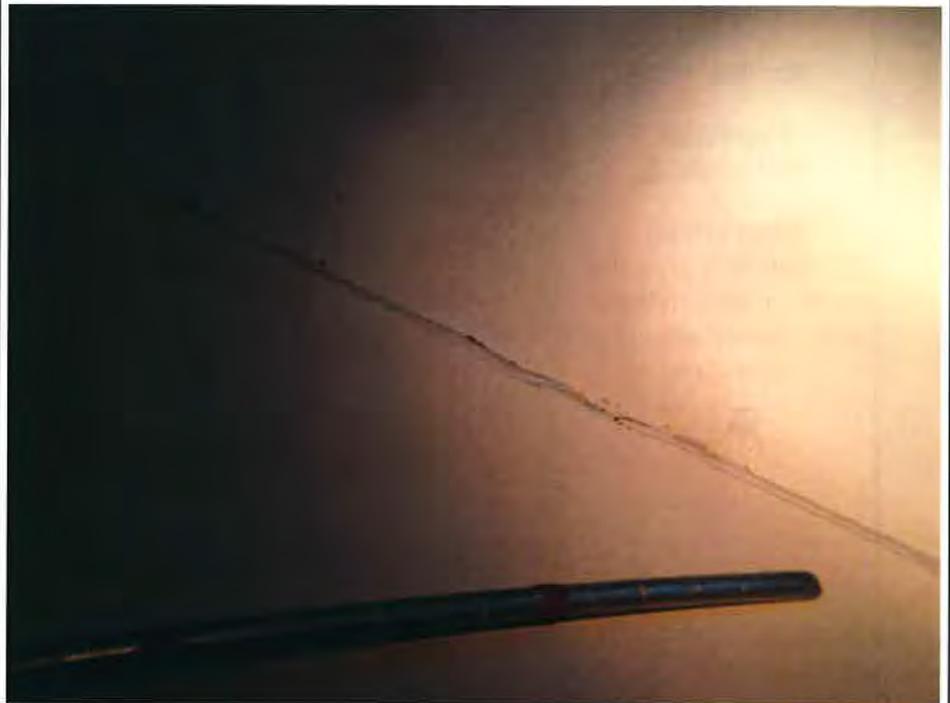
Image #38

Floor 9:00

Condition:
Rust Grade' 9.

Description:
Floor appeared to be in good condition with a minor amount of corrosion.

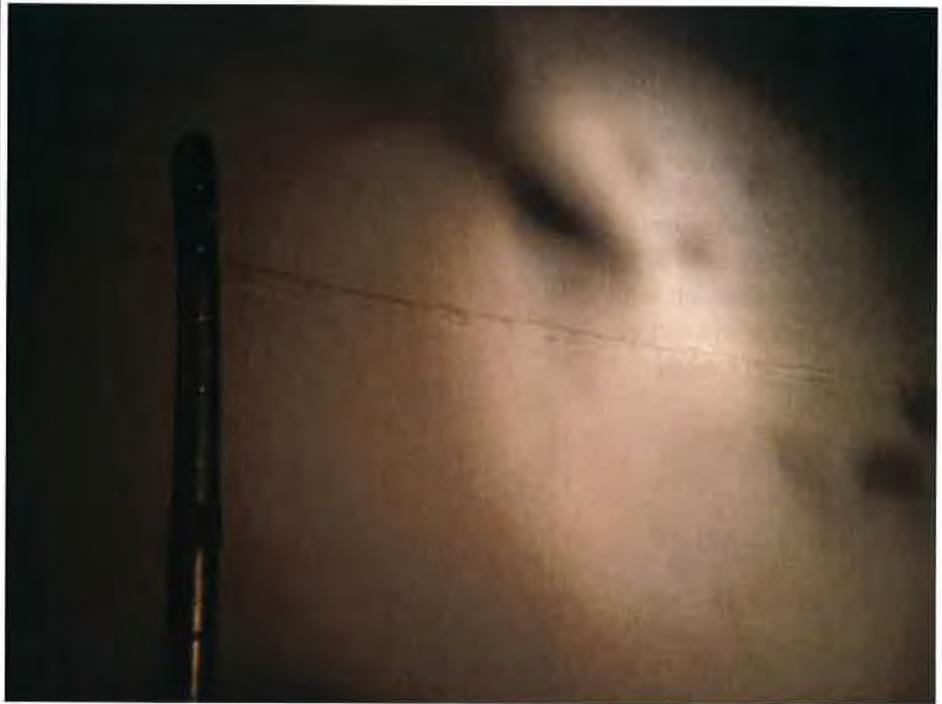
Image #39

Condition:
Rust Grade' 9.

Description:
Wall appeared to be in good condition with a minor amount of corrosion.

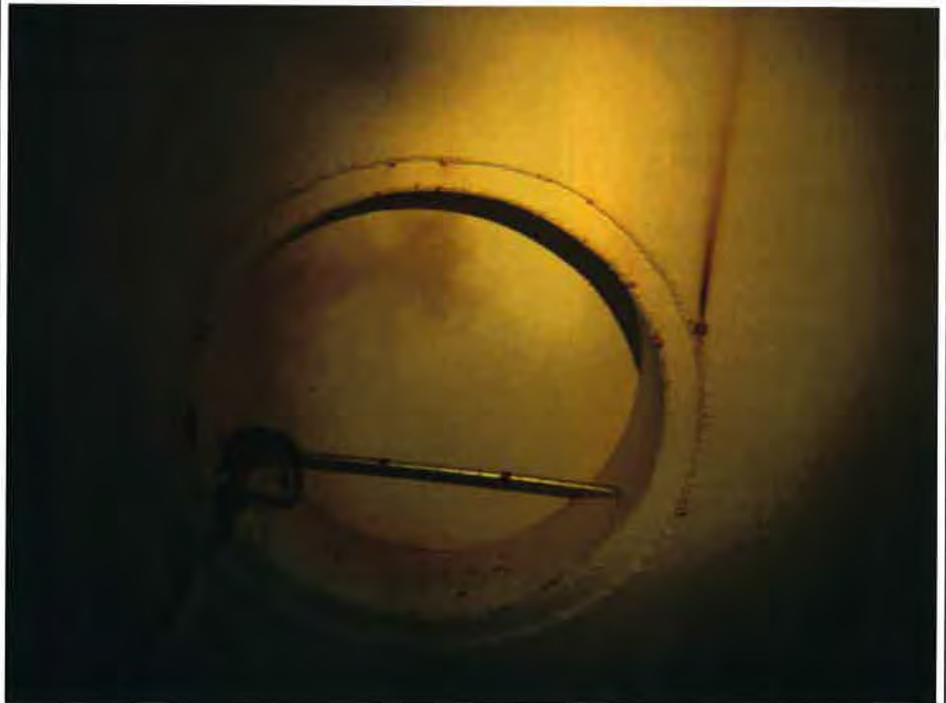
Image #40

Man Way 11:30

Condition:
Rust Grade' 8.

Description:
24" Man Way appeared to be in fair condition with a minor amount of corrosion.

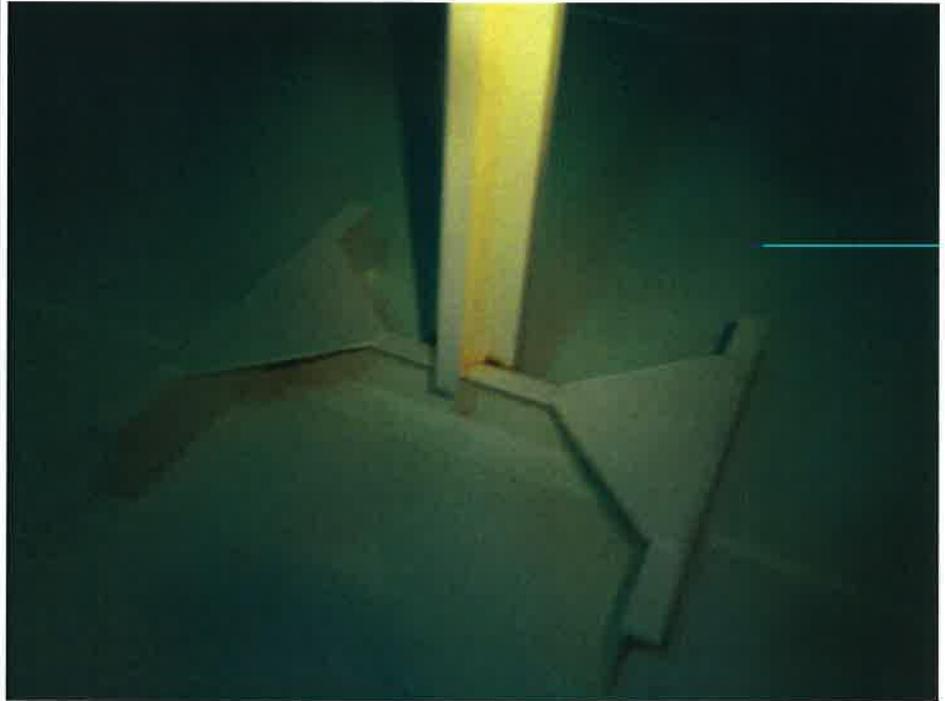
Image #41

Condition:
Rust Grade' 7.

Description:
6'' Column appeared to be in good condition with a minor amount of corrosion.

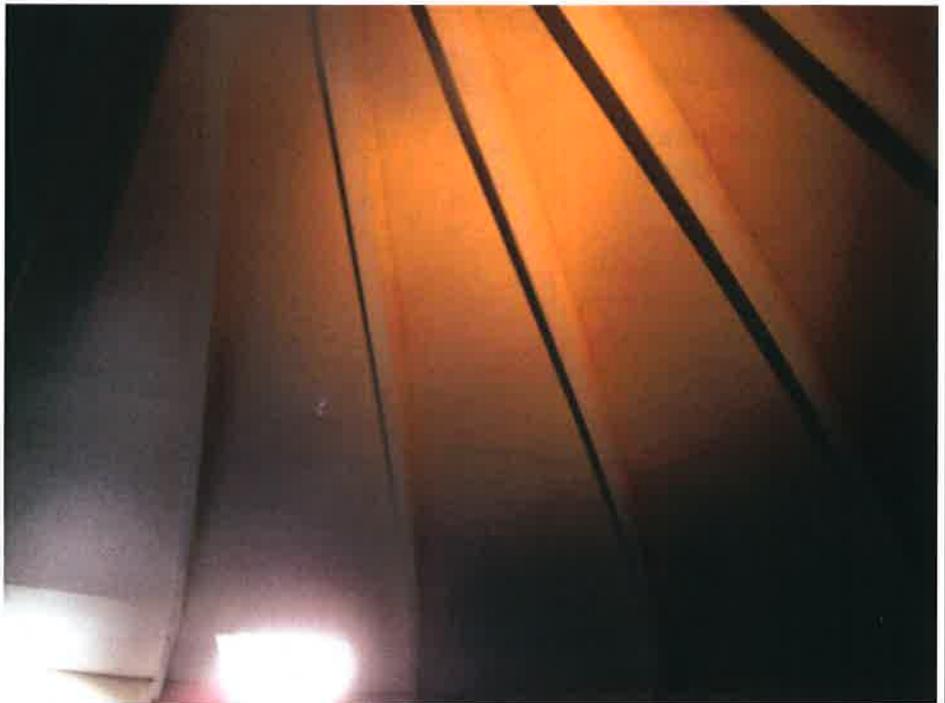
Image #42

Ceiling 12:00

Condition:
Rust Grade' 9.

Description:
Ceiling appeared to be in good condition with a minor amount of corrosion.

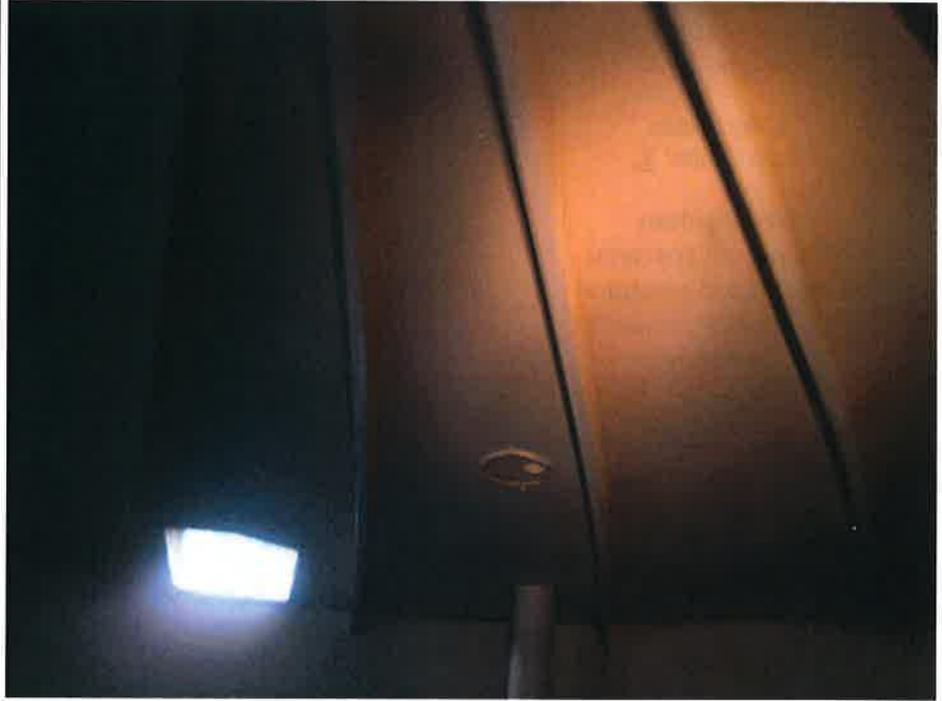
Image #43

Condition:
Rust Grade' 9.

Description:
Ceiling appeared to be in good condition with a minor amount of corrosion.

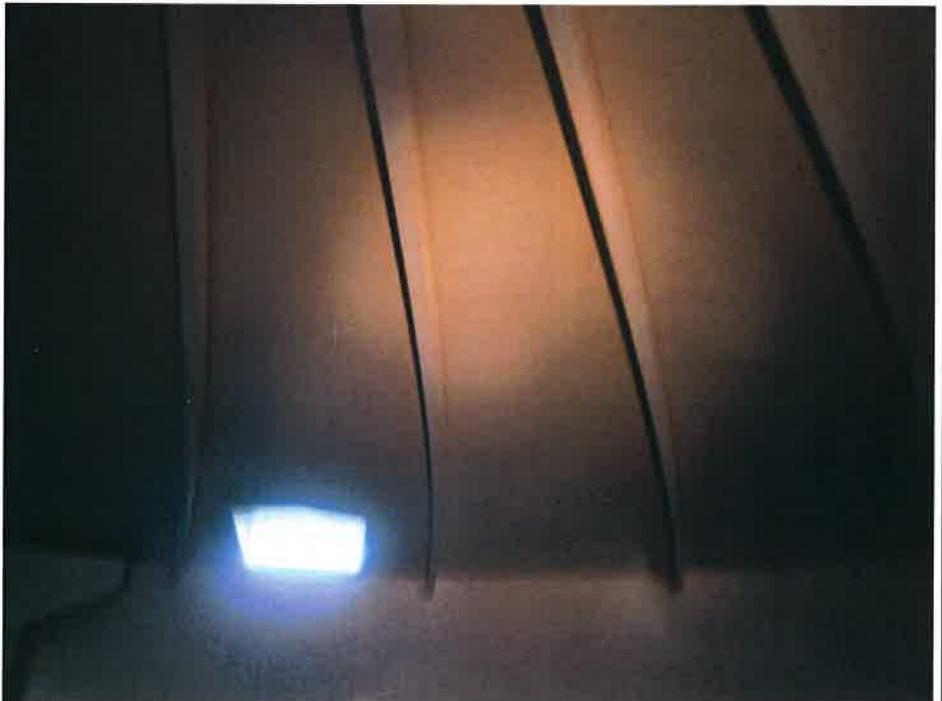
Image #44

Ceiling 6:00

Condition:
Rust Grade' 9.

Description:
Ceiling appeared to be in good condition with a minor amount of corrosion.

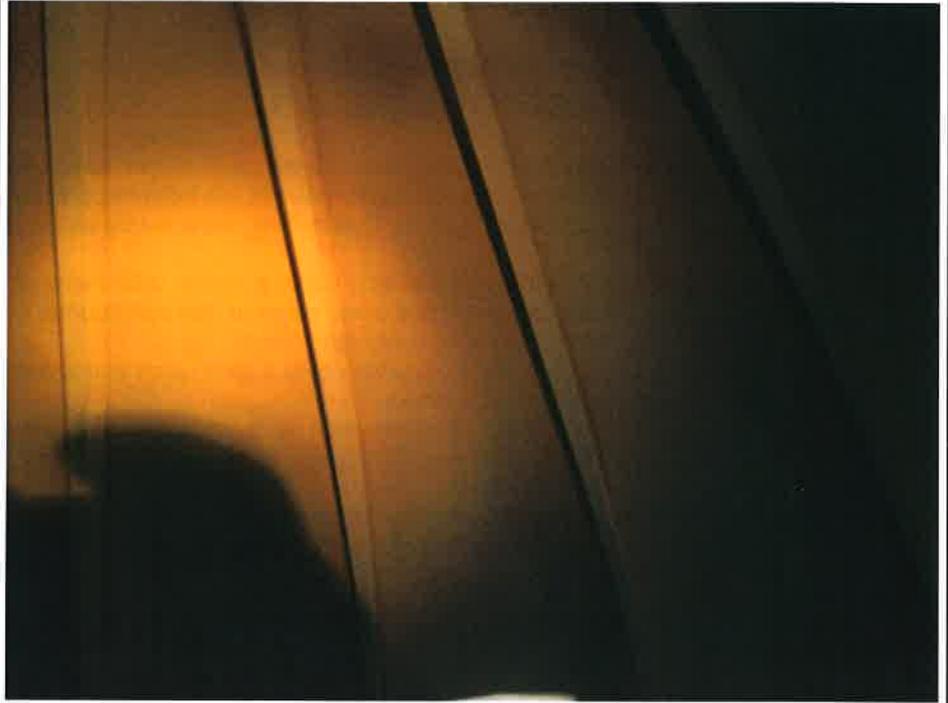
Image #45

Condition:
Rust Grade' 9.

Description:
Ceiling appeared to be in good condition with a minor amount of corrosion.

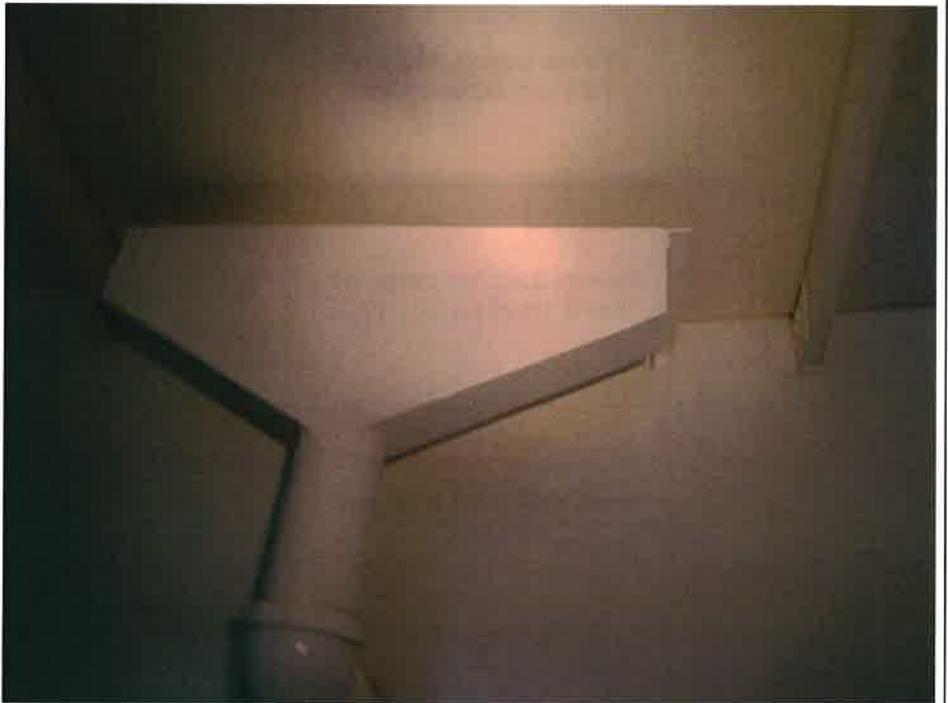
Image #46

Overflow Bell 6:00

Condition:
Rust Grade' 9.

Description:
48"x6"x18" Overflow Bell appeared to be in good condition with a minor amount of corrosion.

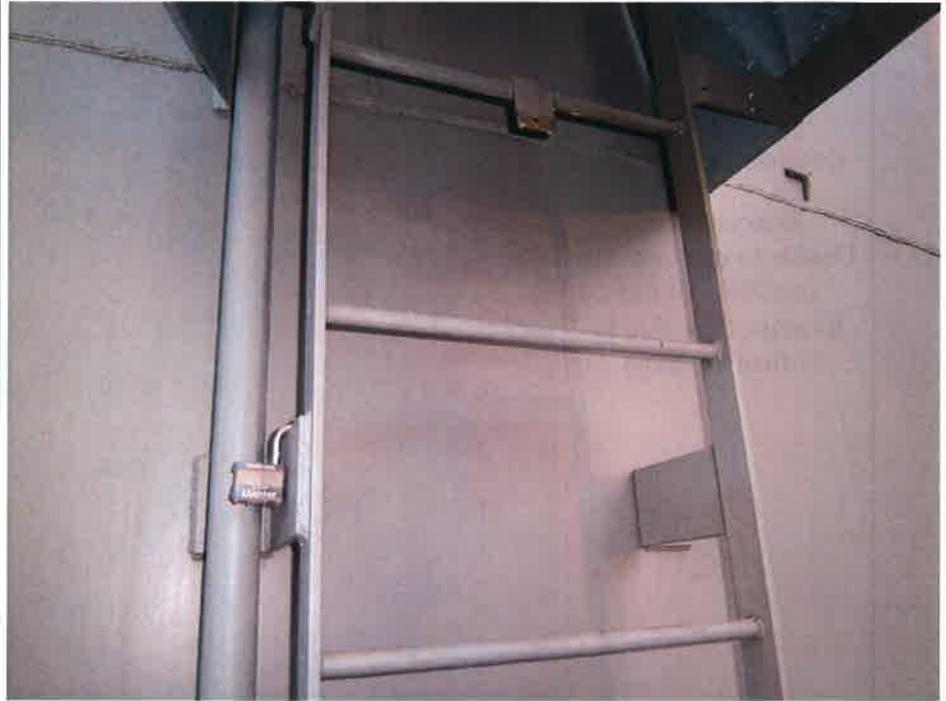
Condition:
Rust Grade' 9.

Description:
Exterior Ladder
appeared to be in good
condition with minor
signs of corrosion.

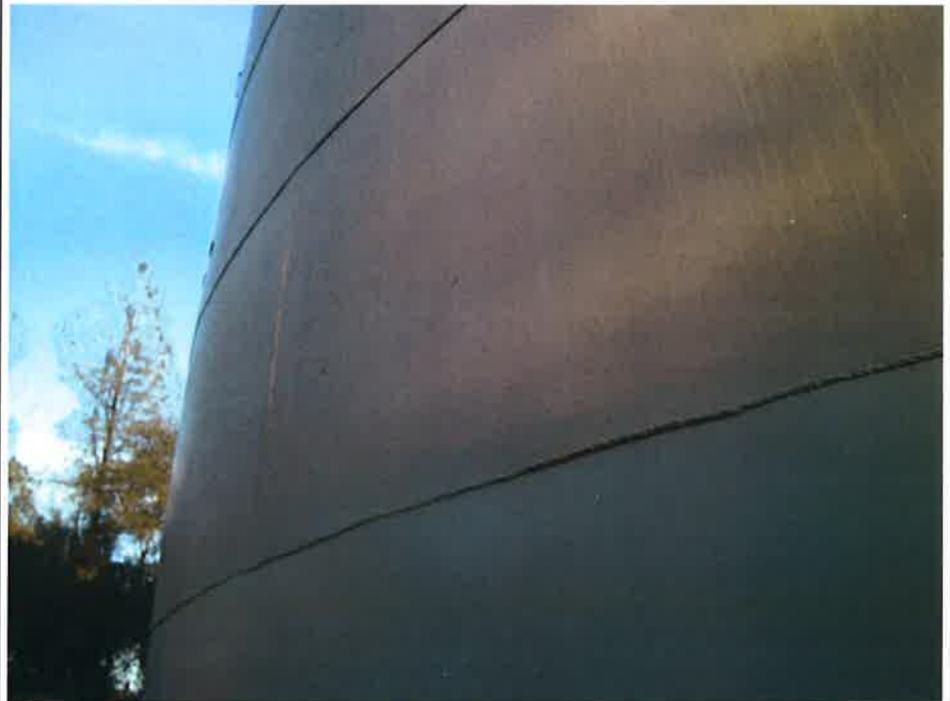
Image #2

Exterior Wall 3:00

Condition:
Rust Grade' 9.

Description:
Exterior Wall
appeared to be in good
condition with a minor
amount of corrosion.

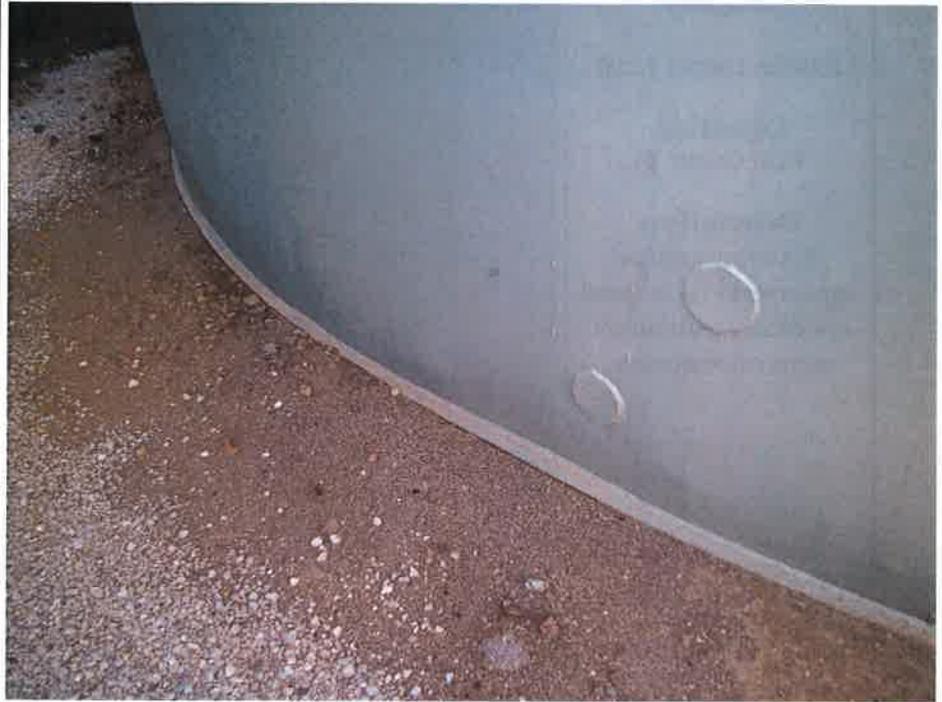
Image #3

Condition:
Concrete Deform³ UE.

Description:
Unable to evaluate the condition of the Exterior Base due to earthen covering.

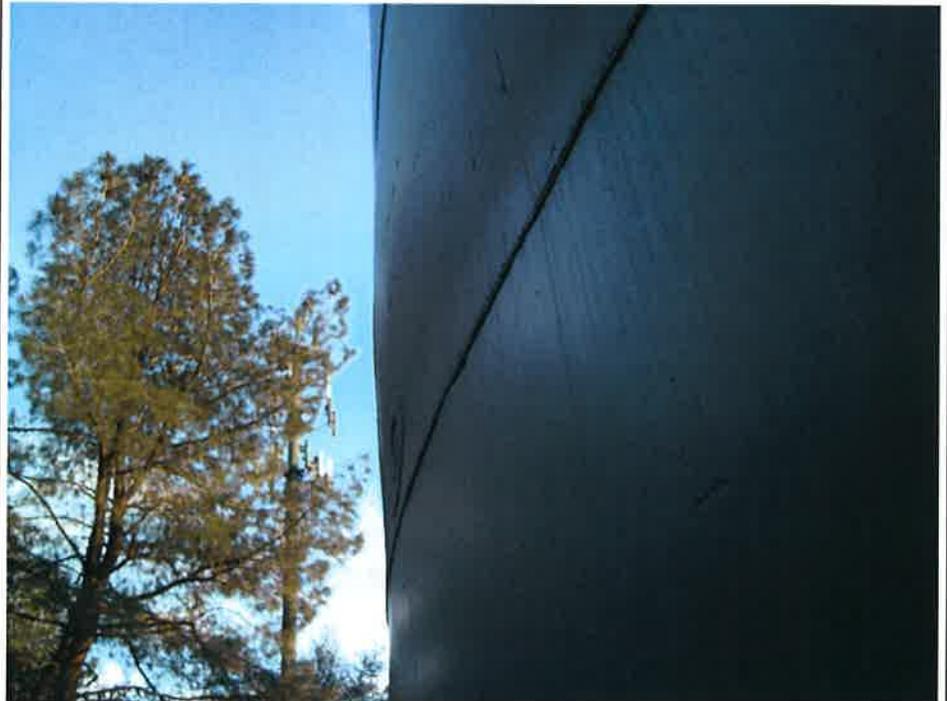
Image #4

Exterior Wall 6:00

Condition:
Rust Grade¹ 9.

Description:
Exterior Wall appeared to be in fair condition with a minor amount of corrosion and some minor structural bowing.

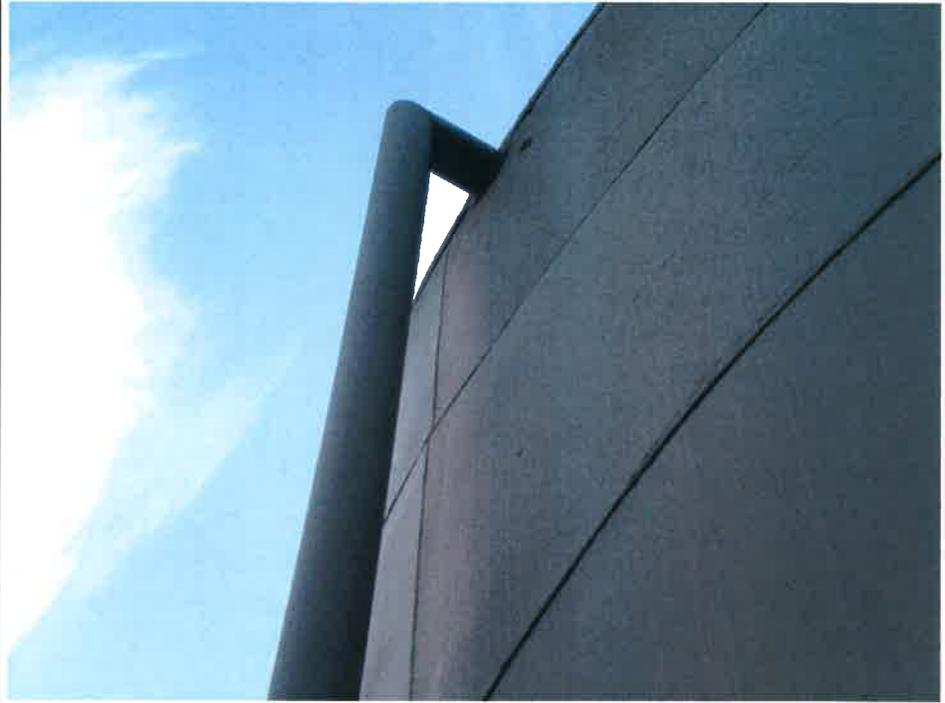
Image #5

Condition:
Rust Grade¹ 9.

Description:
8" Outlet appeared to be in good condition with a minor amount of corrosion.

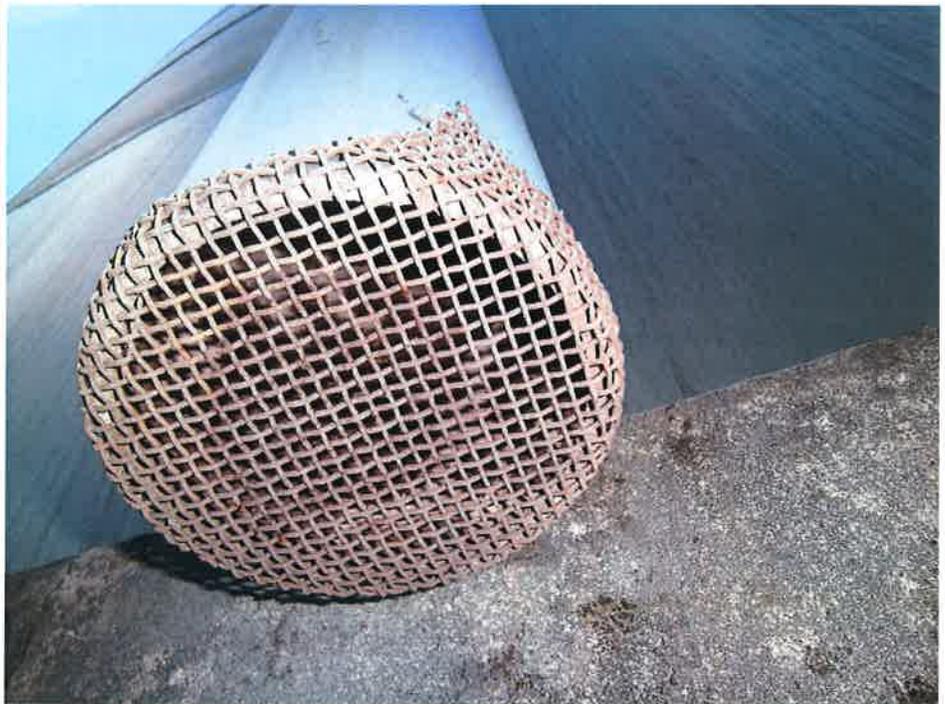
Image #6

Overflow Screen 7:30

Condition:
Rust Grade¹ 9.

Description:
Medium Mesh
Overflow Screen
appeared to be in good condition with a minor amount of corrosion.

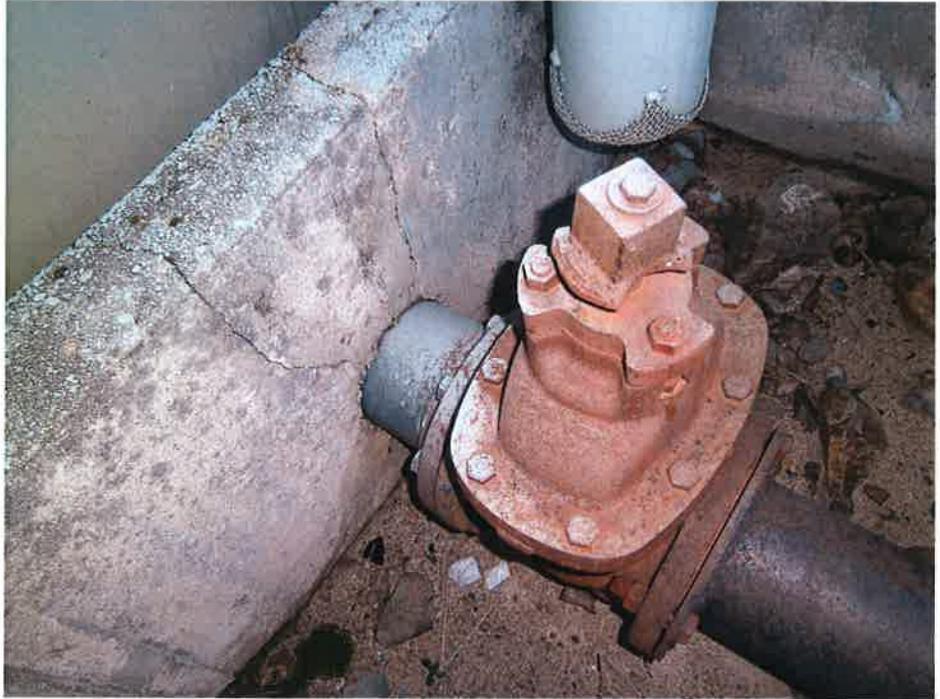
Image #7

Condition:
Rust Grade' 7.

Description:
6" Drain appeared to be in good condition with a minor amount of corrosion.

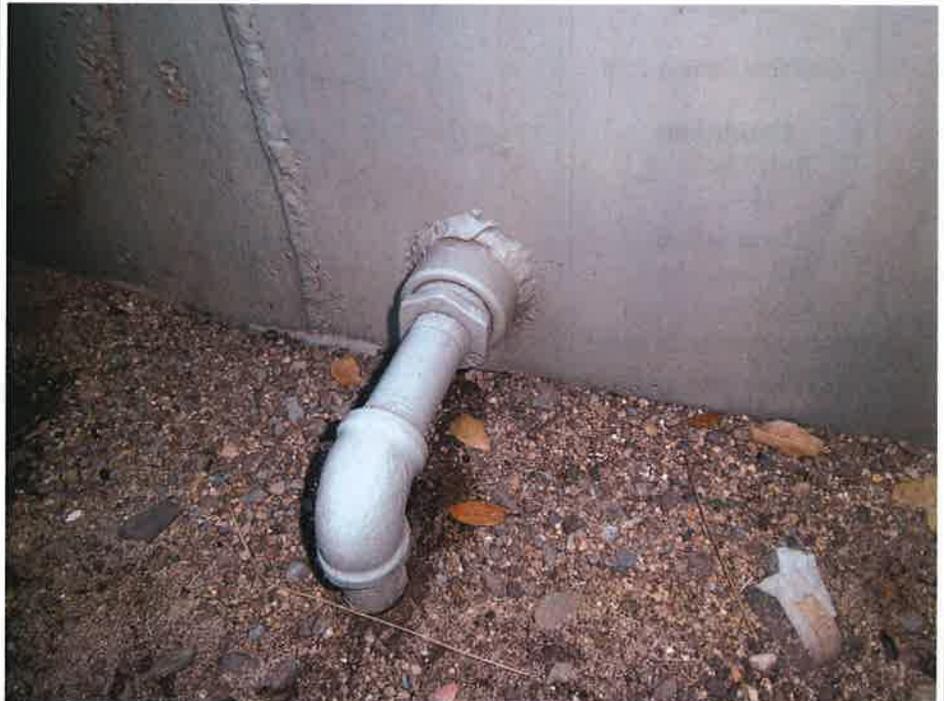
Image #8

Water Tap 8:00

Condition:
Rust Grade' 9.

Description:
2" Water Tap appeared to be in good condition with a minor amount of corrosion.

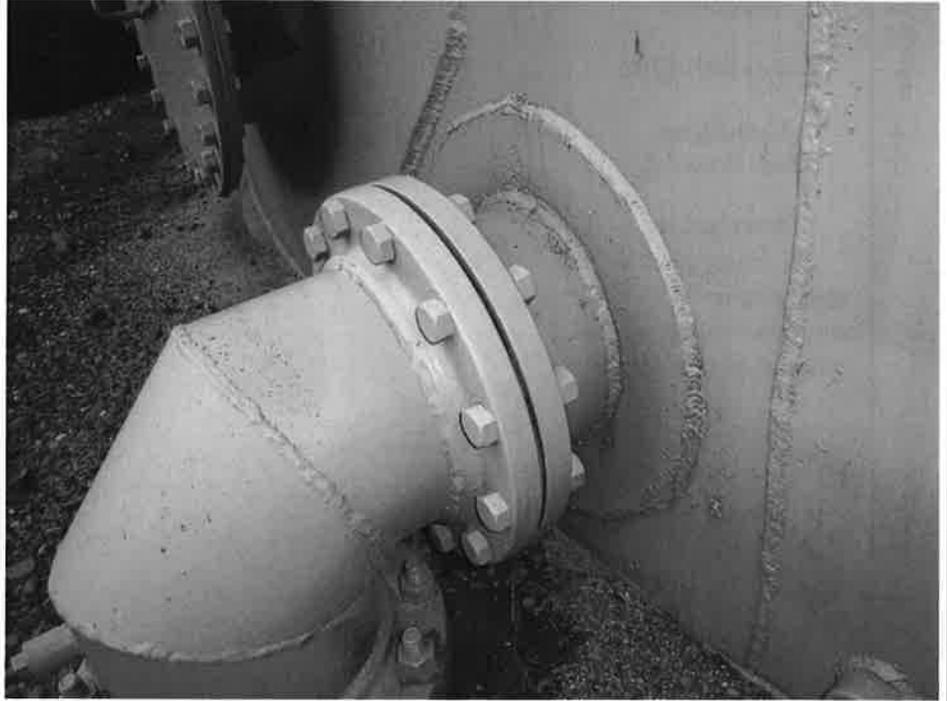
Image #9

Condition:
Rust Grade' 9.

Description:
10" Inlet / Outlet
appeared to be in good
condition with a minor
amount of corrosion.

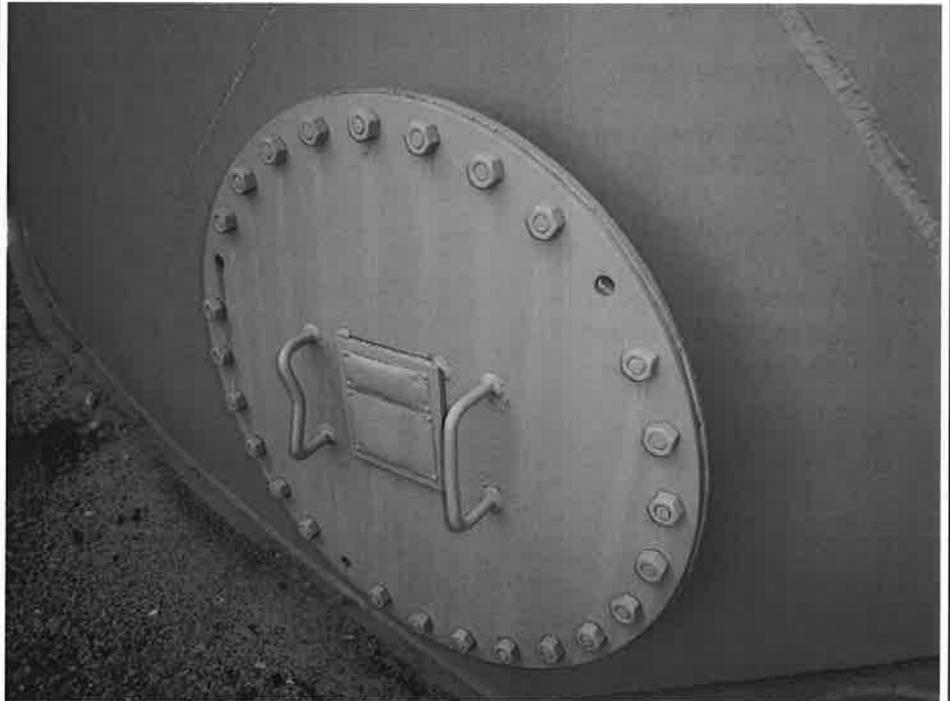
Image #10

Man Way 8:30

Condition:
Rust Grade' 9.

Description:
30" Man Way appeared
to be in good condition
with a minor amount of
corrosion and missing
to bolts.

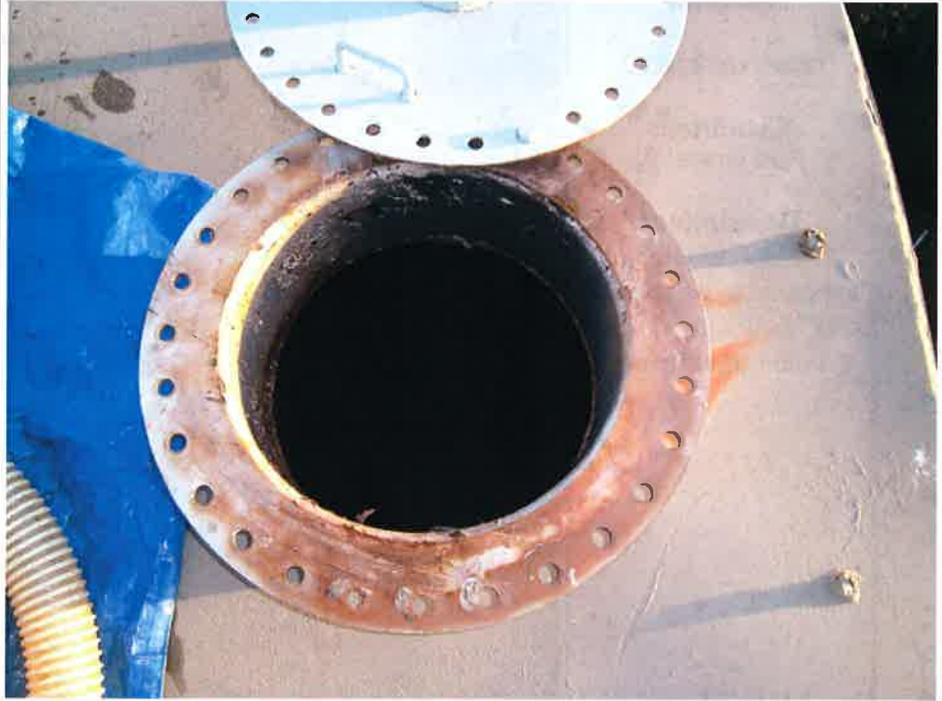
Image #11

Condition:
Rust Grade¹ 8.

Description:
20" Entry Hatch
appeared to be in UE
condition with a minor
amount of corrosion.

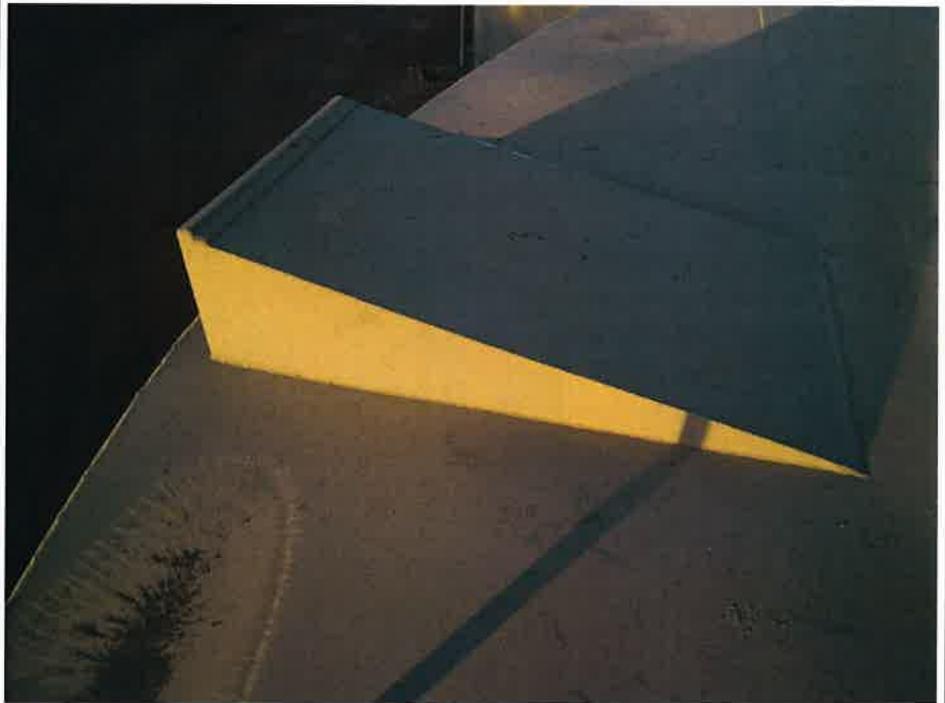
Image #12

Side Vent 2:00

Condition:
Rust Grade¹ 9.

Description:
24"x6" Side Vent
appeared to be in good
condition with a minor
amount of corrosion.

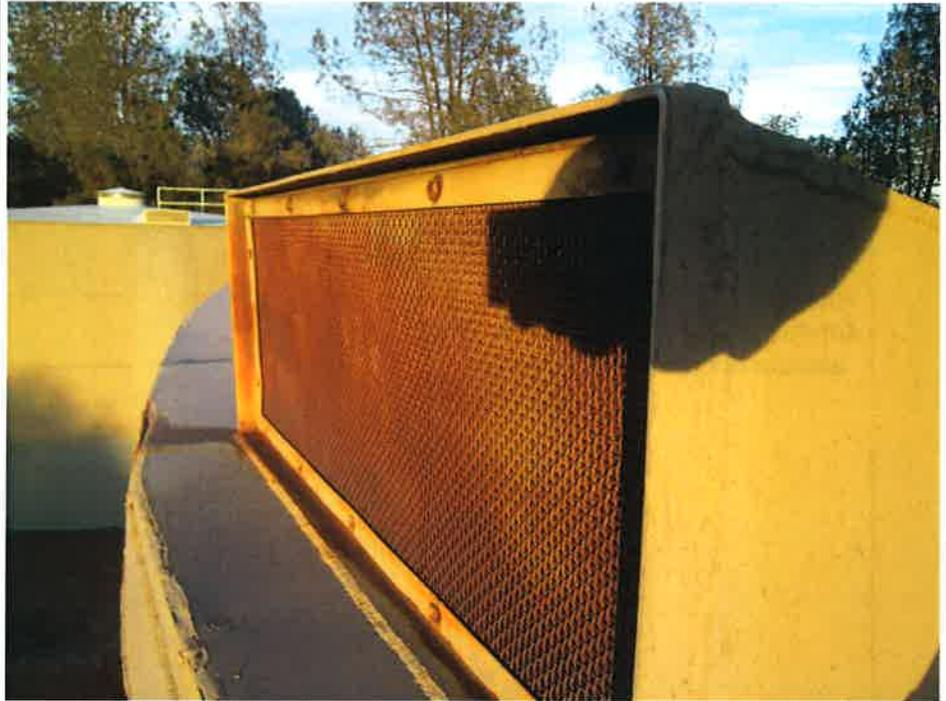
Image #13

Condition:
Rust Grade! 8.

Description:
Fine Mesh Vent Screen appeared to be in good condition with a minor amount of corrosion and some heavy staining.

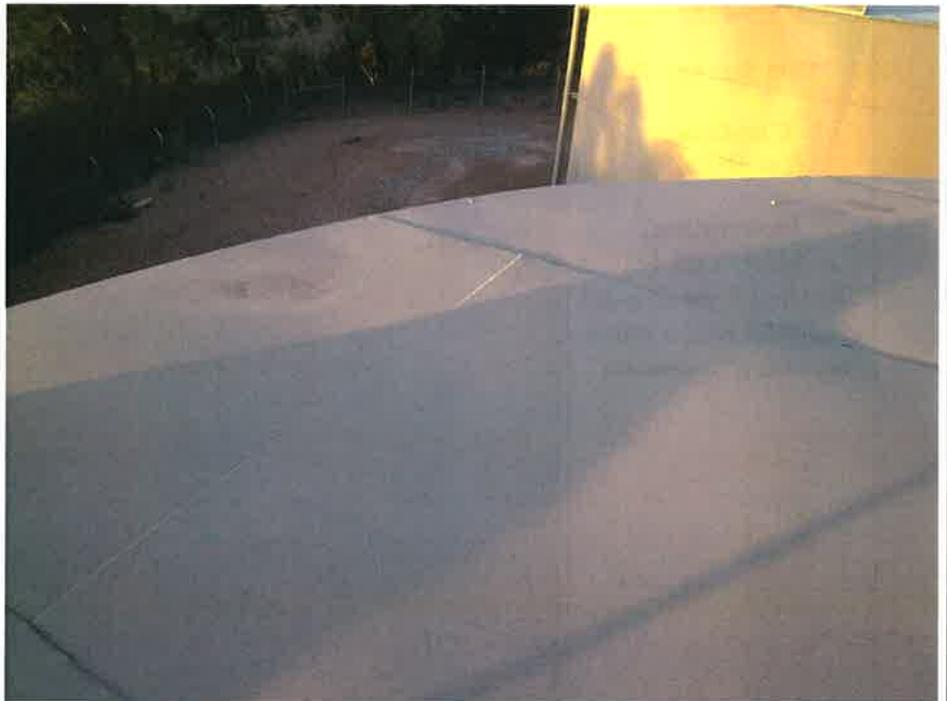
Image #14

Roof 3:00

Condition:
Rust Grade! 9.

Description:
Roof appeared to be in good condition with a minor amount of corrosion.

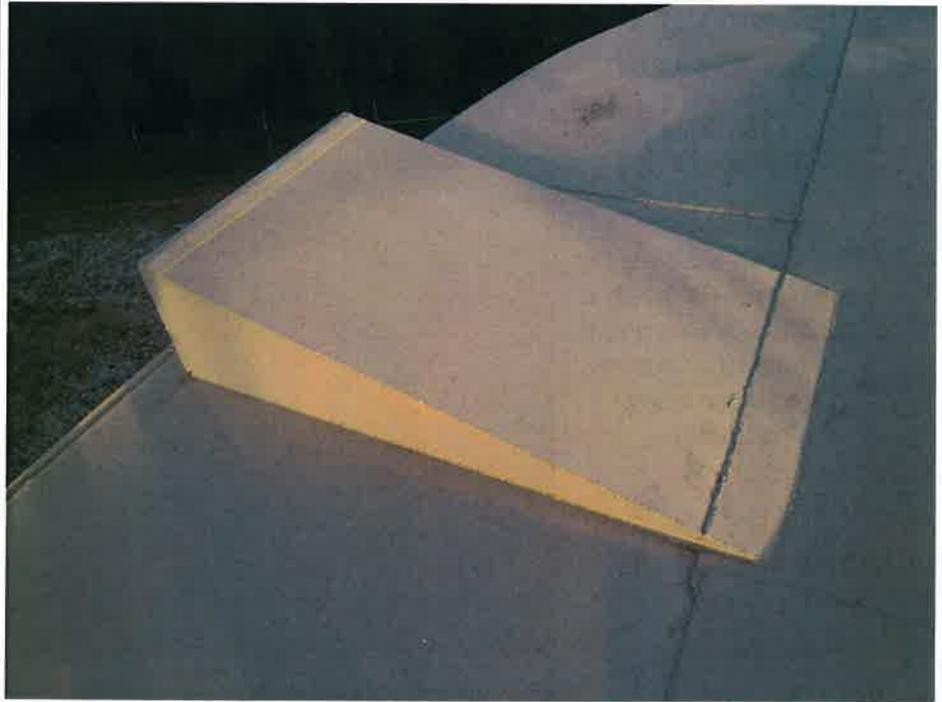
Image #15

Condition:
Rust Grade¹ 9.

Description:
26"x6" Side Vent
appeared to be in good
condition with a minor
amount of corrosion.

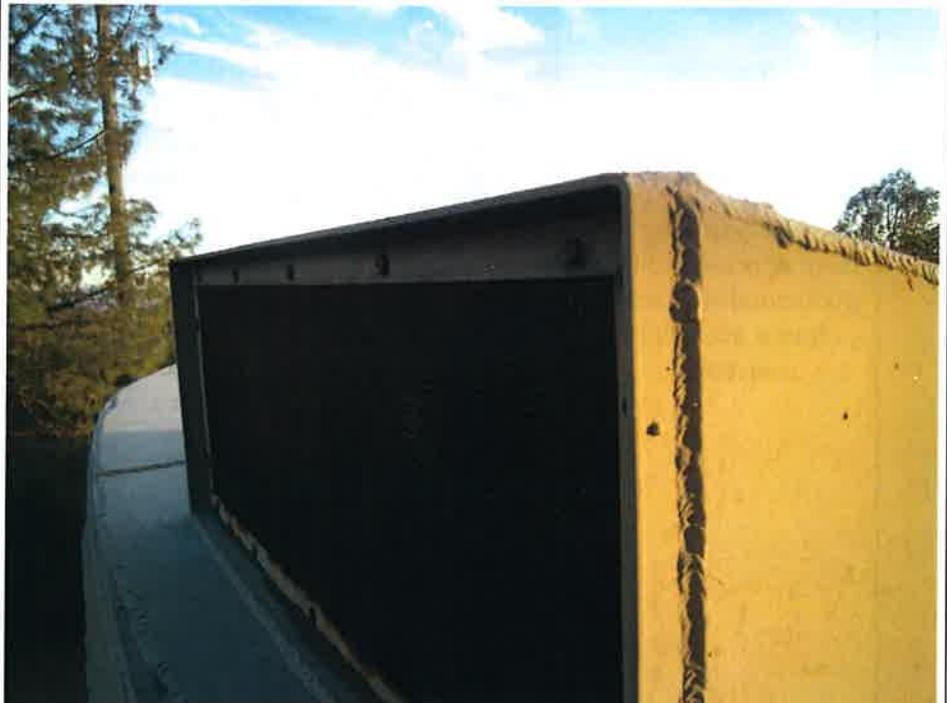
Image #16

Vent Screen 4:00

Condition:
Rust Grade¹ 9.

Description:
Fine Mesh Vent Screen
appeared to be in good
condition with a minor
amount of corrosion.

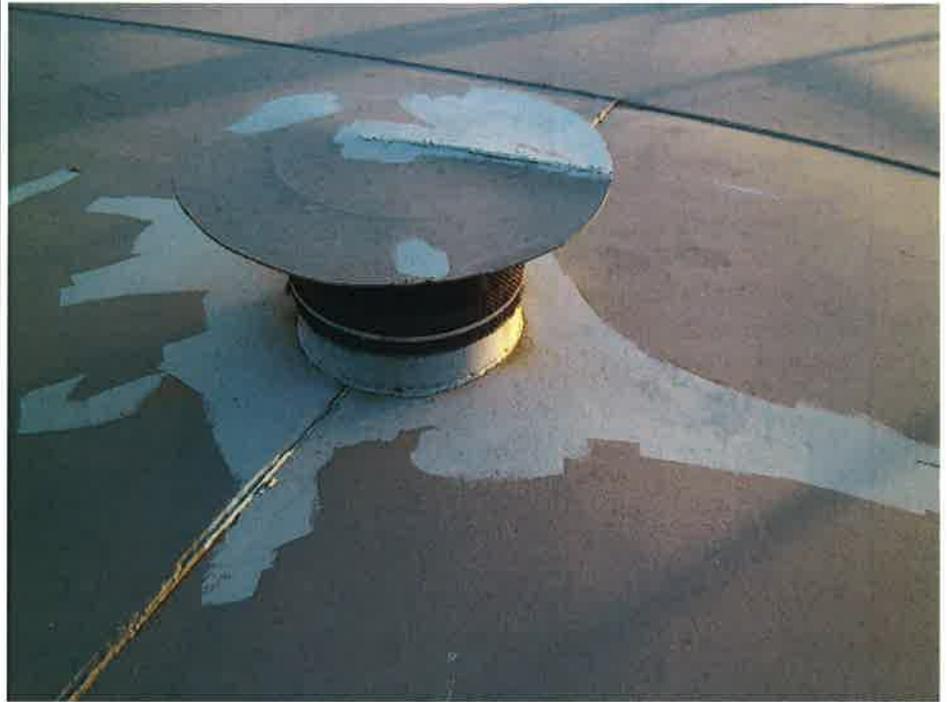
Image #17

Condition:
Rust Grade¹ 9.

Description:
18" Vent appeared to be in good condition with a minor amount of corrosion.

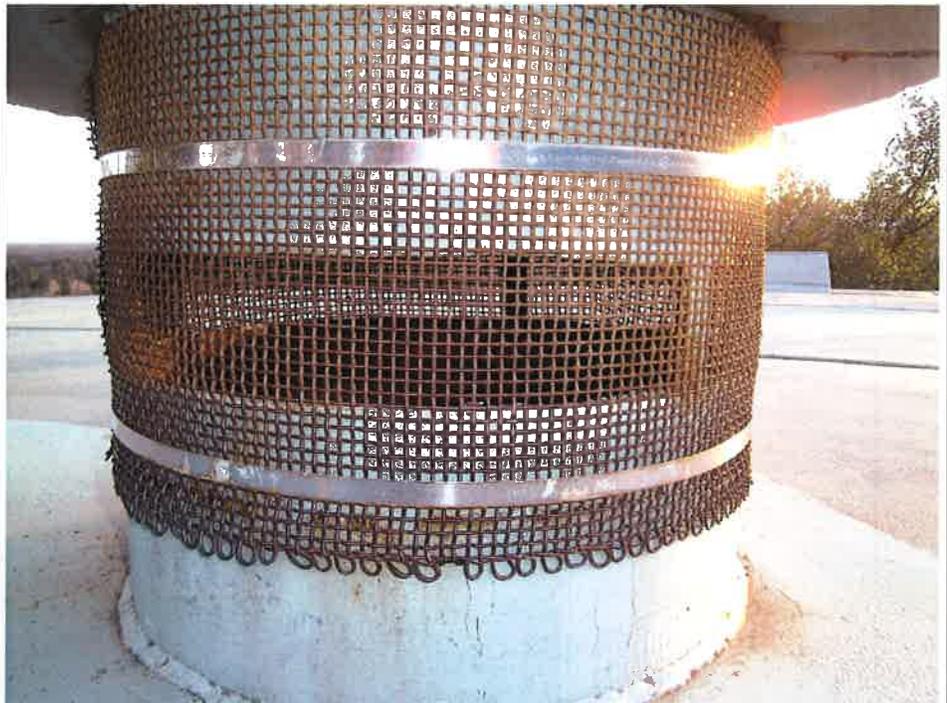
Image #18

Vent Screen Center

Condition:
Rust Grade¹ 7.

Description:
Medium Mesh Vent Screen appeared to be in good condition with a minor amount of corrosion.

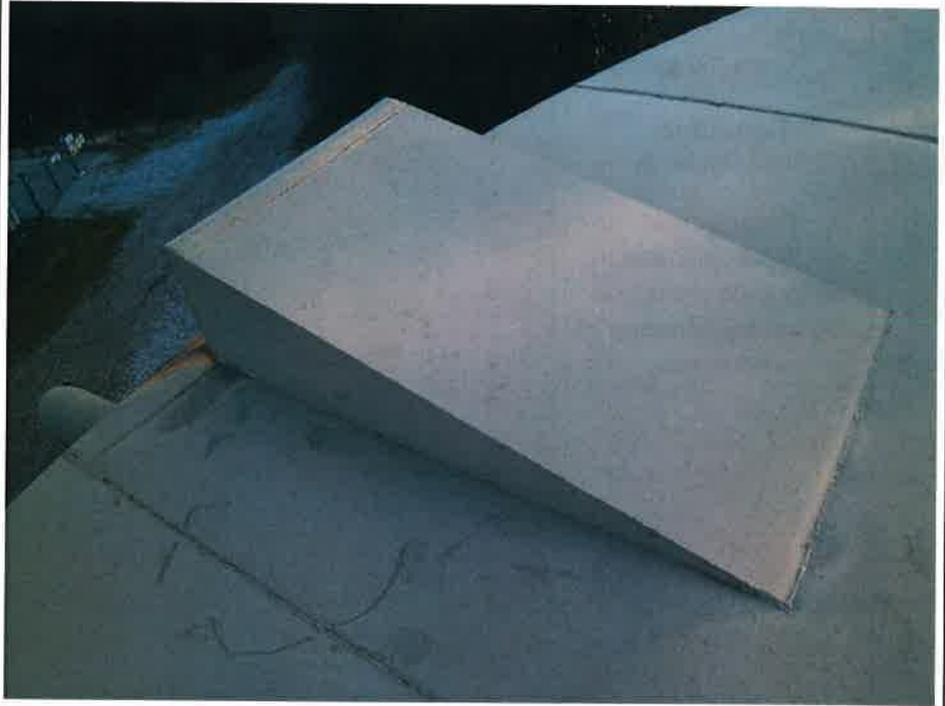
Image #19

Condition:
Rust Grade' 9.

Description:
24"x6" Side Vent
appeared to be in good
condition with a minor
amount of corrosion.

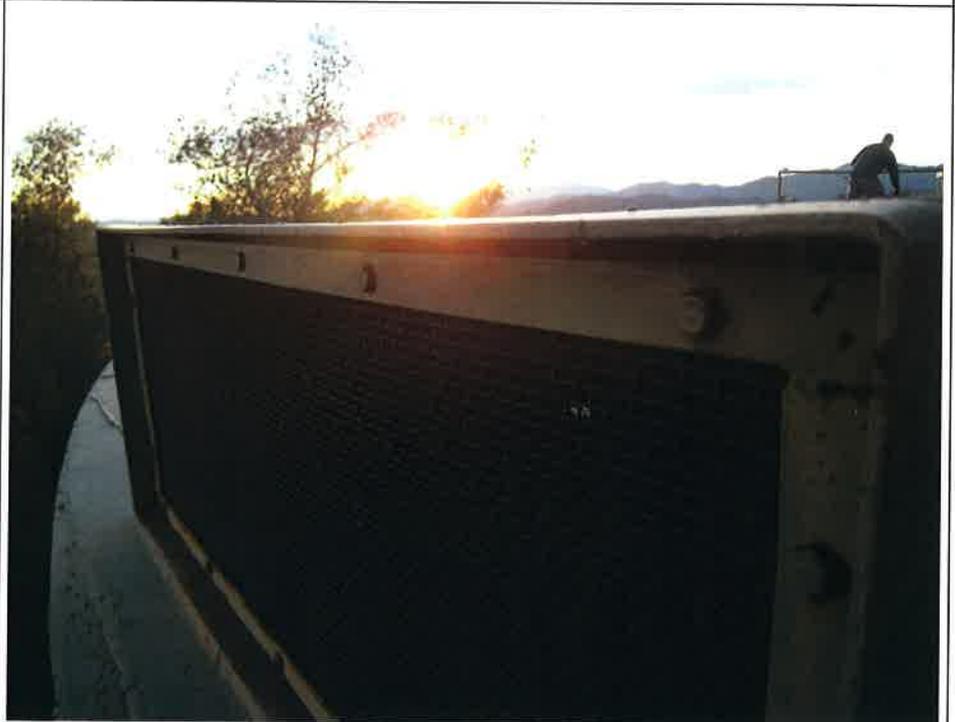
Image #20

Vent Screen 8:00

Condition:
Rust Grade' 9.

Description:
Fine Mesh Vent Screen
appeared to be in good
condition with a minor
amount of corrosion.
