CITY OF SHASTA LAKE

2016-2026 WATER MASTER PLAN

FINAL • OCTOBER 2016

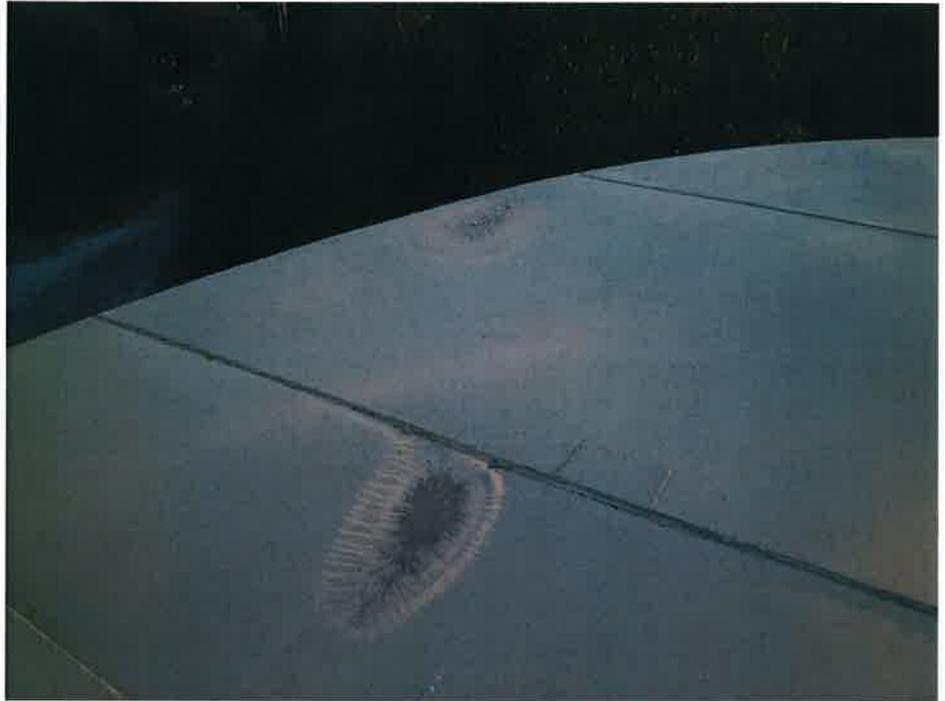
Image #21

Condition:
Rust Grade 9.

Description:
Roof appeared to be in good condition with a minor amount of corrosion.

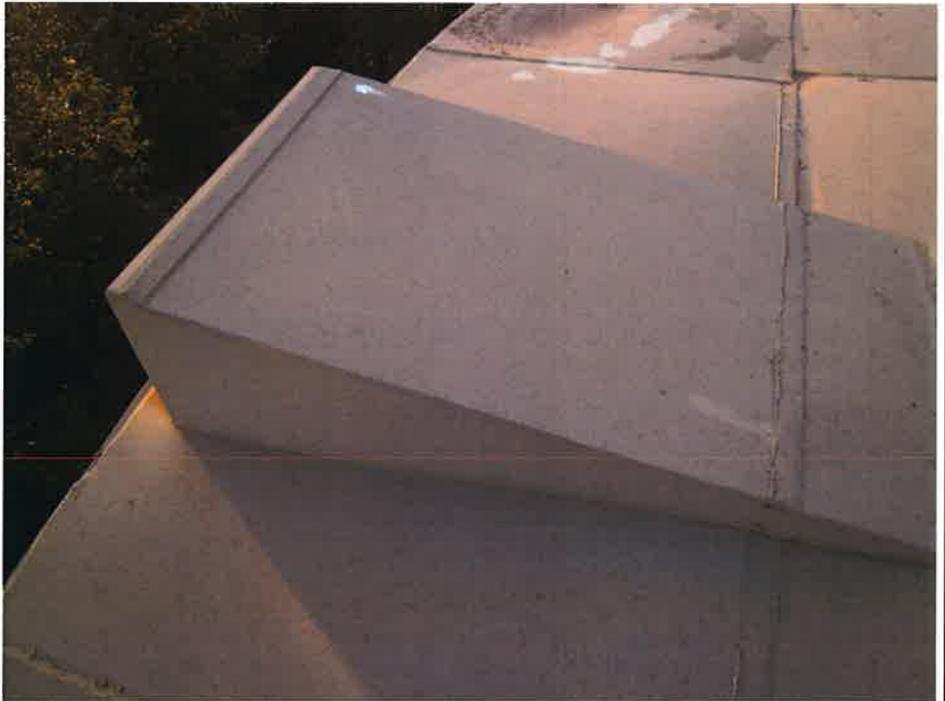
Image #22

Side Vent 10:00

Condition:
Rust Grade 9.

Description:
24"x6" Side Vent appeared to be in good condition with a minor amount of corrosion.

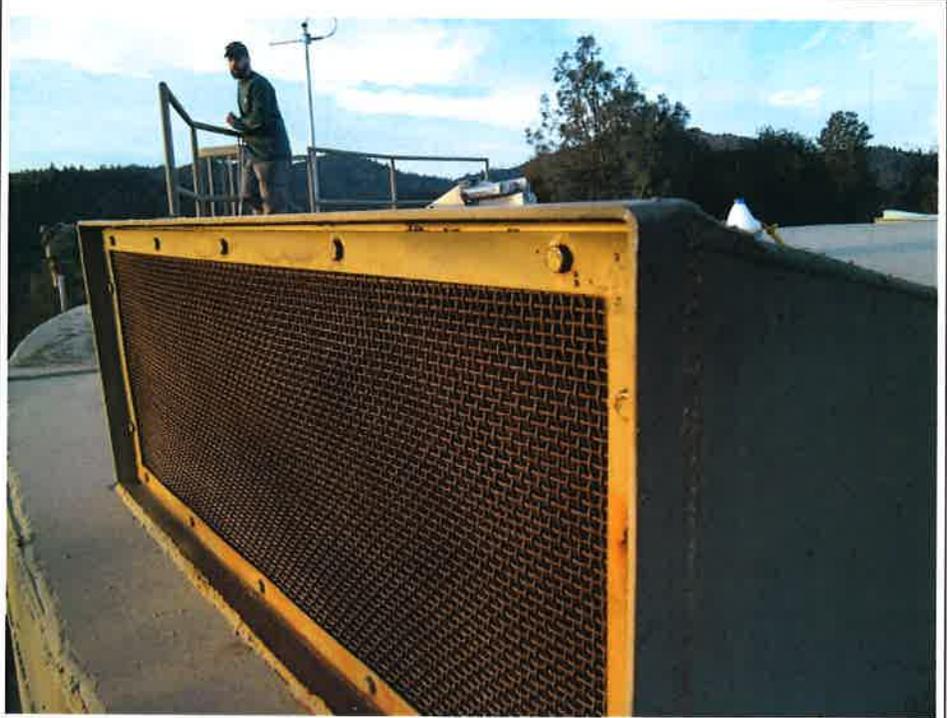
Image #23

Condition:
Rust Grade' 8.

Description:
Fine Mesh Vent Screen appeared to be in good condition with a minor amount of corrosion.

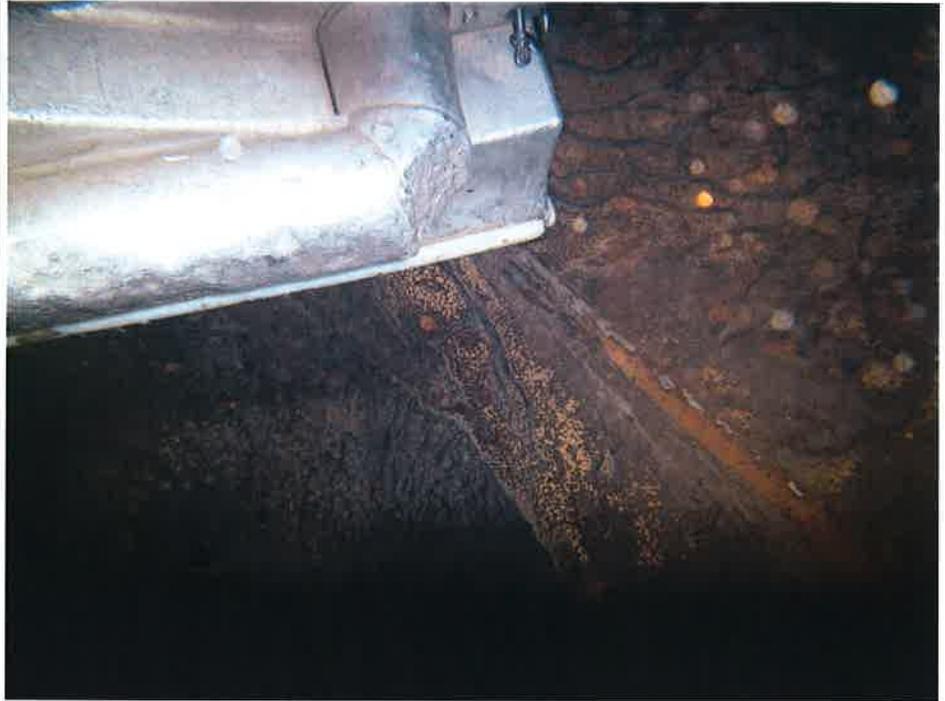
Image #25

Sediment

Description:
Light skiff of sediment
was removed from
reservoir floor.

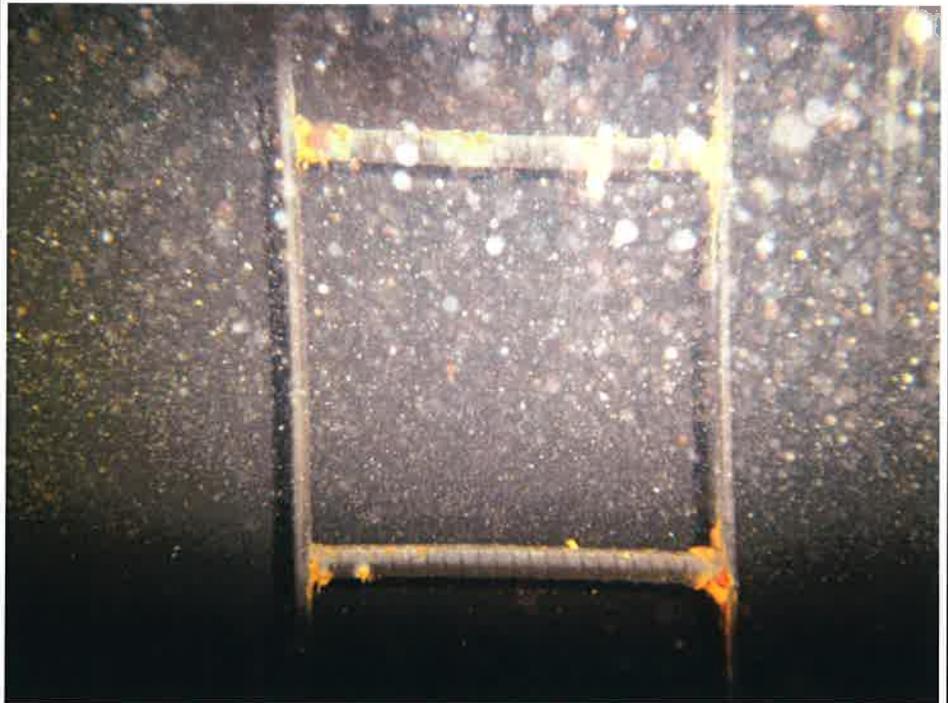
Image #26

Interior Ladder 12:00

Condition:
Rust Grade' 6.

Description:
Interior Ladder
appeared to be in fair
condition with a
moderate amount of
corrosion.

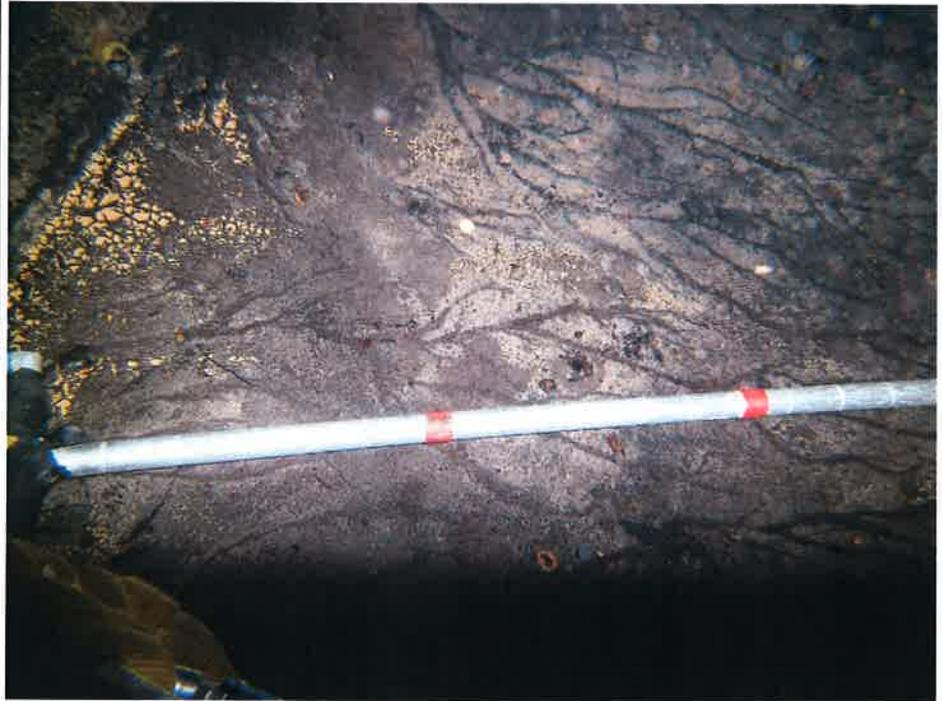
A heavy amount of rust scale and debris was removed from reservoir floor.

Condition:
Rust Grade¹ UE.

Description:
Unable to evaluate the condition of the Floor due to cold tar coating.

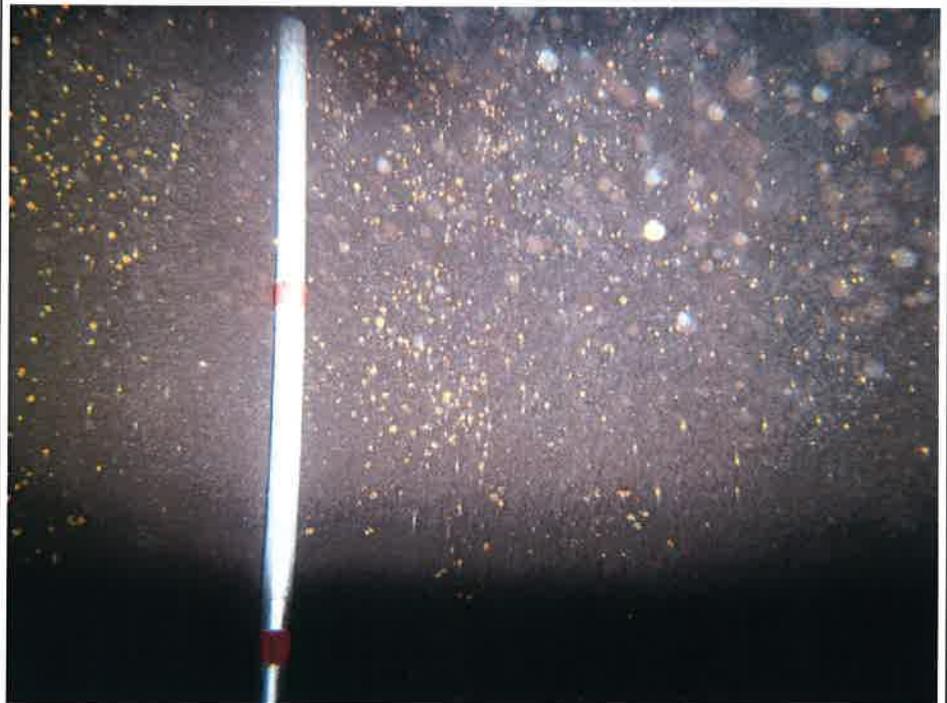
Image #28

Wall 12:00

Condition:
Rust Grade¹ UE.

Description:
Unable to evaluate the condition of the Wall due to cold tar coating.

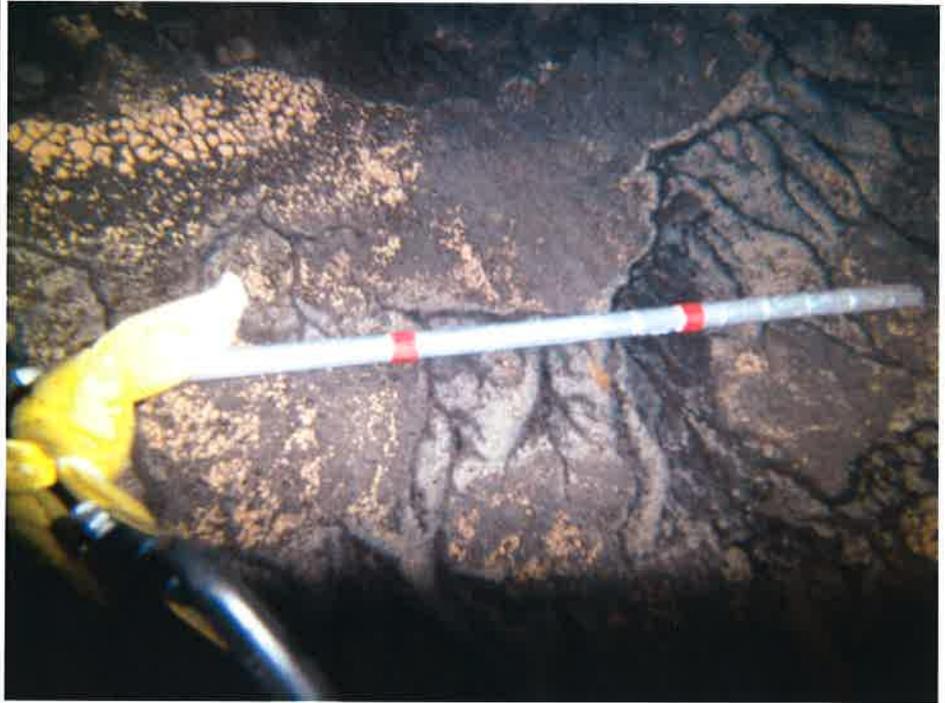
Image #29

Condition:
Rust Grade¹ UE.

Description:
Unable to evaluate the condition of the Floor due to cold tar coating.

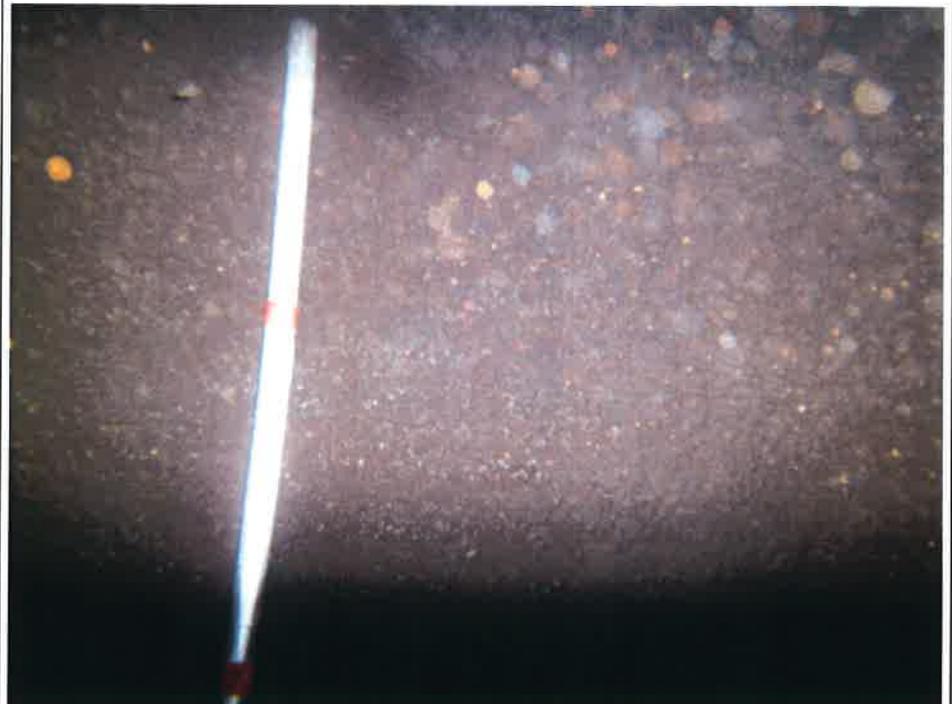
Image #30

Wall 3:00

Condition:
Rust Grade¹ UE.

Description:
Unable to evaluate the condition of the Wall due to cold tar coating.

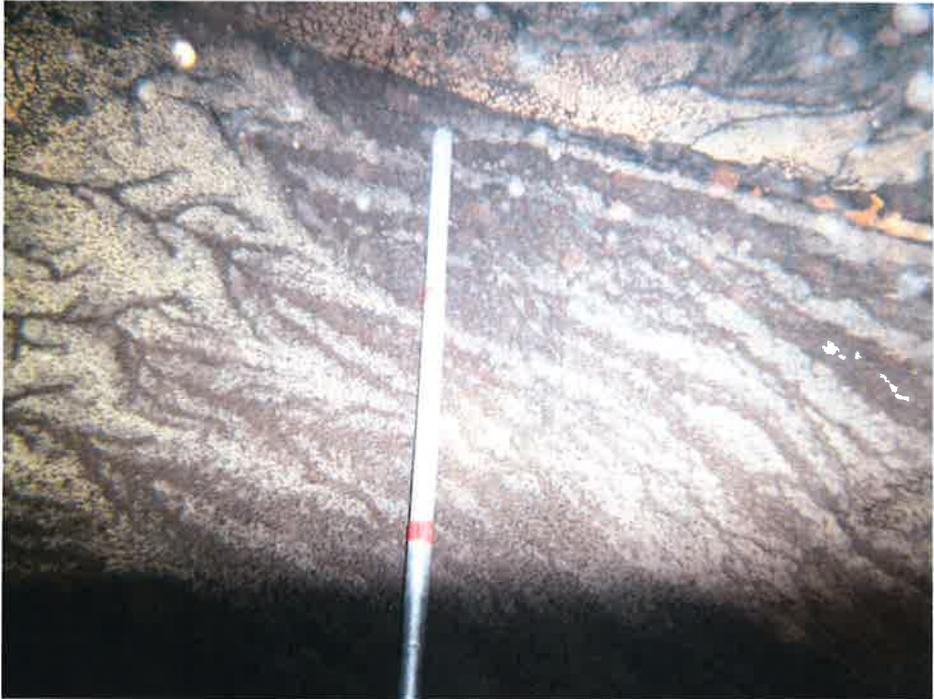
Image #31

Condition:
Rust Grade' UE.

Description:
Unable to evaluate the condition of the Floor due to cold tar coating.

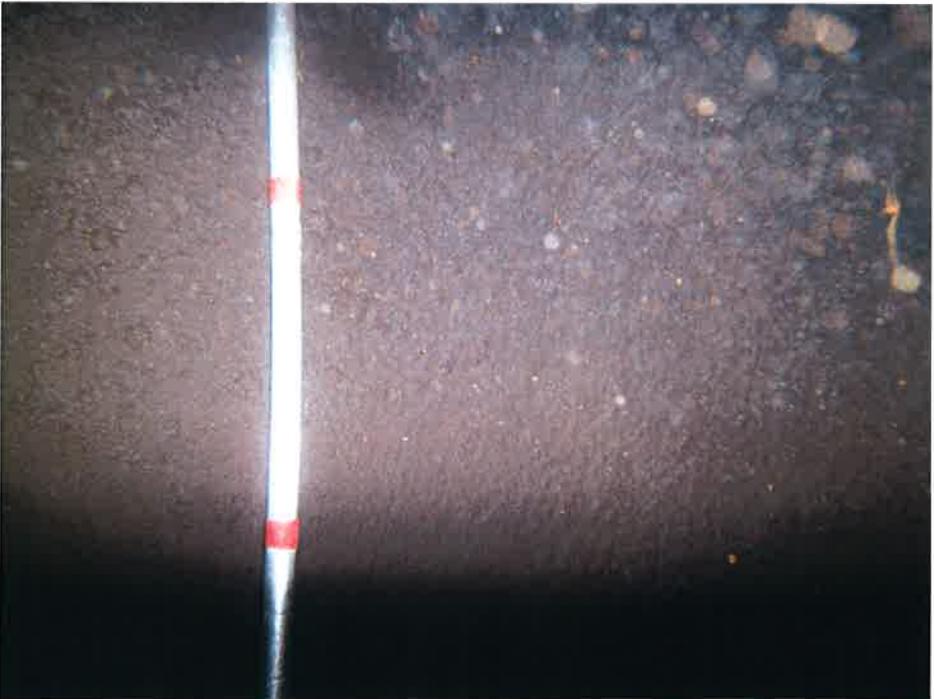
Image #32

Wall 6:00

Condition:
Rust Grade' UE.

Description:
Unable to evaluate the condition of the Wall due to cold tar coating.

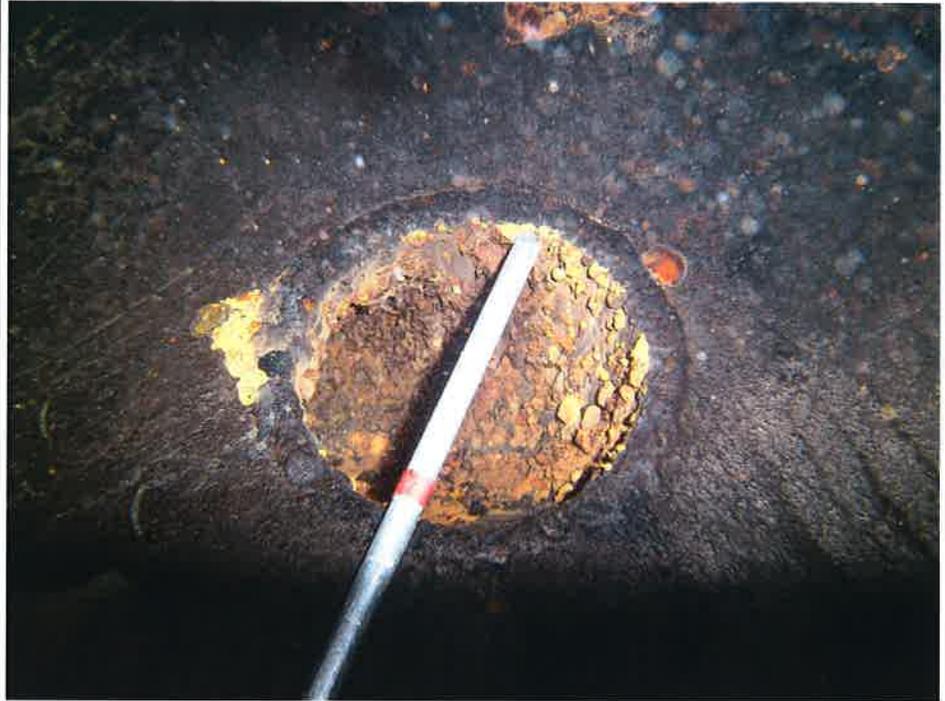
Image #33

Condition:
Rust Grade' Z.

Description:
6" Drain appeared to be in fair condition with a minor amount of corrosion.

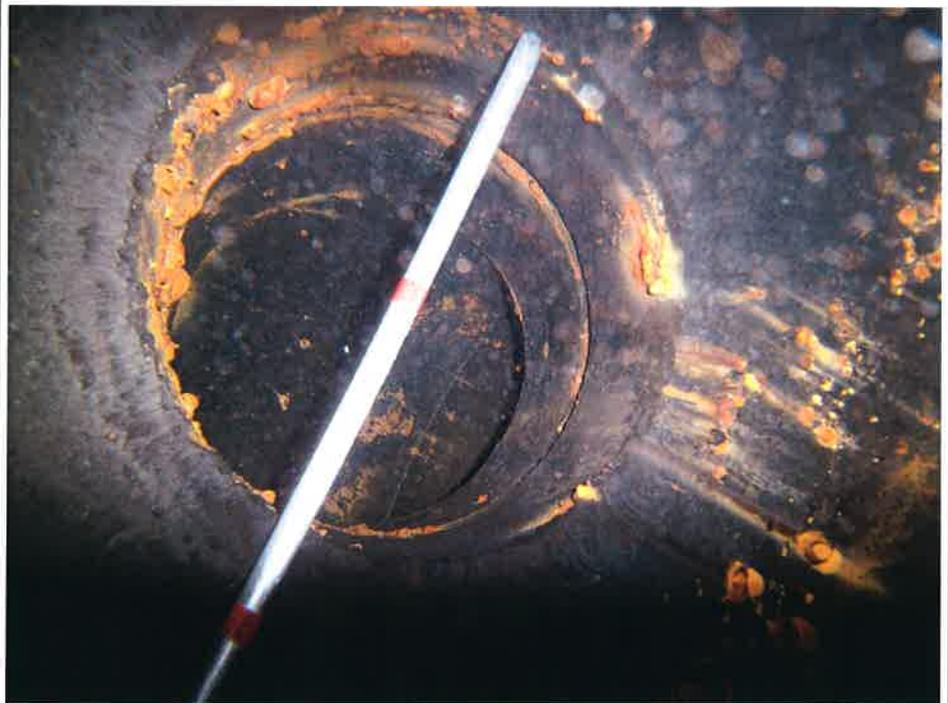
Image #34

Inlet / Outlet 8:10

Condition:
Rust Grade' Z.

Description:
10" Inlet / Outlet appeared to be in fair condition with a minor amount of corrosion.

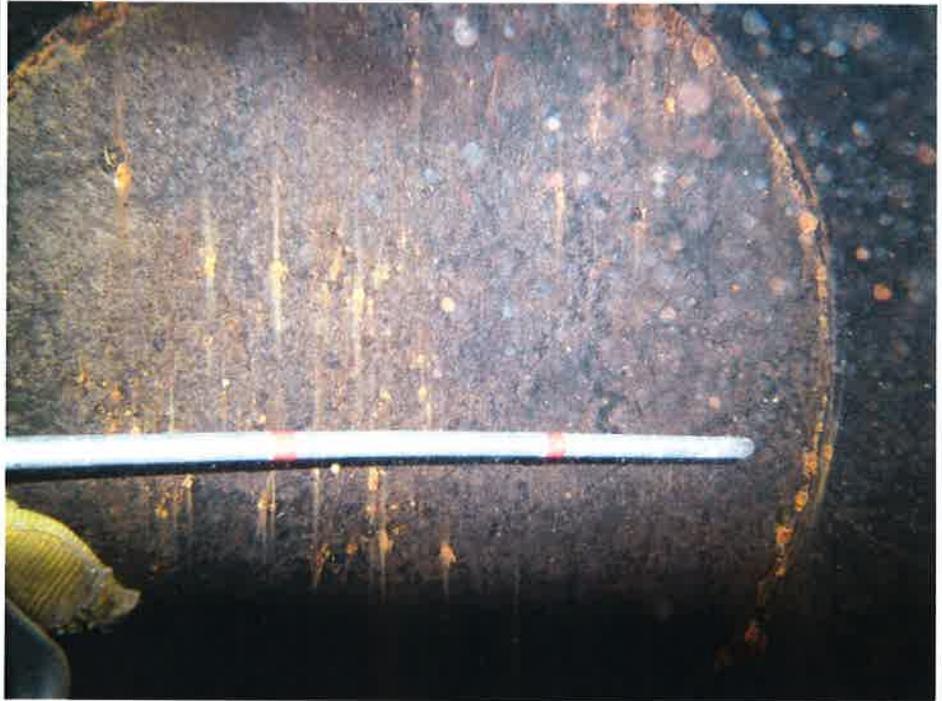
Image #35

Condition:
Rust Grade' Z.

Description:
30" Man Way appeared to be in fair condition with a minor amount of corrosion.

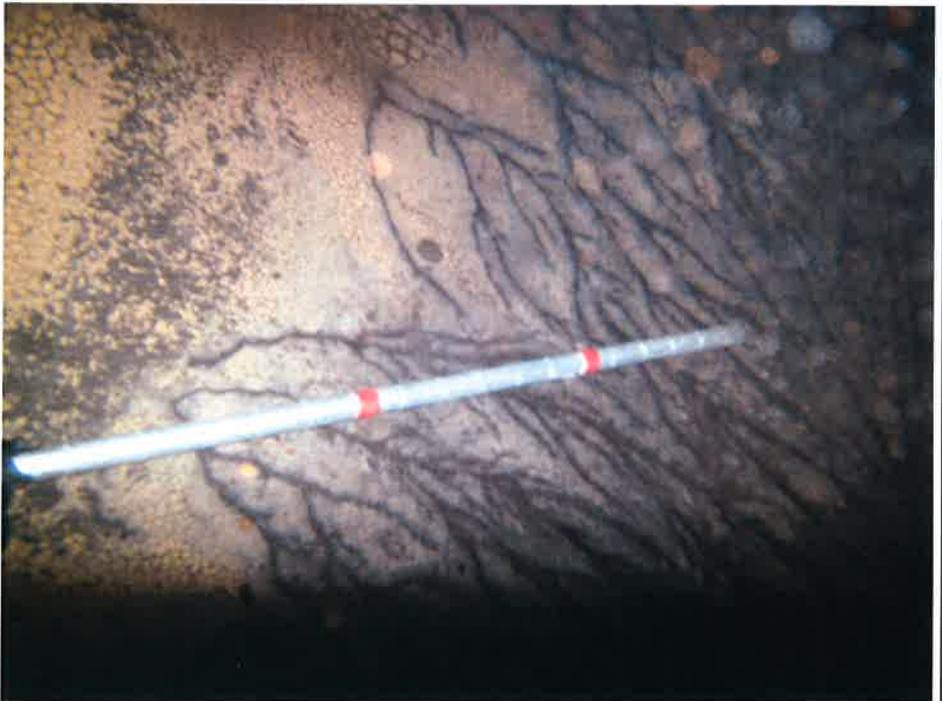
Image #36

Floor 9:00

Condition:
Rust Grade' UE.

Description:
Unable to evaluate the condition of the Floor due to cold tar coating.

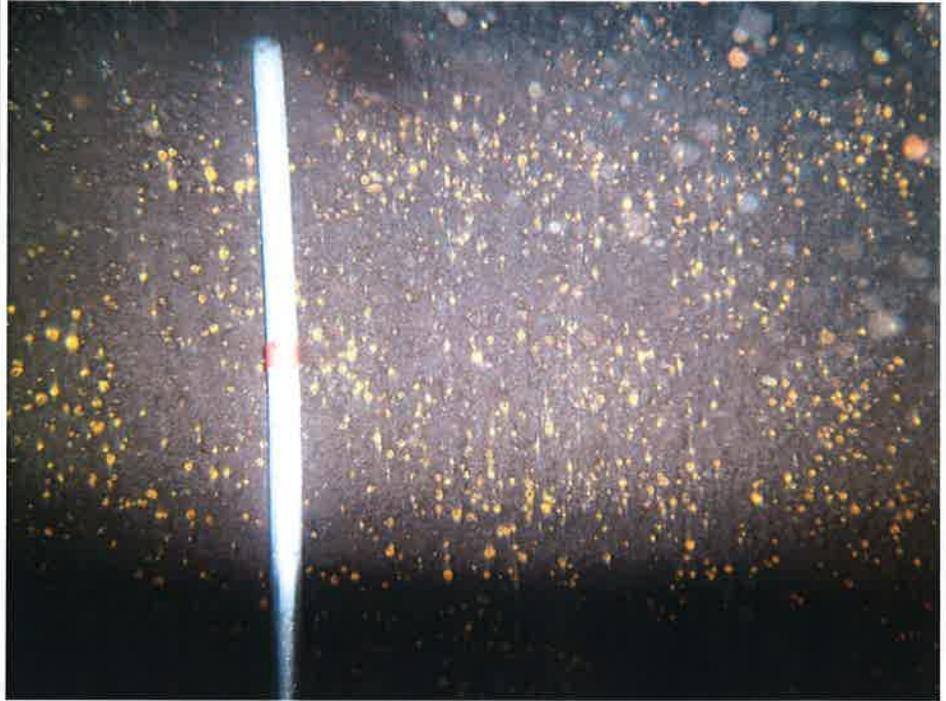
Image #37

Condition:
Rust Grade¹ UE.

Description:
Unable to evaluate the condition of the Wall due to cold tar coating.

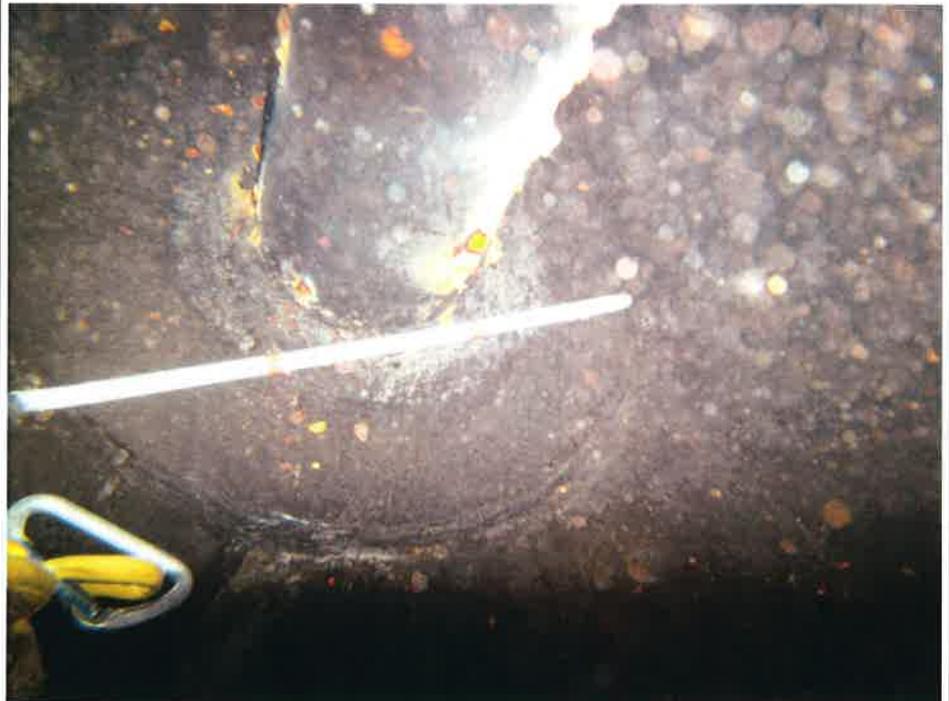
Image #38

Column Center

Condition:
Rust Grade¹ Z.

Description:
8" Column appeared to be in good condition with a minor amount of corrosion.

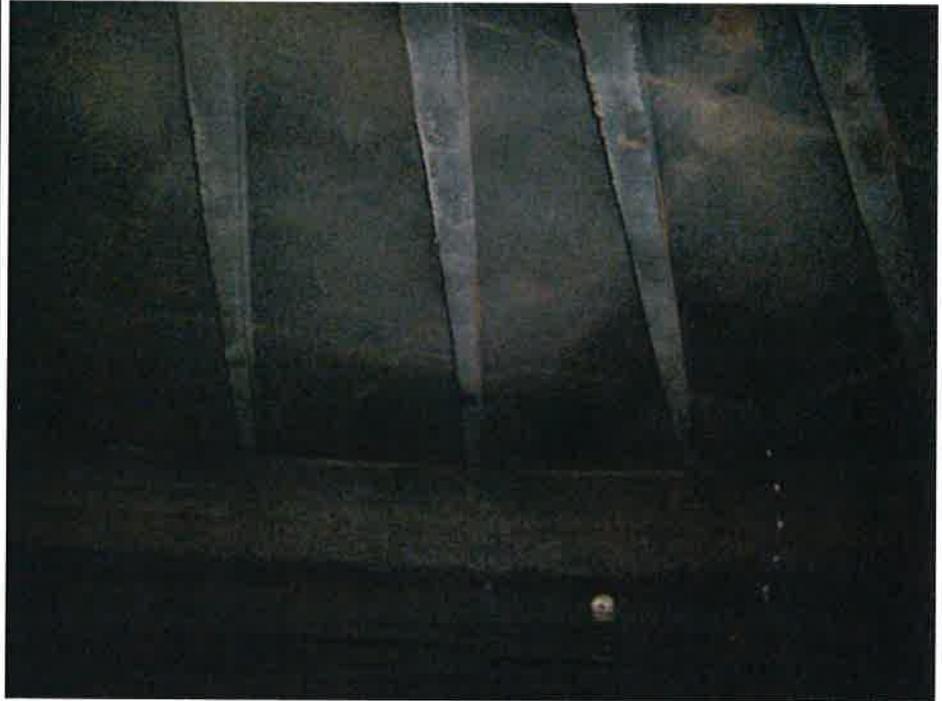
Image #39

Condition:
Rust Grade' 7.

Description:
Ceiling appeared to be in fair condition with a minor amount of corrosion.

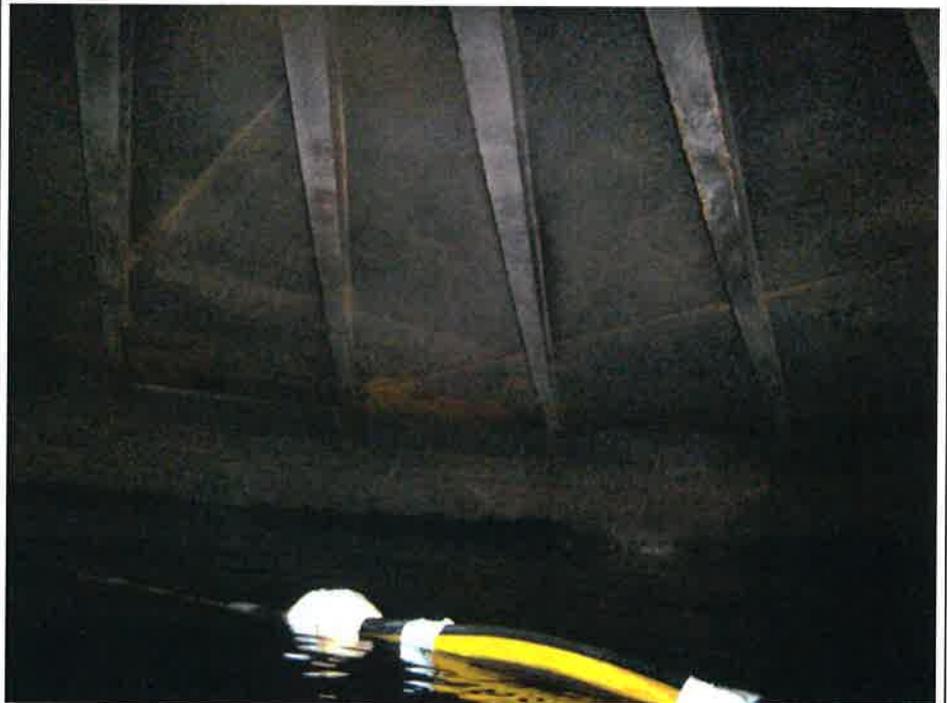
Image #40

Ceiling 3:00

Condition:
Rust Grade' 7.

Description:
Ceiling appeared to be in fair condition with a minor amount of corrosion.

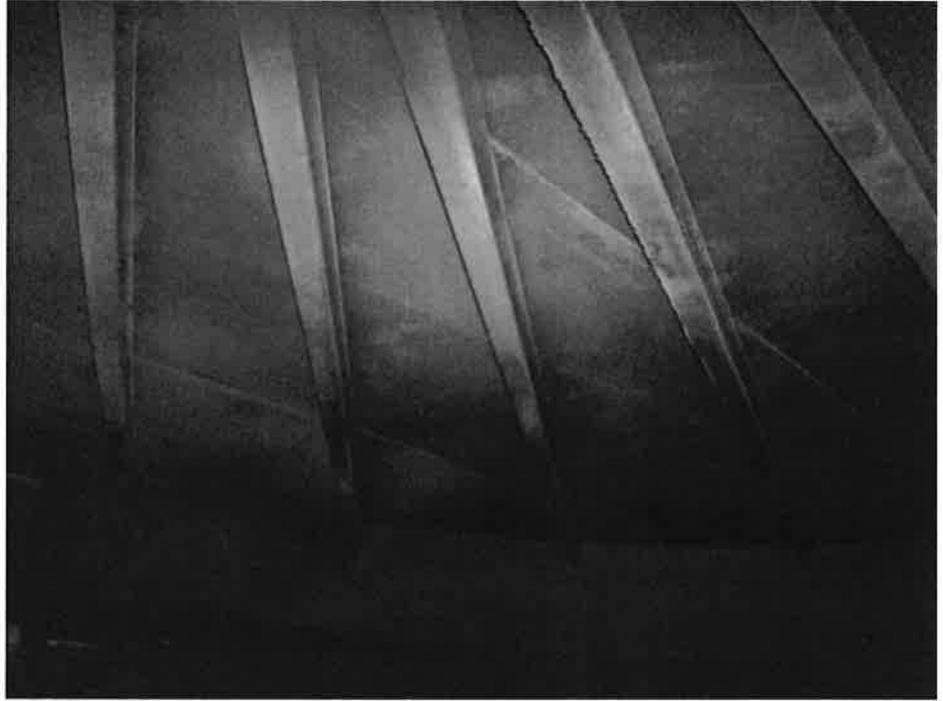
Image #41

Condition:
Rust Grade' Z.

Description:
Ceiling appeared to be in fair condition with a minor amount of corrosion.

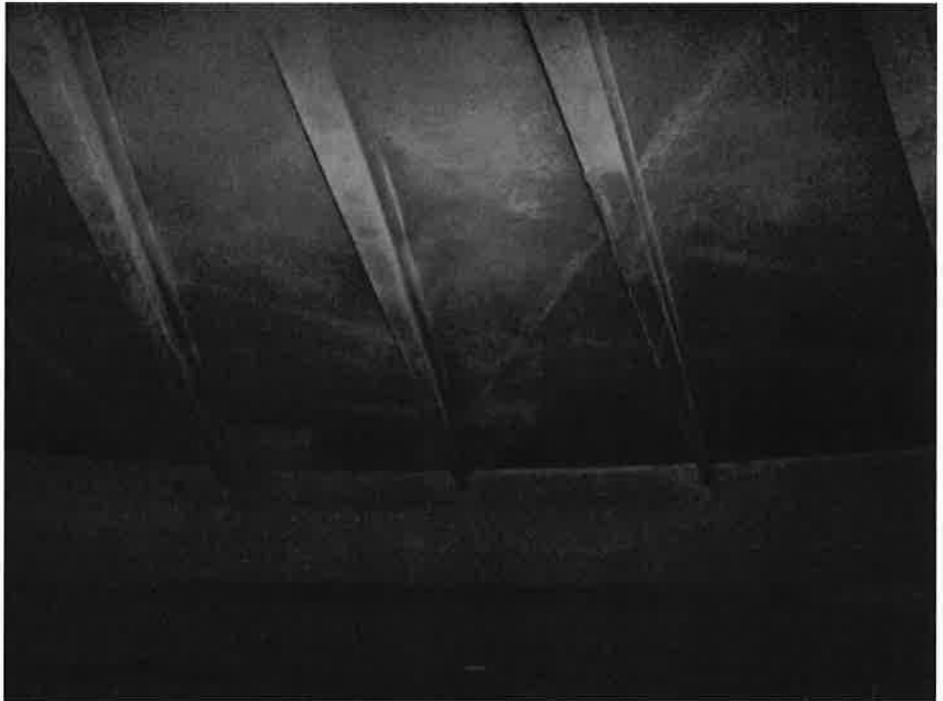
Image #42

Ceiling 9:00

Condition:
Rust Grade' Z.

Description:
Ceiling appeared to be in fair condition with a minor amount of corrosion.

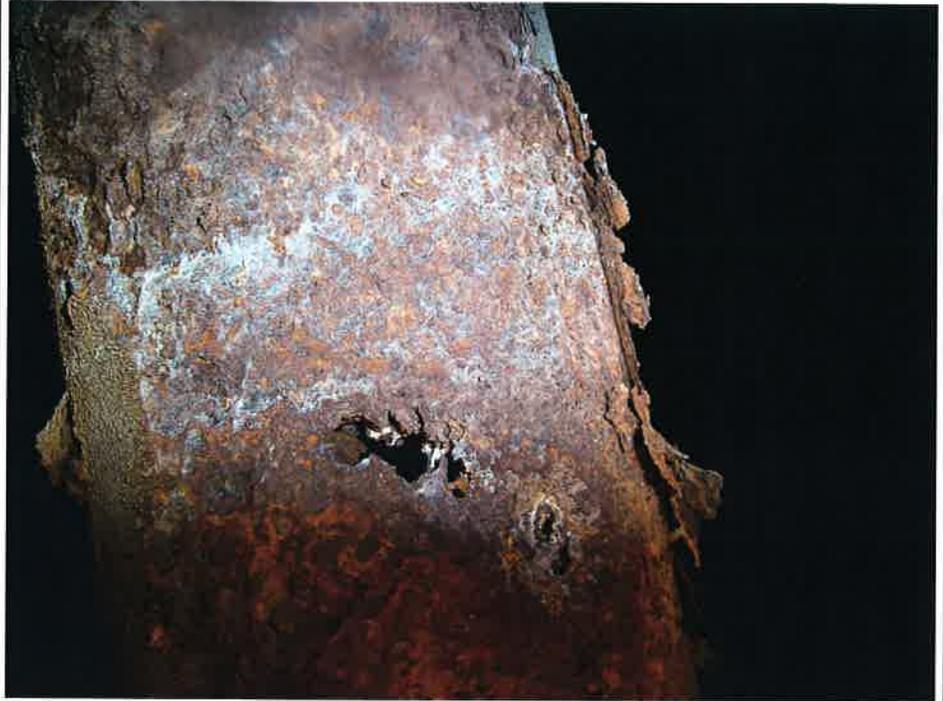
Image #43

Condition:
Rust Grade' 0.

Description:
8" Column appeared to be in poor condition with a heavy amount of corrosion towards the top above the water line.

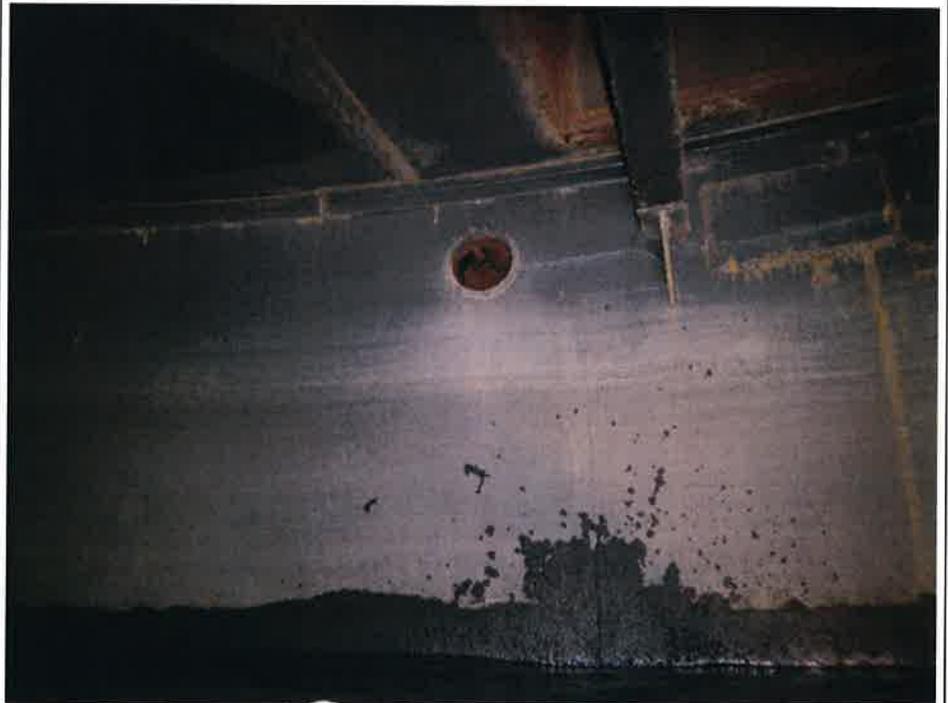
Image #44

Overflow 8:30

Condition:
Rust Grade' 2.

Description:
8" Overflow appeared to be in fair condition with a minor amount of corrosion.

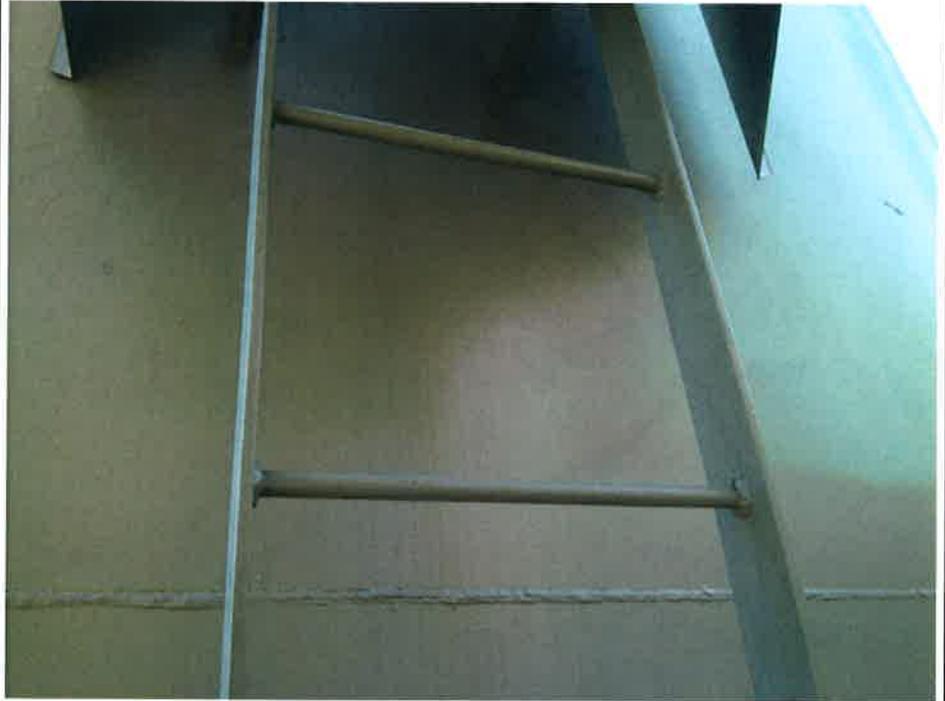
Condition:
Rust Grade' 10.

Description:
Exterior Ladder
appeared to be in good
condition with no signs
of corrosion.

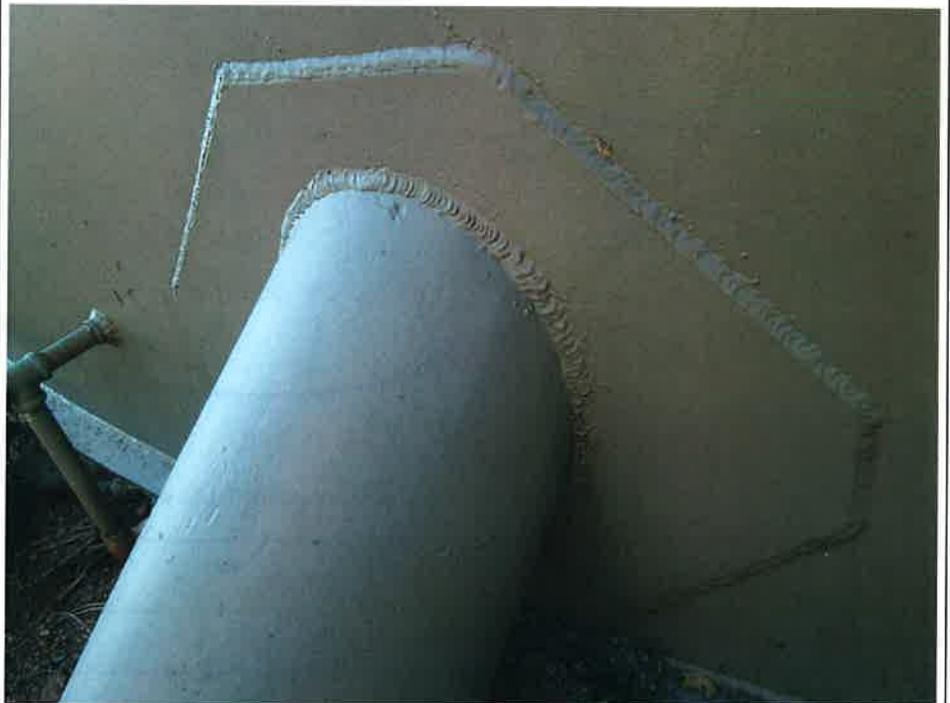
Image #2

Inlet / Outlet 12:05

Condition:
Rust Grade' 10.

Description:
10" Inlet / Outlet
appeared to be in good
condition with no signs
of corrosion.

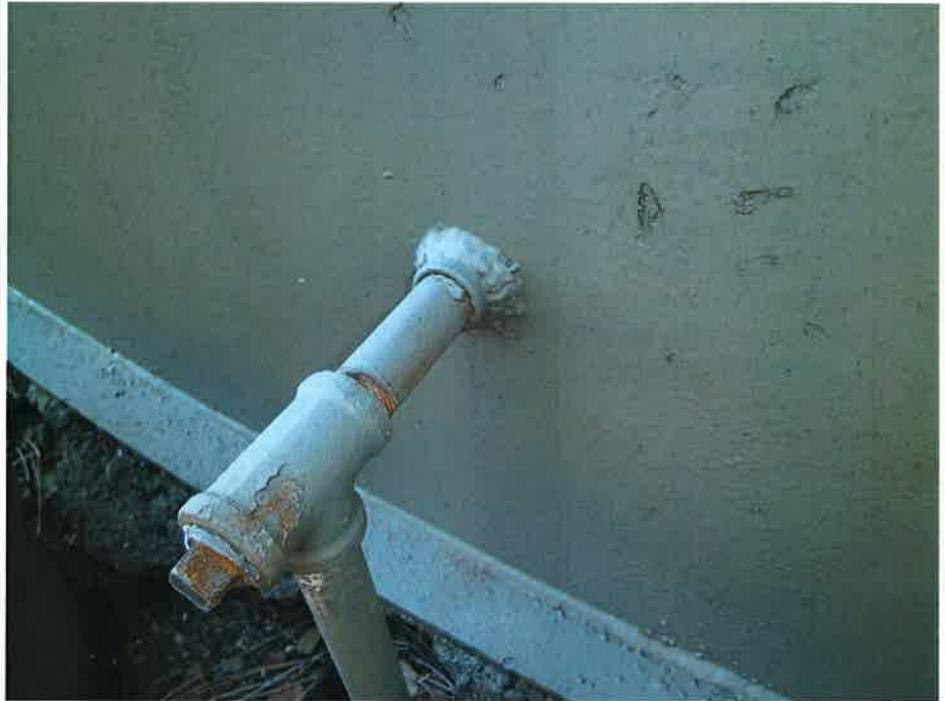
Image #3

Condition:
Rust Grade! 9.

Description:
1" Water Tap appeared to be in good condition with a minor amount of corrosion.

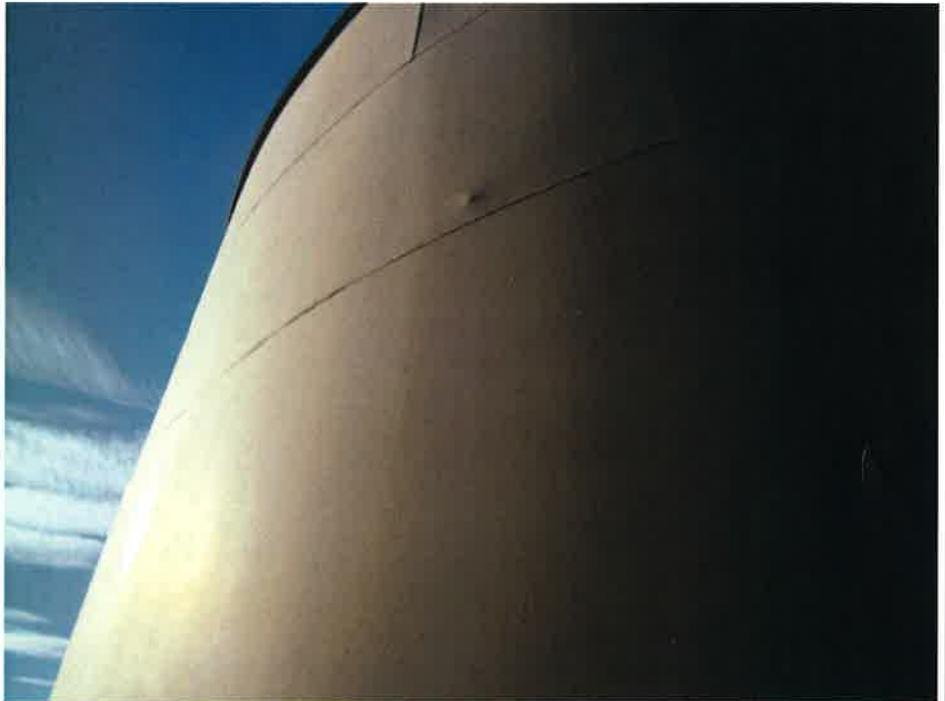
Image #4

Exterior Wall 3:00

Condition:
Rust Grade! 9.

Description:
Exterior Wall appeared to be in good condition with a minor amount of corrosion.

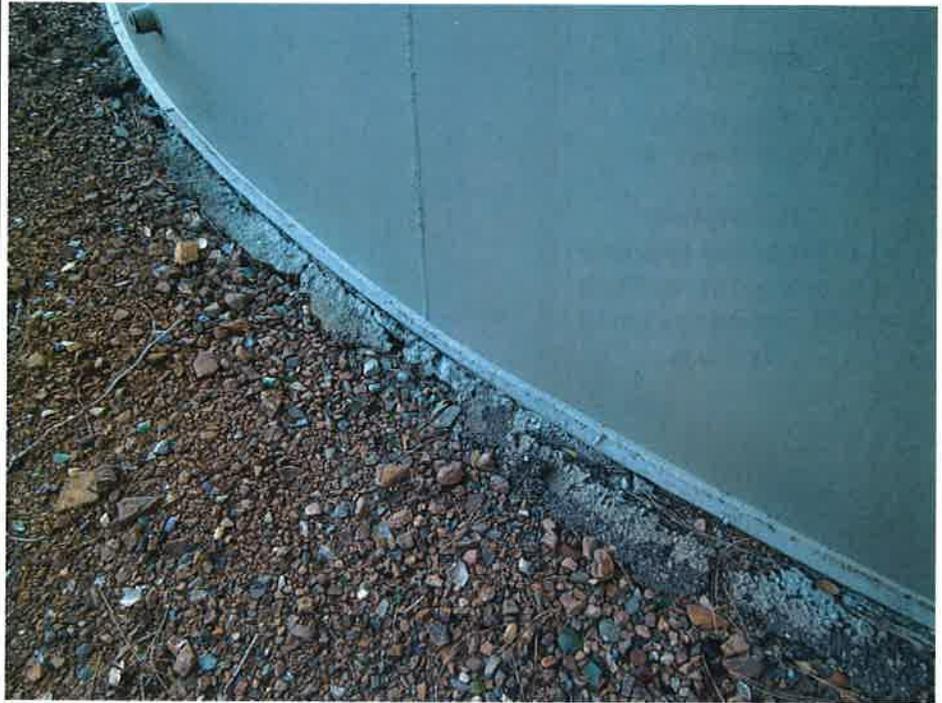
Image #5

Condition:
Concrete Deform³ **CK.**

Description:
Exterior Base
appeared to be in poor
condition with a heavy
amount of cracking.

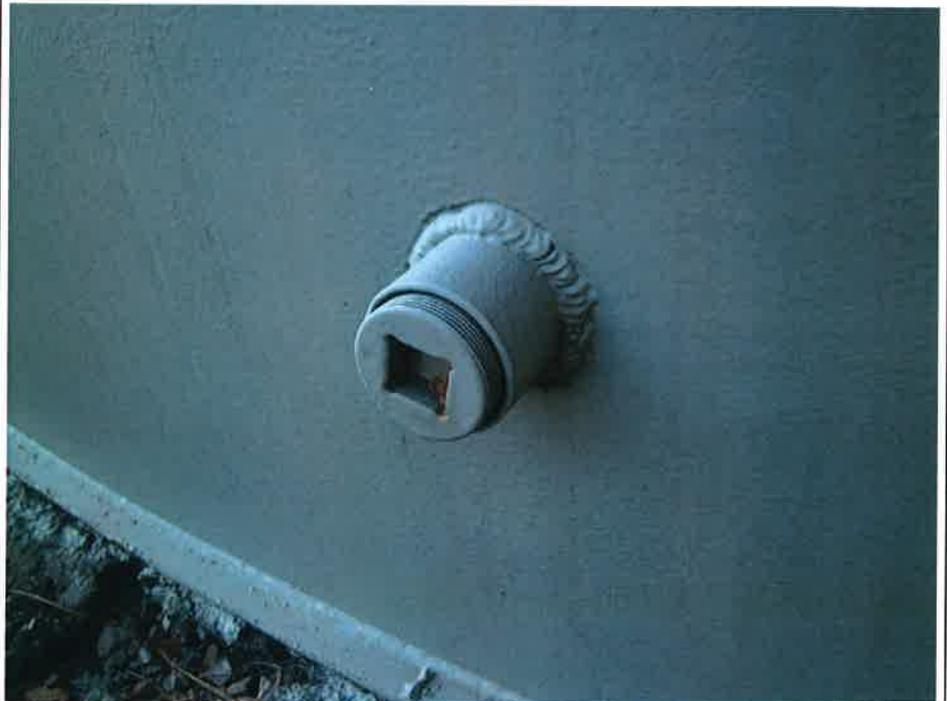
Image #6

*Capped Off Penetration
3:30*

Condition:
Rust Grade¹ **2.**

Description:
2" Capped Off
Penetration appeared to
be in good condition
with a minor amount of
corrosion.

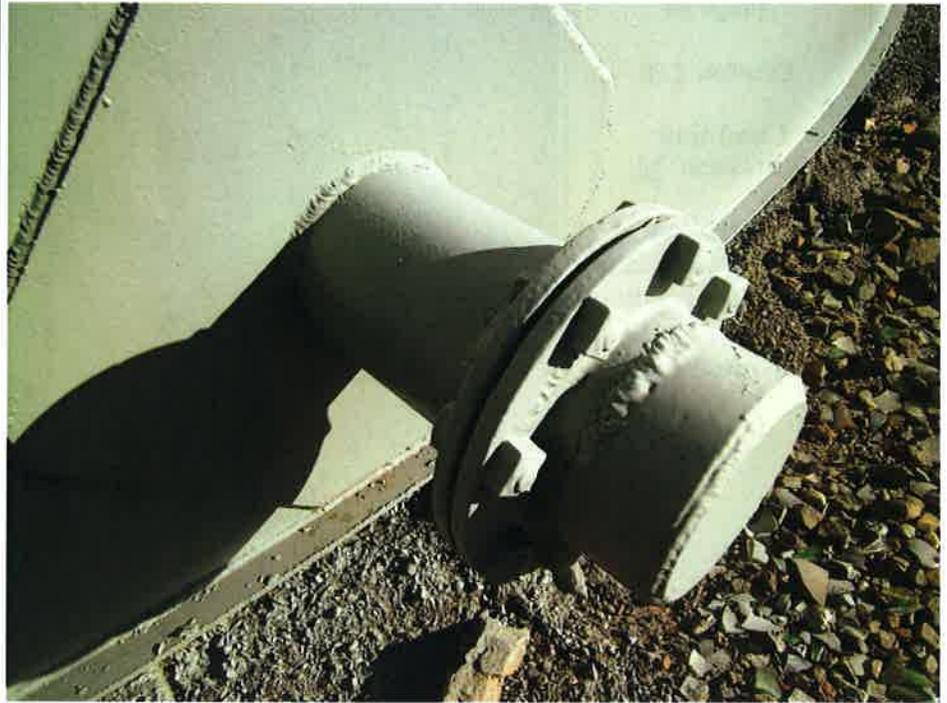
Image #7

Condition:
Rust Grade' 10.

Description:
6" Capped Off
Penetration appeared to
be in good condition
with no signs of
corrosion.

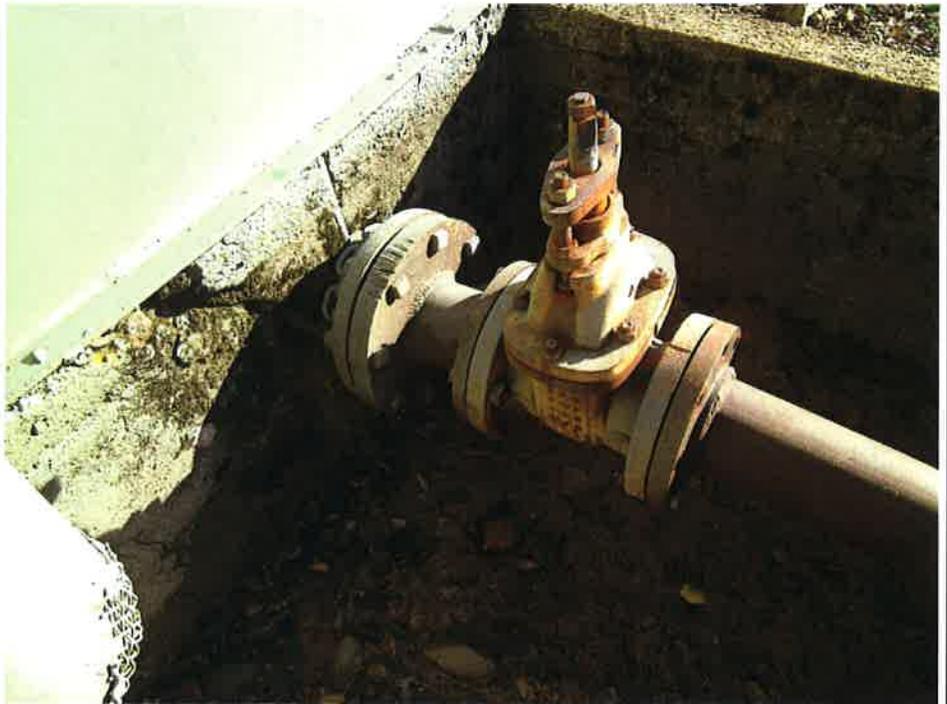
Image #8

Drain 6:30

Condition:
Rust Grade' 7.

Description:
4" Drain appeared to
be in good condition
with a minor amount of
corrosion.

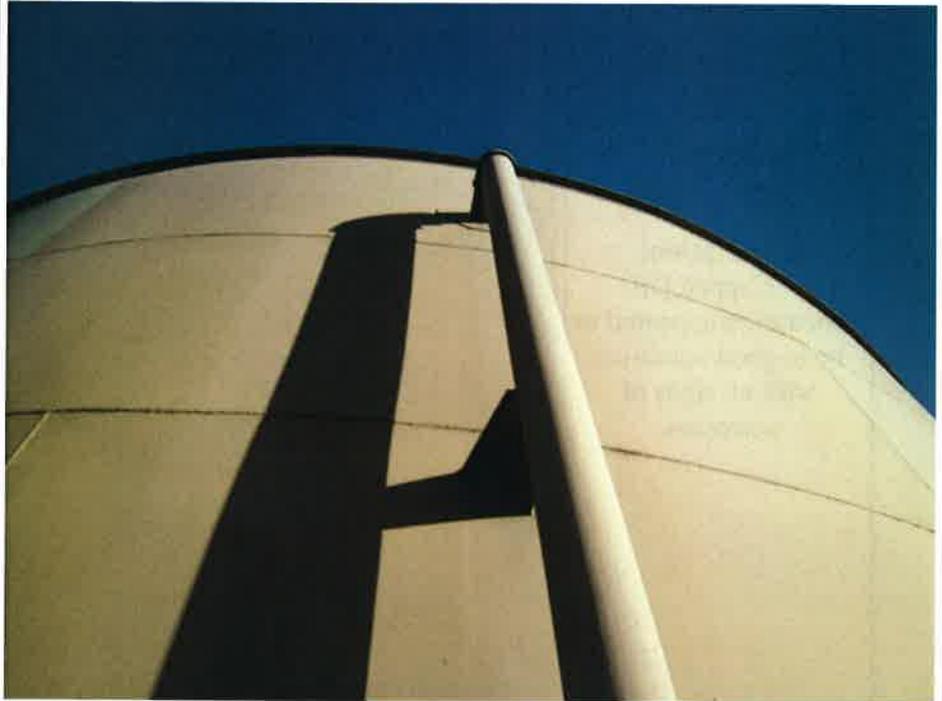
Image #9

Condition:
Rust Grade! 10.

Description:
8" Overflow appeared to be in good condition with no signs of corrosion.

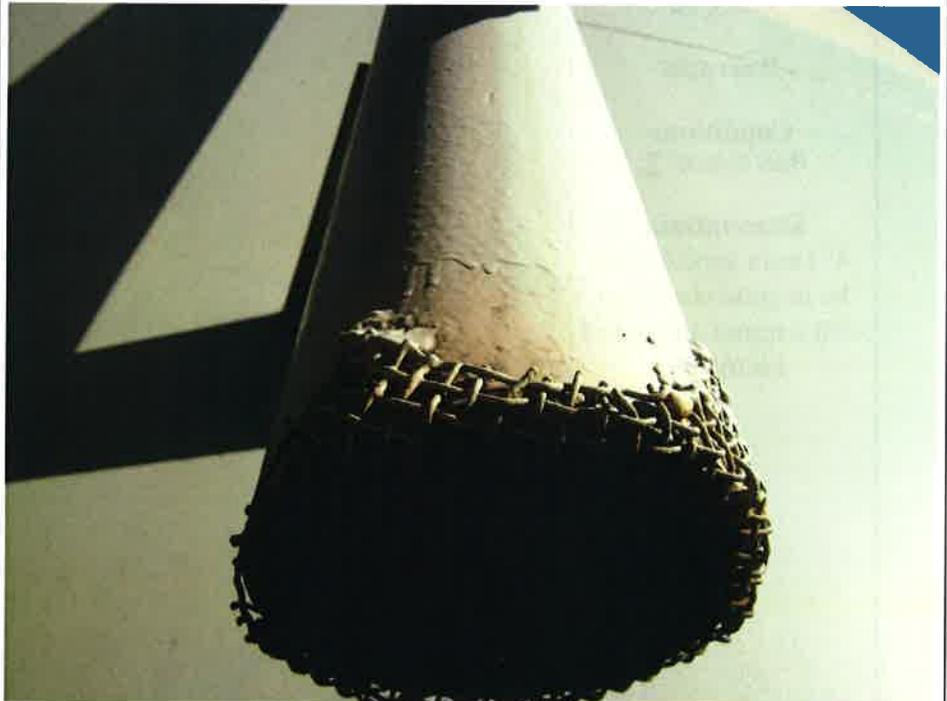
Image #10

Overflow Screen 7:30

Condition:
Rust Grade! 7.

Description:
Medium Mesh Overflow Screen appeared to be in good condition with a minor amount of corrosion.
