CITY OF SHASTA LAKE

2016-2026 WATER MASTER PLAN

FINAL • OCTOBER 2016

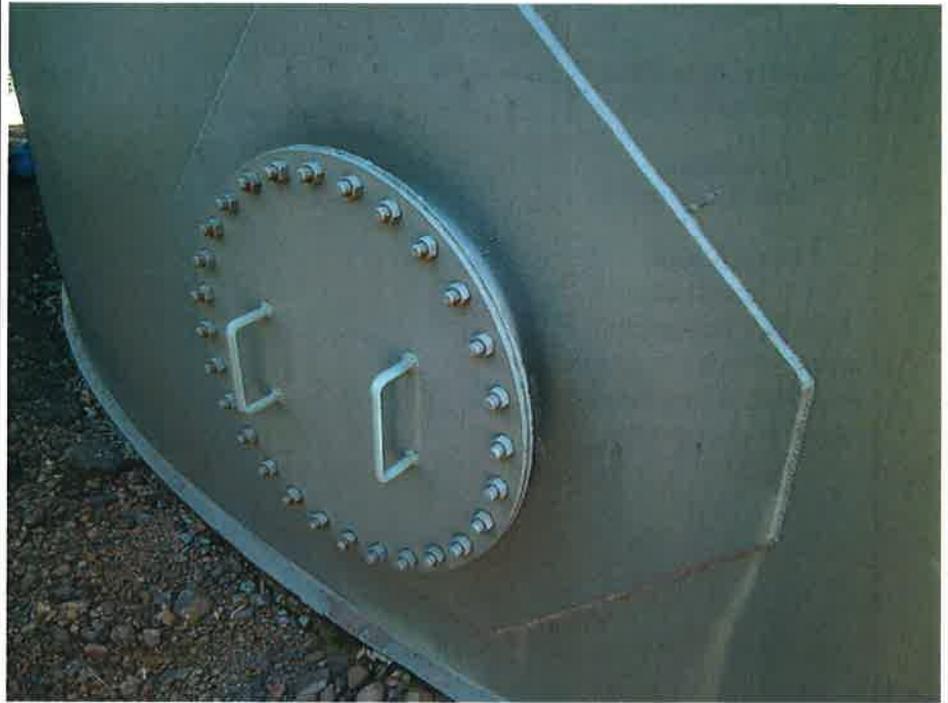
Image #11

Condition:
Rust Grade' 10.

Description:
24" Man Way appeared to be in good condition with no signs of corrosion.

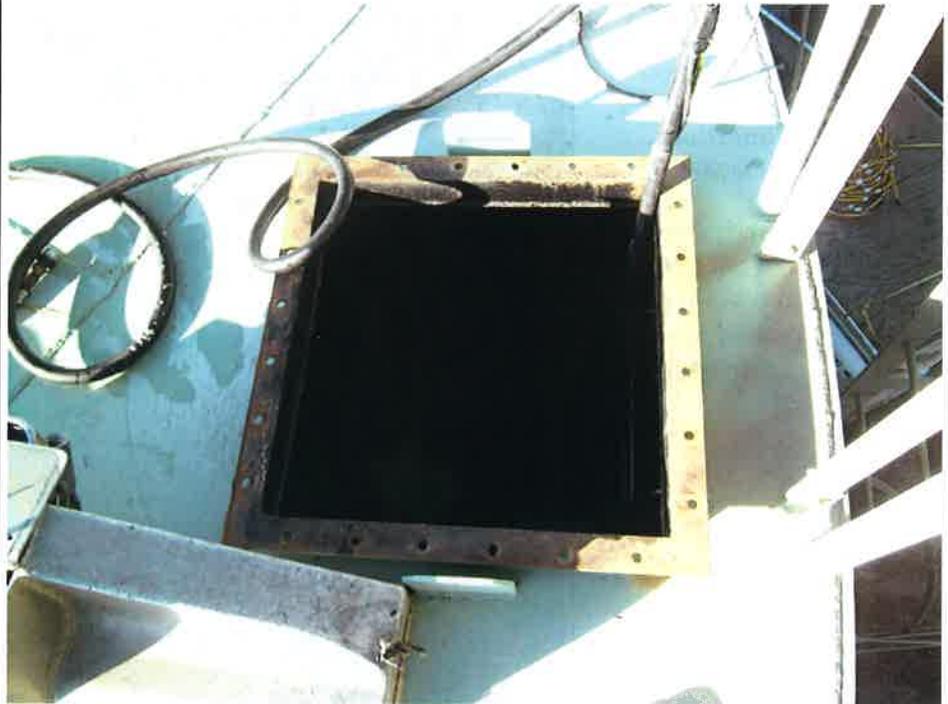
Image #12

Entry Hatch 12:00

Condition:
Rust Grade' 8.

Description:
24"x24" Entry Hatch appeared to be in good condition with a minor amount of corrosion.

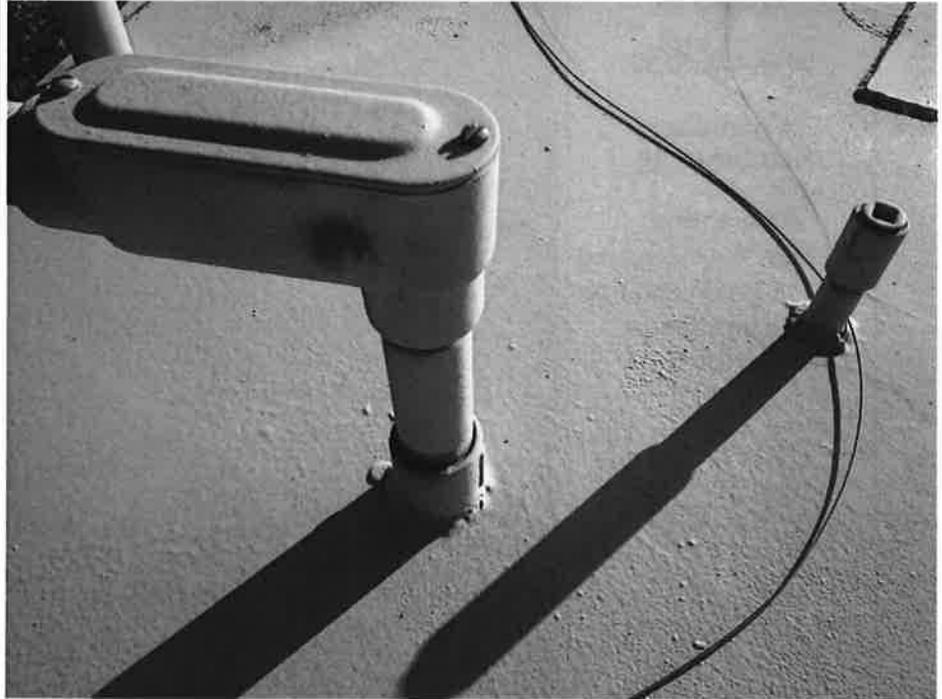
Image #13

Condition:
Rust Grade' 9.

Description:
1" Liquid Level Indicator Penetration appeared to be in good condition with a minor amount of corrosion.

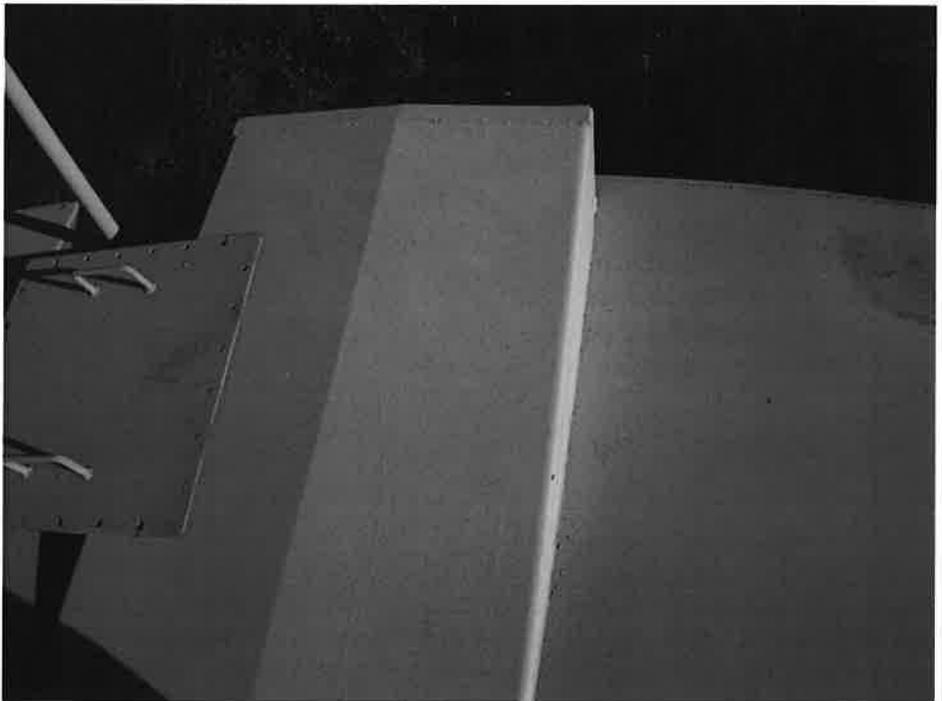
Image #14

Side Vent 2:00

Condition:
Rust Grade' 9.

Description:
24"x6" Vent appeared to be in good condition with a minor amount of corrosion.

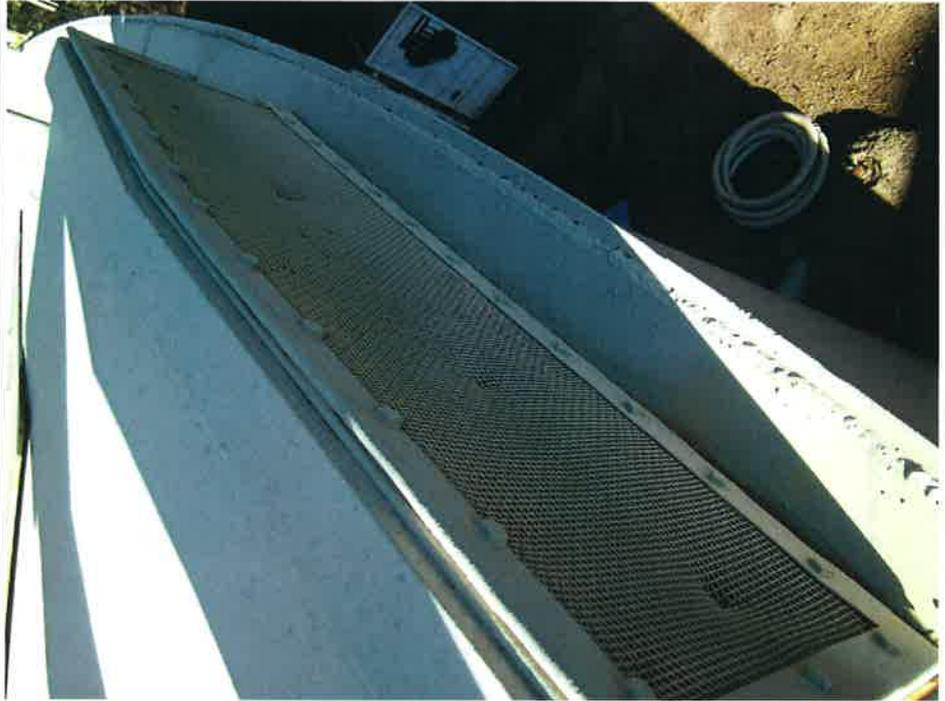
Image #15

Condition:
Rust Grade' 9.

Description:
Fine Mesh Vent Screen appeared to be in good condition with a minor amount of corrosion.

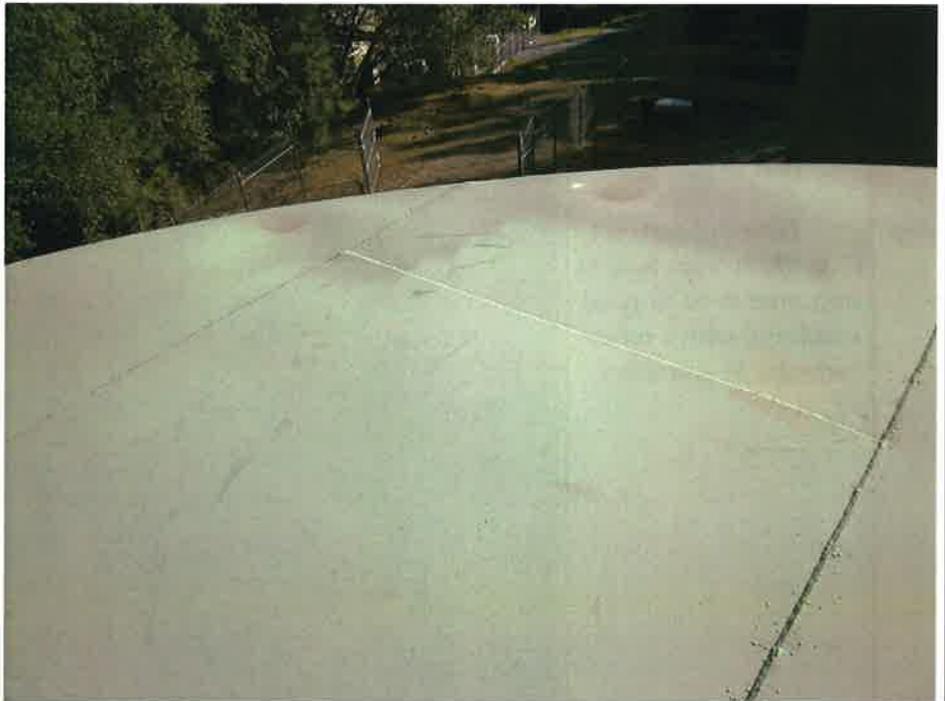
Image #16

Roof 3:00

Condition:
Rust Grade' 9.

Description:
Roof appeared to be in good condition with a minor amount of corrosion.

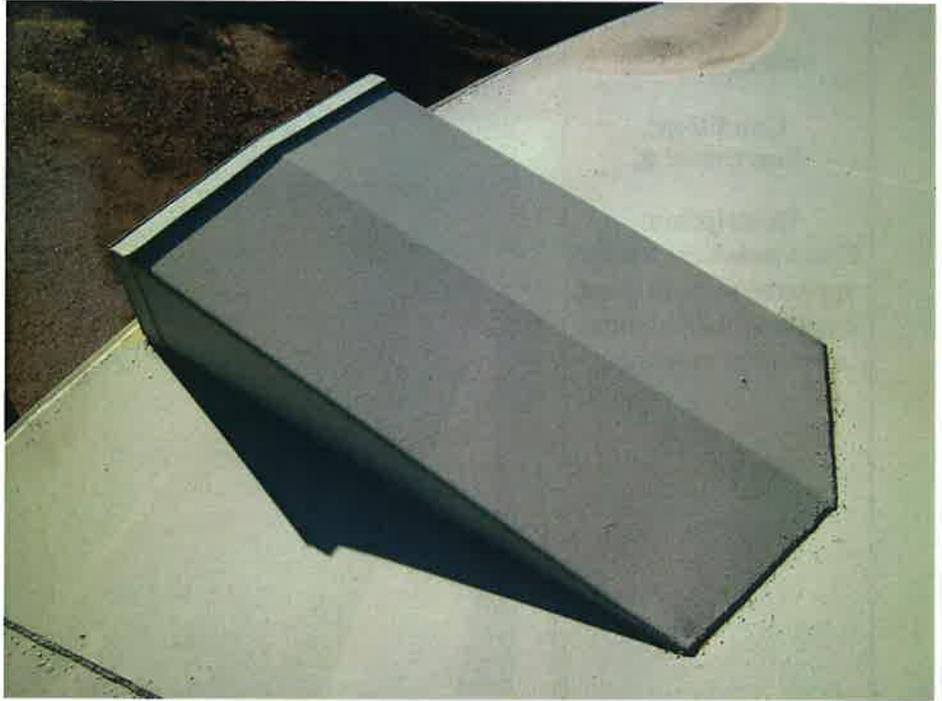
Image #17

Condition:
Rust Grade¹ 9.

Description:
24"x6" Side Vent
appeared to be in good
condition with a minor
amount of corrosion.

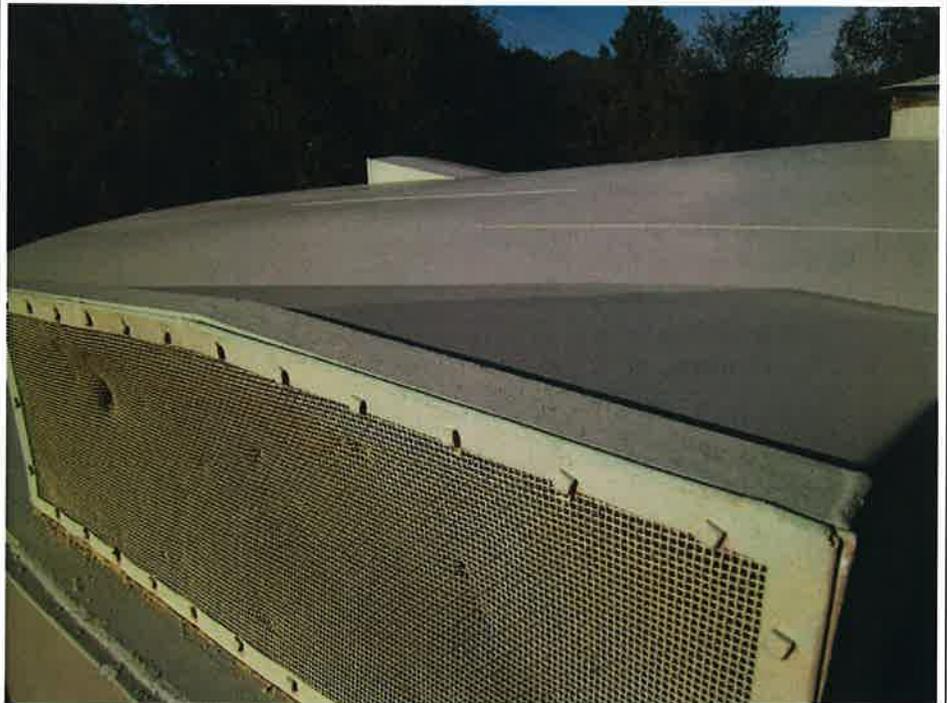
Image #18

Vent Screen 4:00

Condition:
Rust Grade¹ 9.

Description:
Fine Mesh Vent Screen
appeared to be in good
condition with a minor
amount of corrosion.

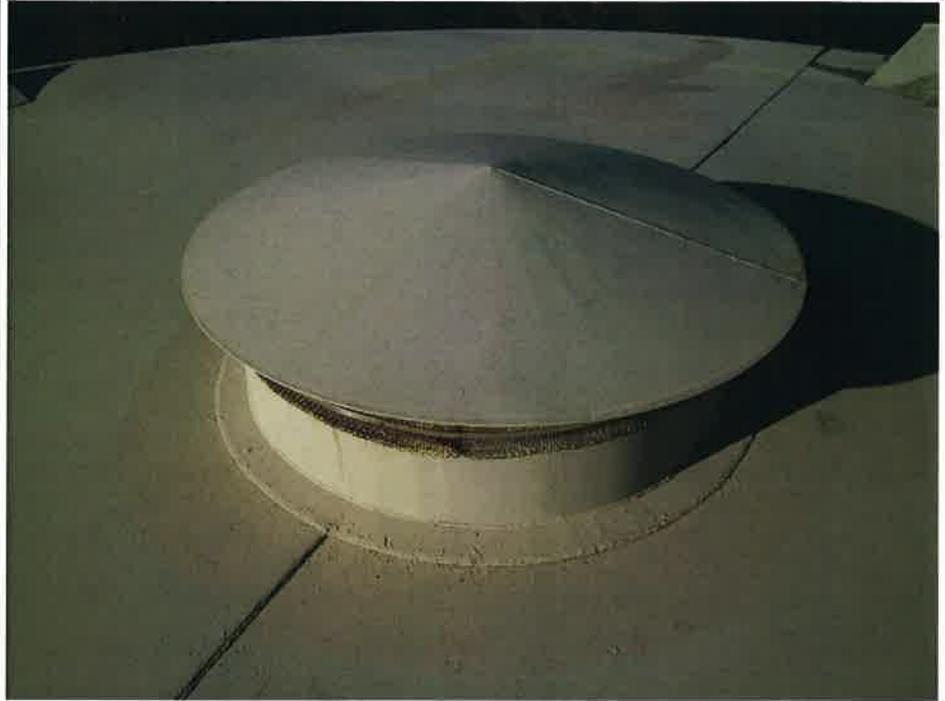
Image #19

Condition:
Rust Grade¹ 9.

Description:
36" Vent appeared to be in good condition with a minor amount of corrosion.

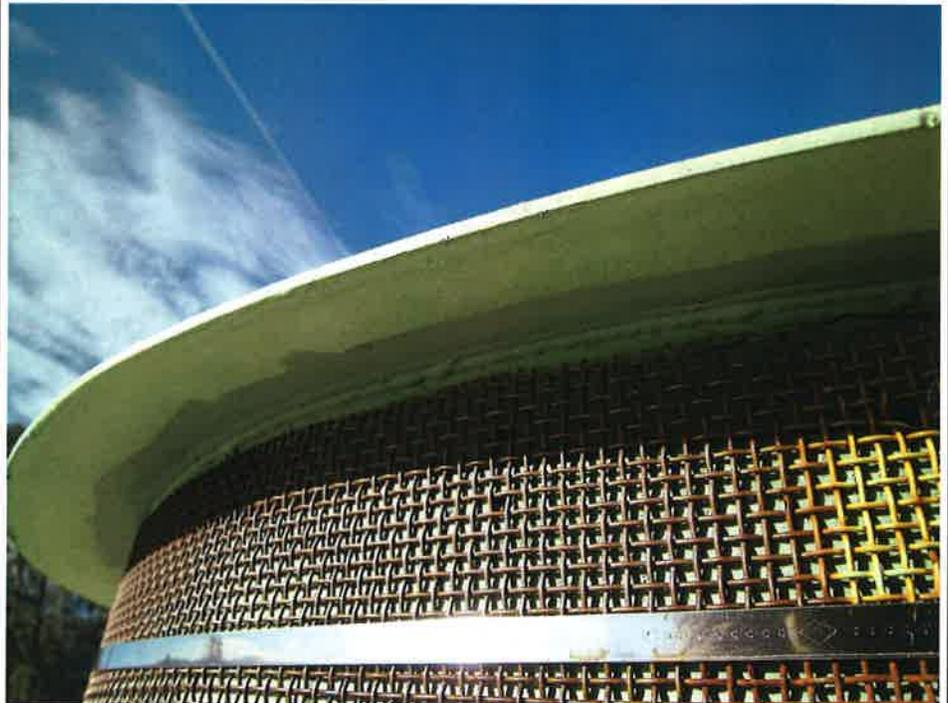
Image #21

Condition:
Rust Grade¹ 8.

Description:
Medium Mesh Vent Screen appeared to be in good condition with a minor amount of corrosion.

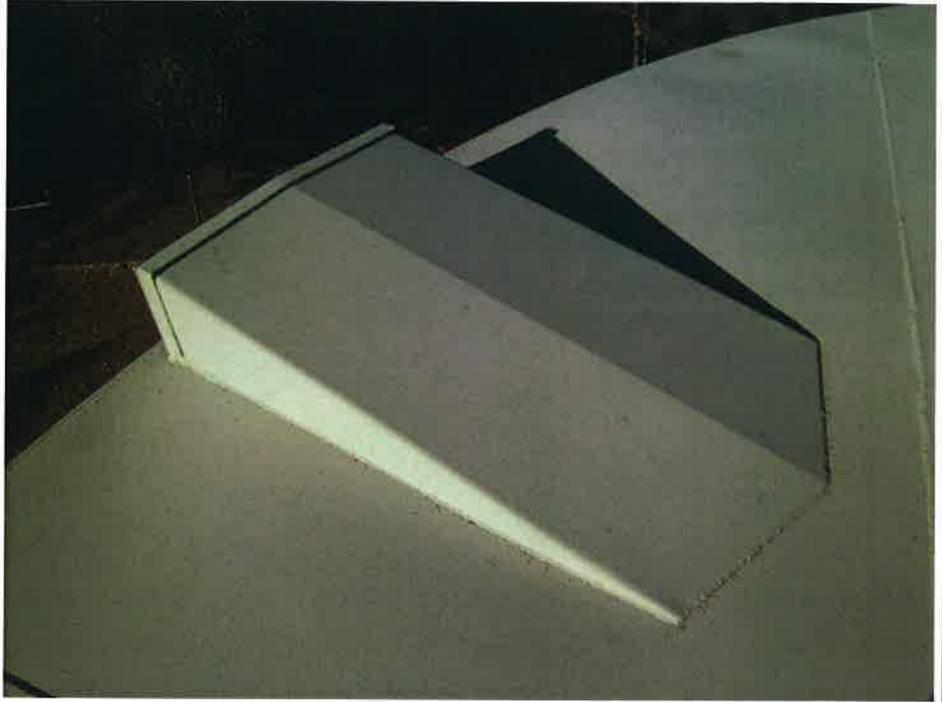
Image #22

Condition:
Rust Grade¹ 9.

Description:
24"x6" Side Vent
appeared to be in good
condition with a minor
amount of corrosion.

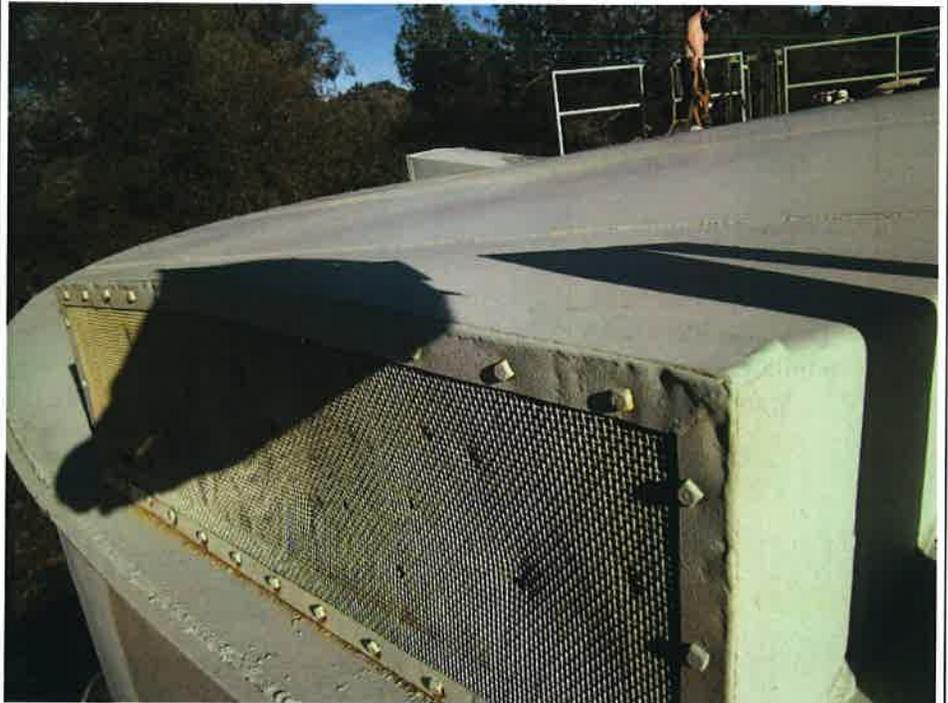
Image #23

Vent Screen 8:00

Condition:
Rust Grade¹ 9.

Description:
Fine Mesh Vent Screen
appeared to be in fair
condition with a minor
amount of corrosion.

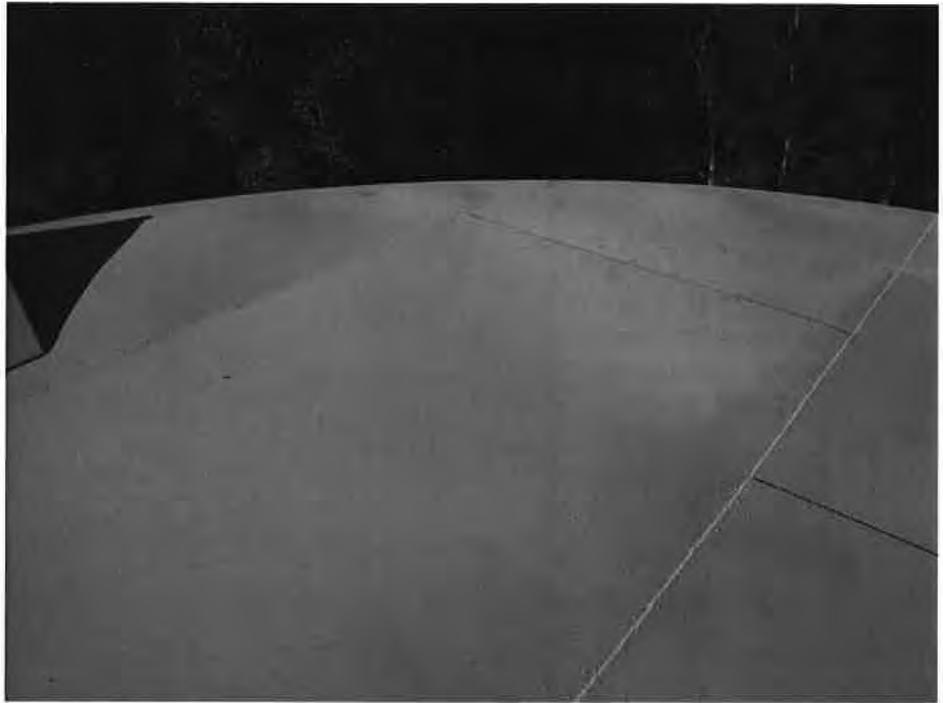
Image #24

Condition:
Rust Grade¹ 9.

Description:
Roof appeared to be in good condition with a minor amount of corrosion.

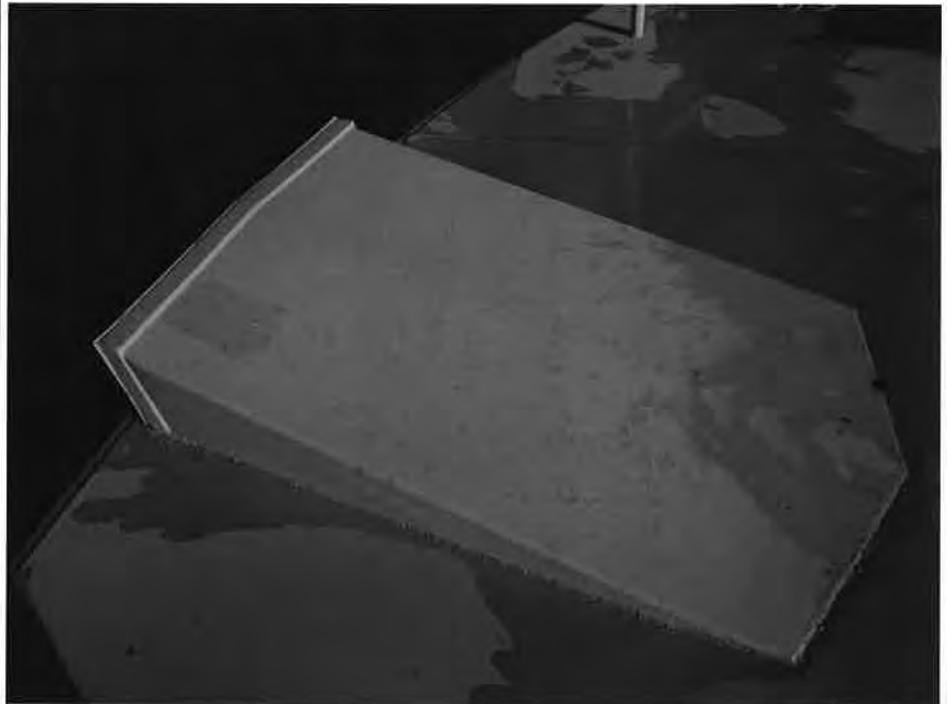
Image #25

Side Vent 10:00

Condition:
Rust Grade¹ 9.

Description:
24"x6" Side Vent appeared to be in good condition with a minor amount of corrosion.

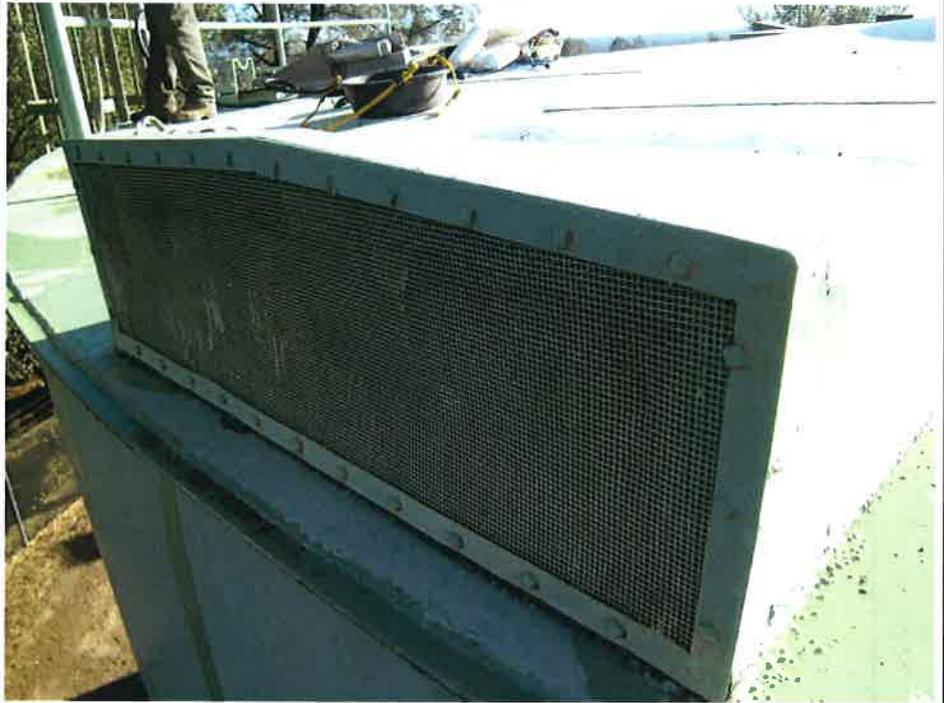
Image #26

Condition:
Rust Grade¹ 9.

Description:
Fine Mesh Vent Screen appeared to be in good condition with a minor amount of corrosion.

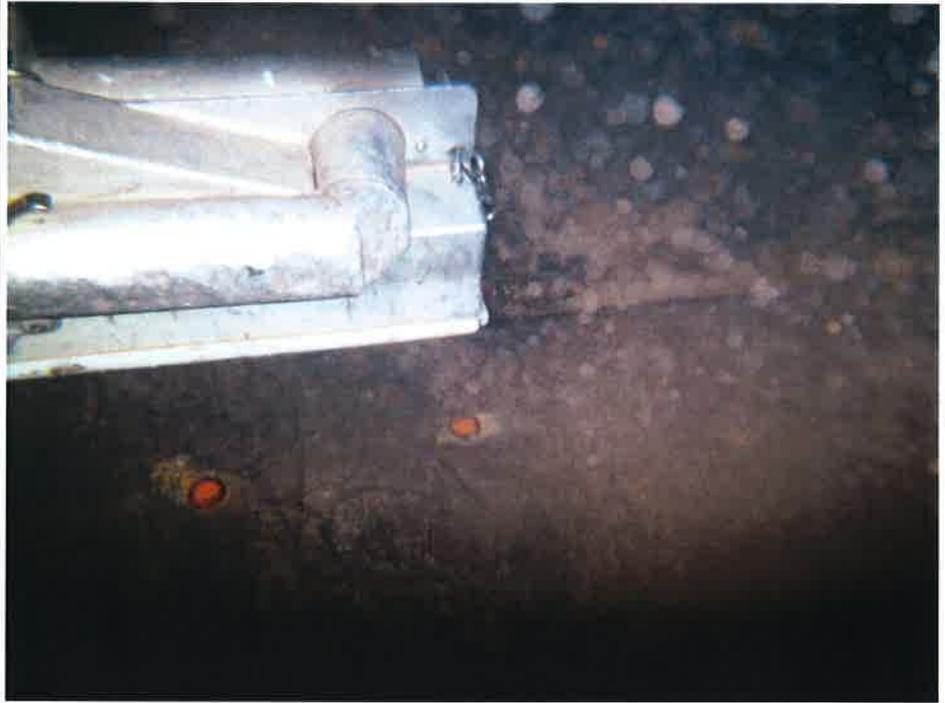
Image #28

Sediment

Description:
Light Skiff of
sediment was removed
from reservoir floor.

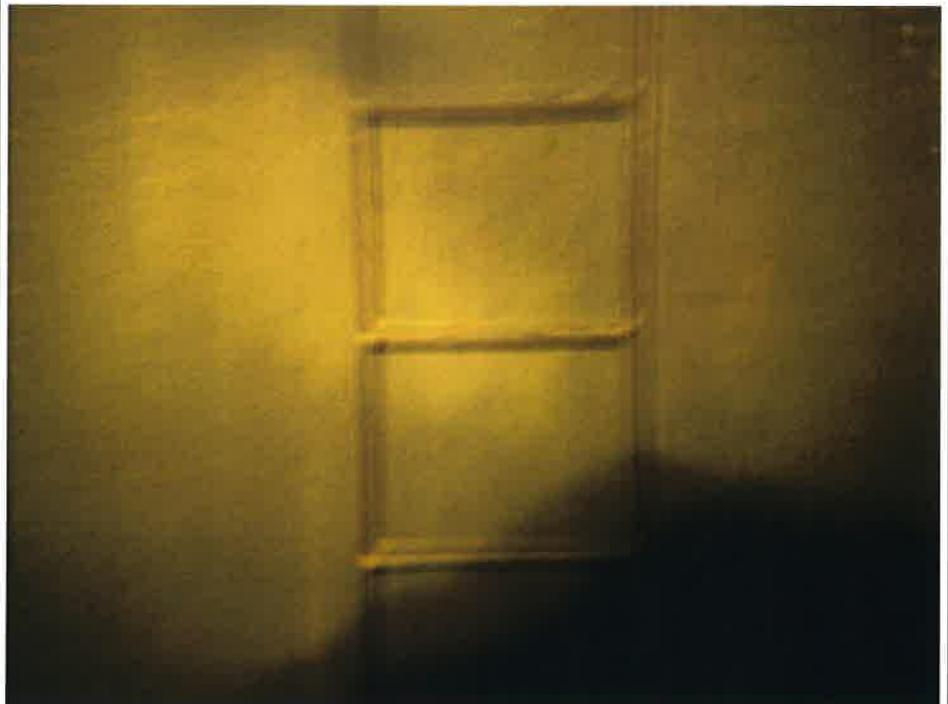
Image #29

Interior Ladder 12:00

Condition:
Rust Grade' 9.

Description:
Interior Ladder
appeared to be in good
condition with a minor
amount of corrosion.

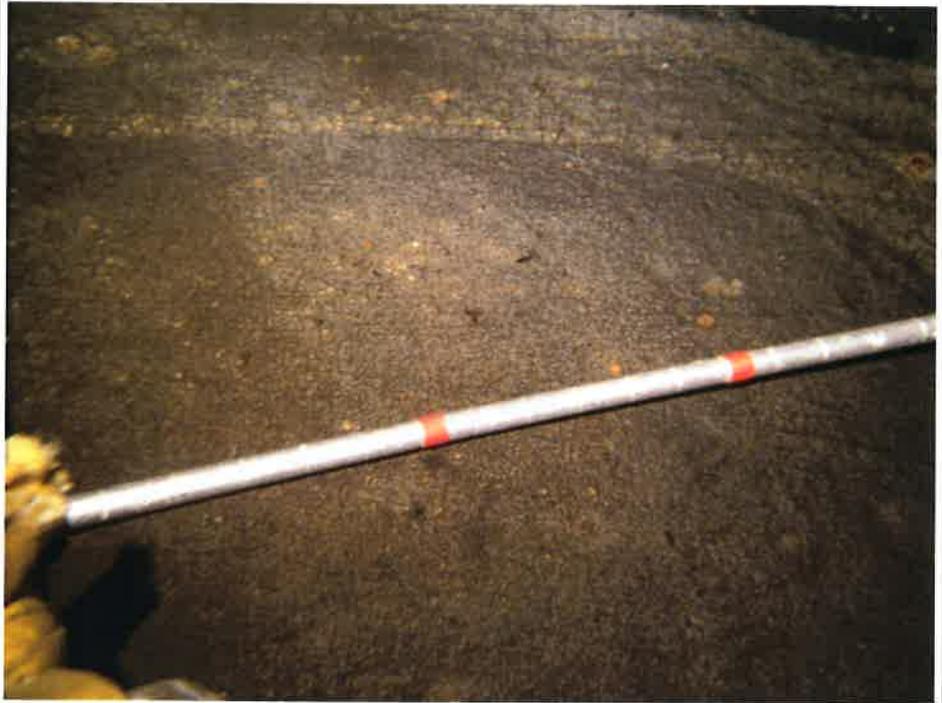
Image #30

Condition:
Rust Grade¹ UE.

Description:
Unable to evaluate the condition of the Floor due to cold tar coating with moderate corrosion spots.

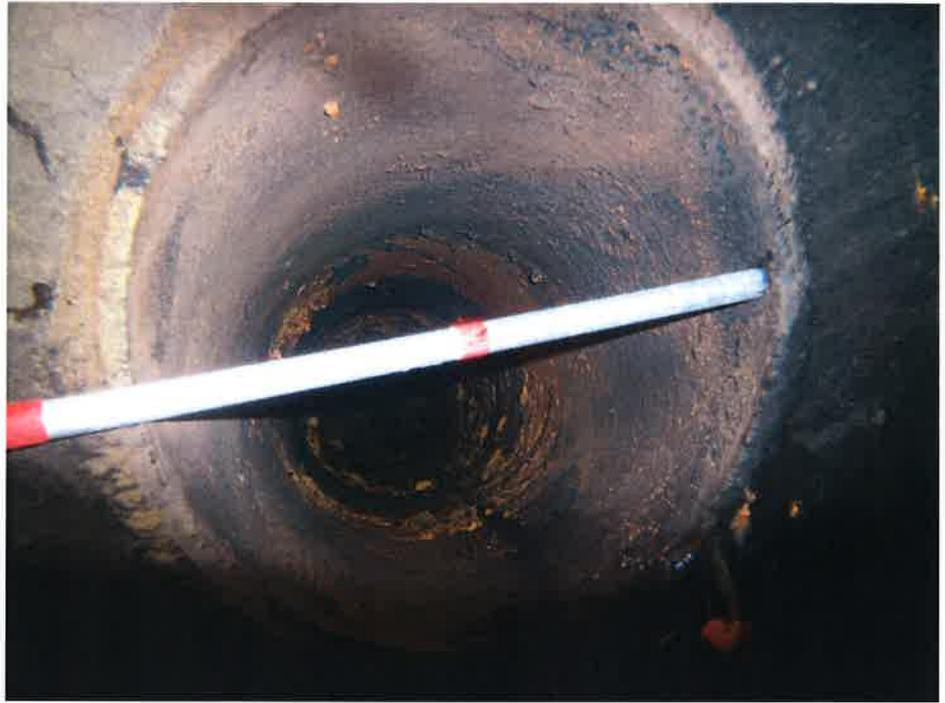
Image #32

Condition:
Rust Grade' 8.

Description:
10'' Inlet / Outlet
appeared to be in good
condition with a minor
amount of corrosion.

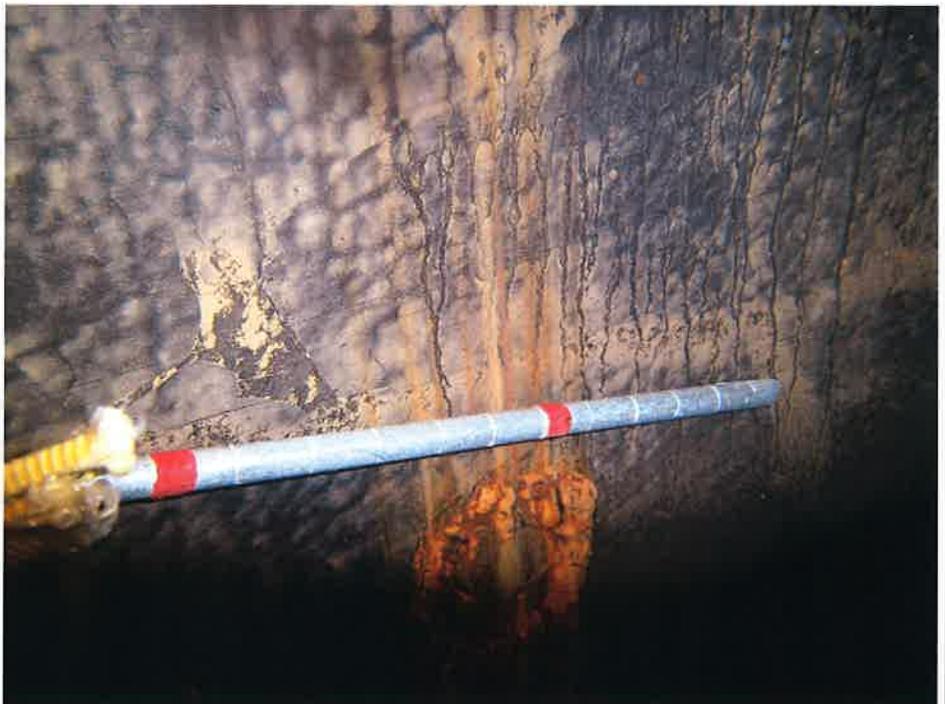
Image #33

Water Tap 12:10

Condition:
Rust Grade' 0.

Description:
2'' Water Tap appeared
to be in poor condition
with a heavy amount of
corrosion.

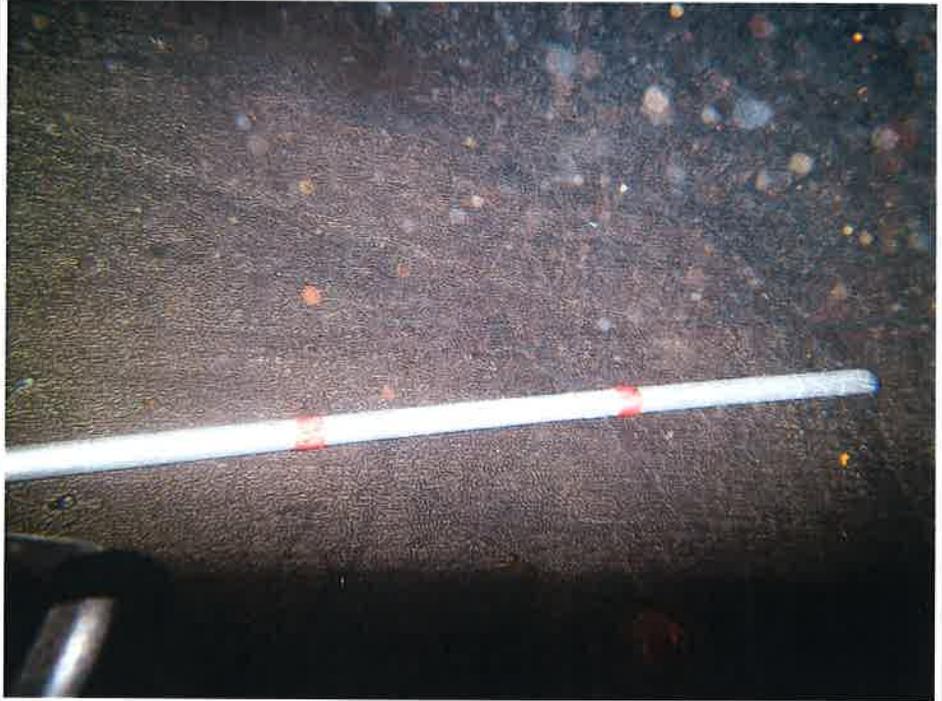
Image #34

Condition:
Rust Grade¹ UE.

Description:
Unable to evaluate the condition of the Floor due to cold tar coating with moderate corrosion spots.

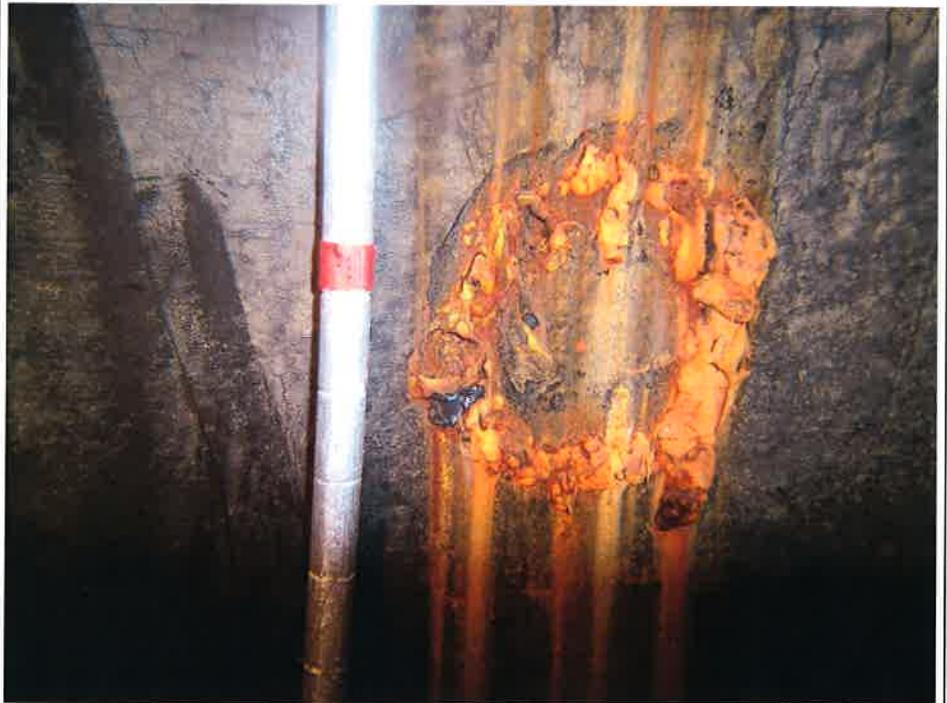
Image #35

Wall/Capped Off
Penetration 3:30

Condition:
Rust Grade¹ 0₂

Description:
3'' Capped Off
Penetration appeared to be in poor condition with a heavy amount of corrosion.

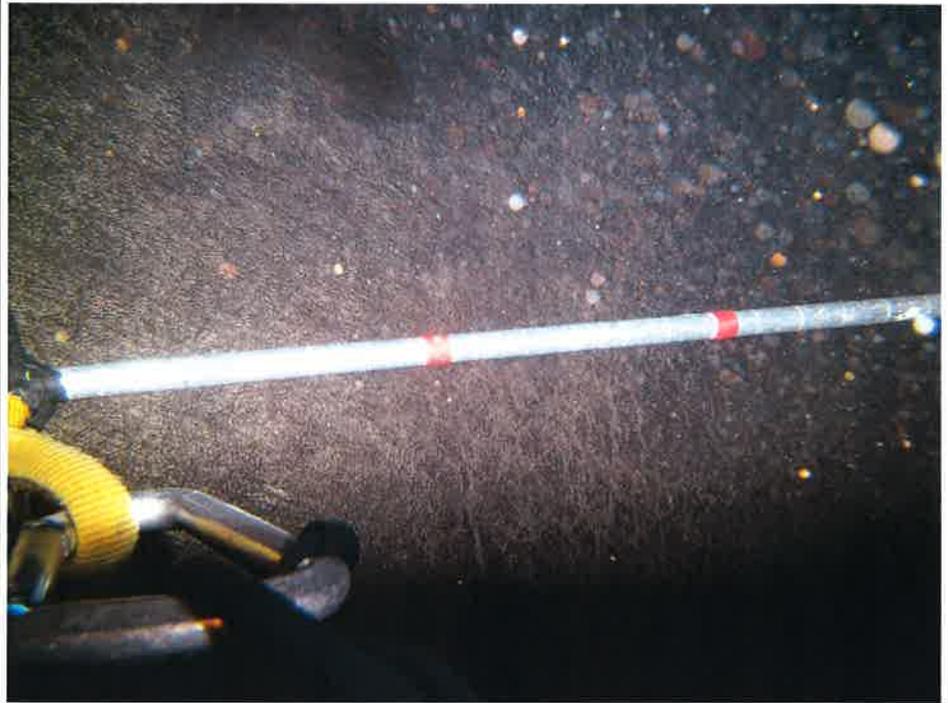
Image #36

Condition:
Rust Grade' UE.

Description:
Unable to evaluate the condition of the Floor due to cold tar coating with moderate corrosion spots.

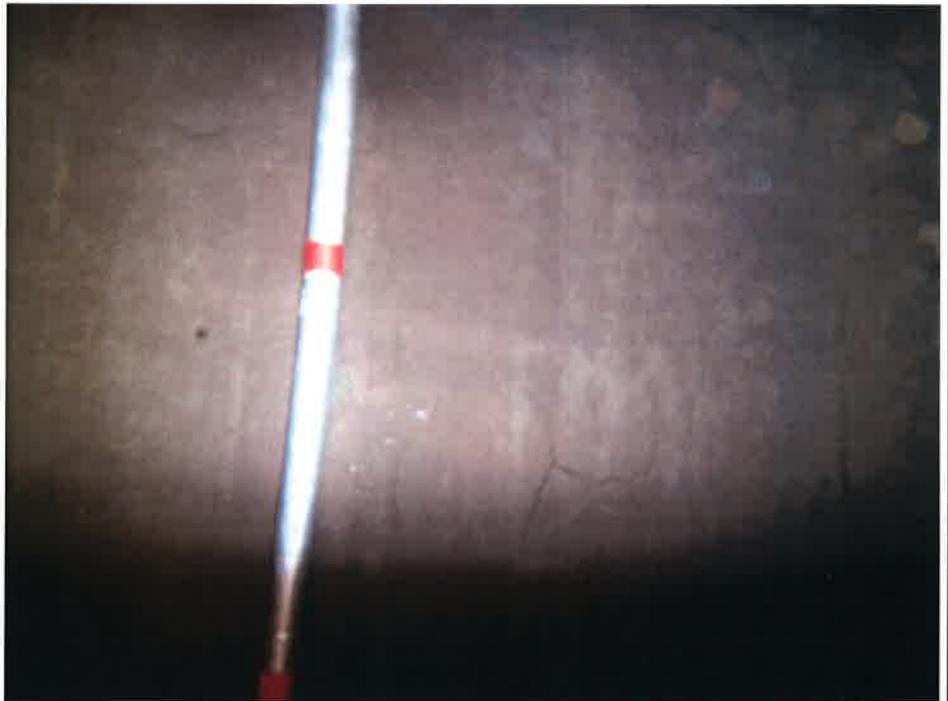
Image #37

Wall 6:00

Condition:
Rust Grade' UE.

Description:
Unable to evaluate the condition of the Floor due to cold tar coating with moderate corrosion spots.

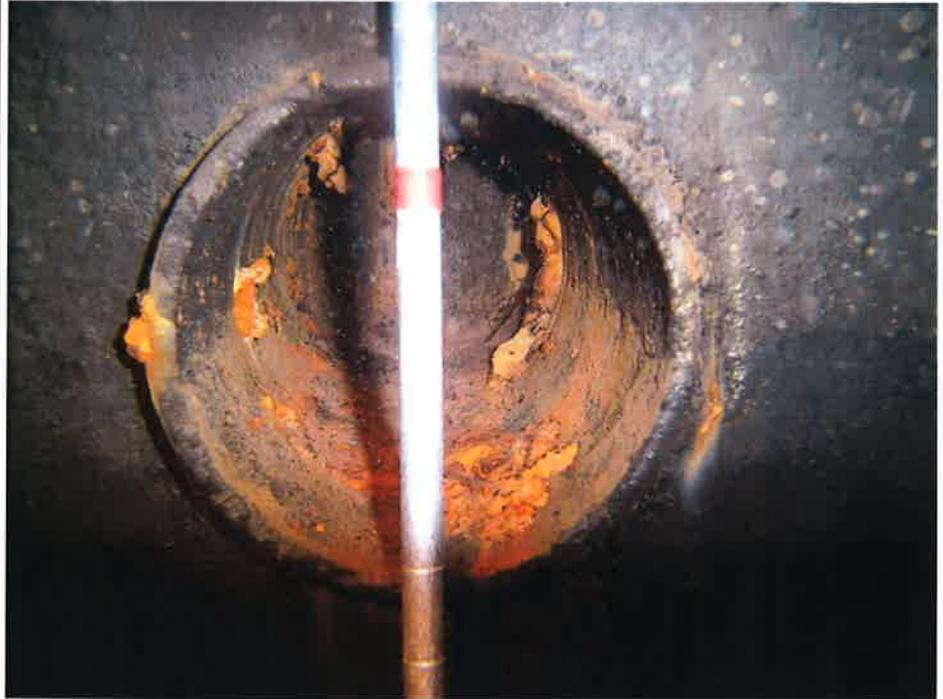
Image #38

Condition:
Rust Grade¹ 8.

Description:
6" Capped Off
Penetration appeared to
be in good condition
with a minor amount of
corrosion.

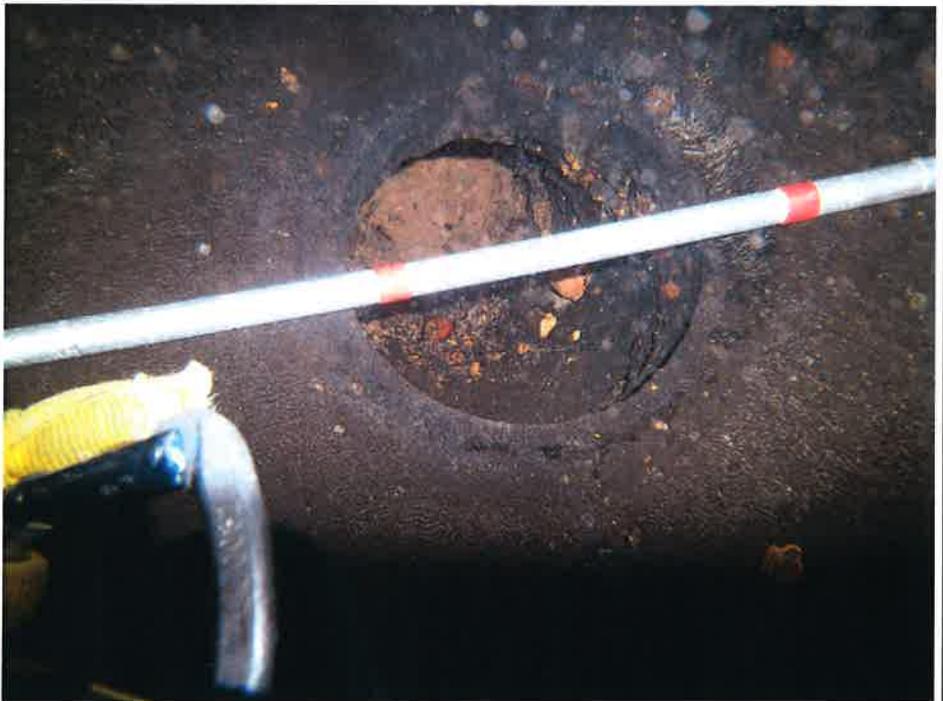
Image #39

Drain 6:30

Condition:
Rust Grade¹ 7.

Description:
6" Drain appeared to
be in good condition
with a minor amount of
corrosion.

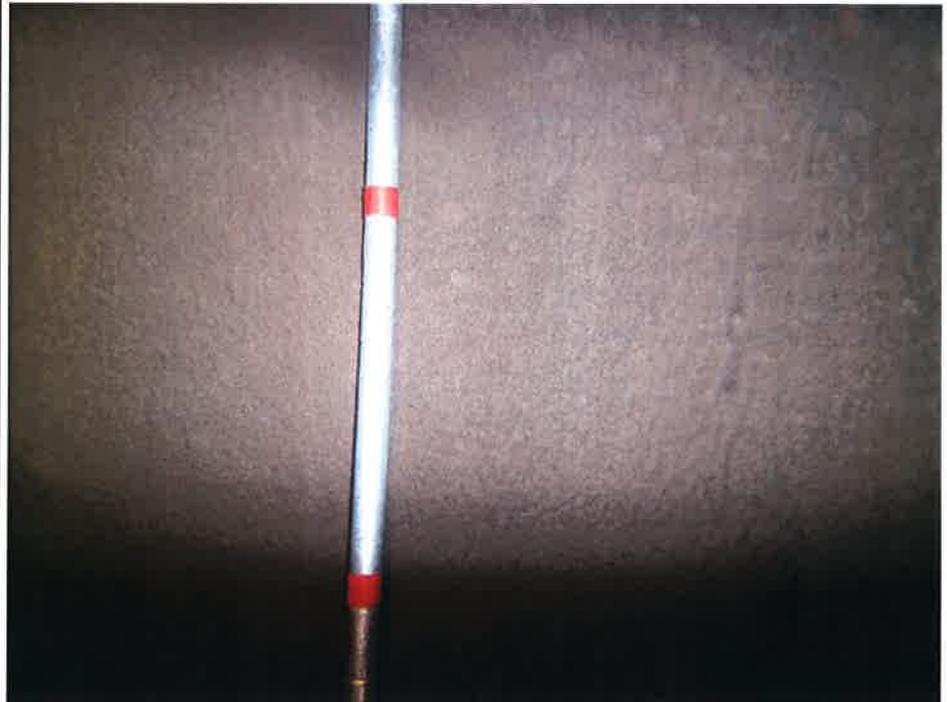
Image #41

Condition:
Rust Grade! UE.

Description:
Unable to evaluate the condition of the Wall due to cold tar coating.

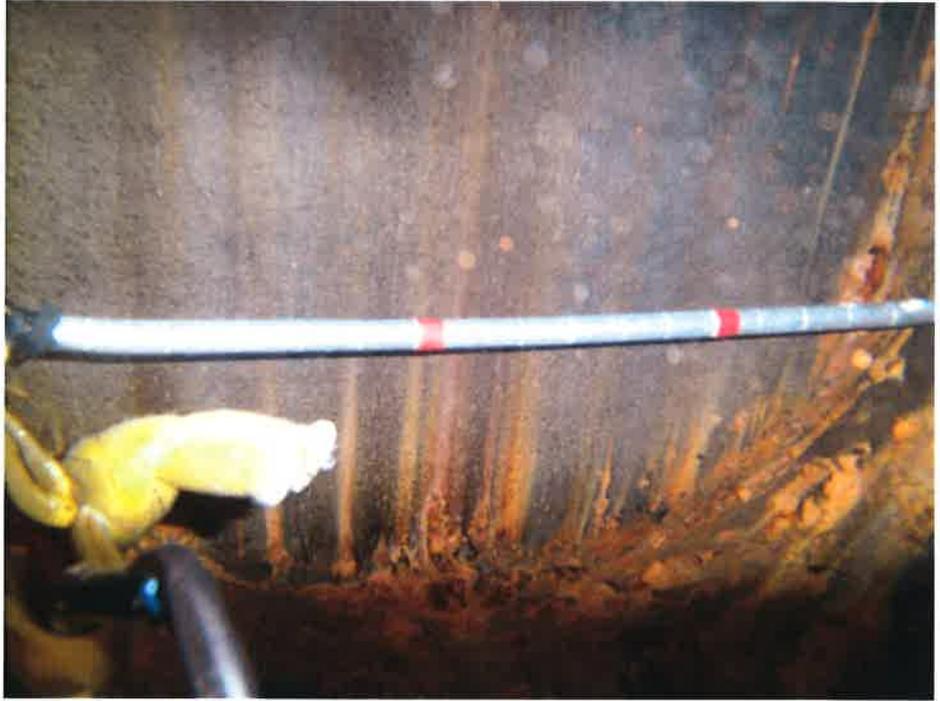
Image #42

Condition:
Rust Grade' 4.

Description:
24" Man Way appeared to be in poor condition with a moderate amount of corrosion.

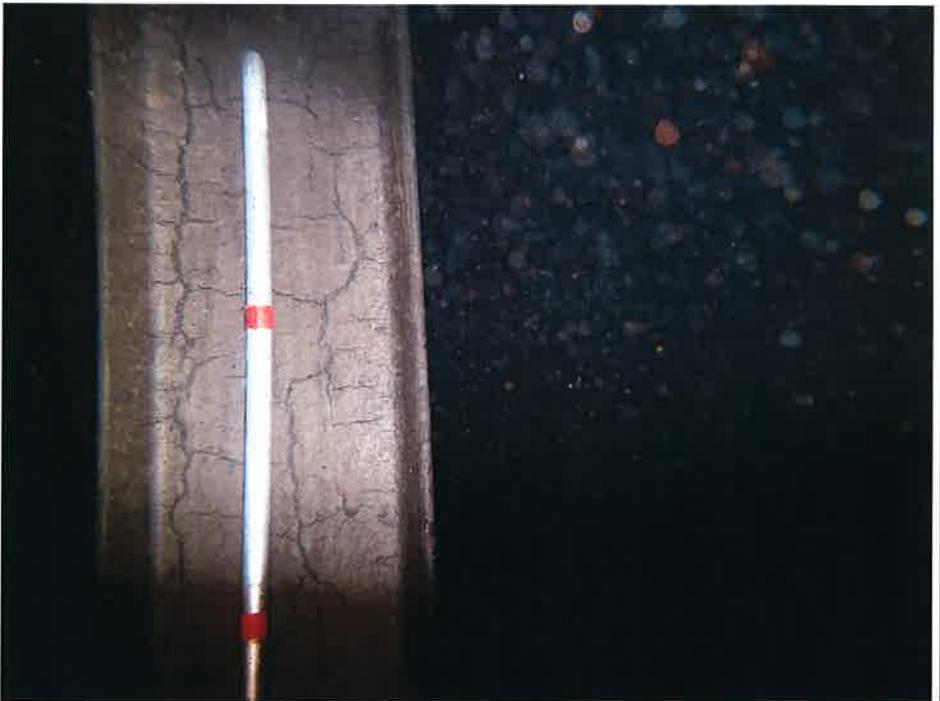
Image #43

Column Center

Condition:
Rust Grade' 7.

Description:
Column appeared to be in fair condition with a minor amount of corrosion.

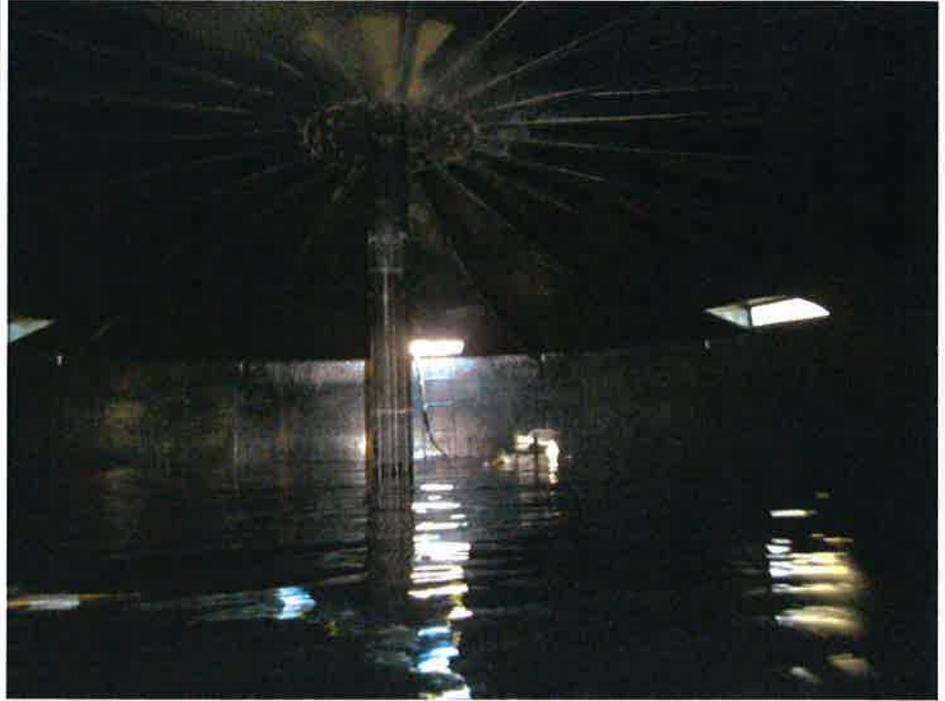
Image #44

Condition:
Rust Grade¹ 3.

Description:
Ceiling appeared to be in fair condition with a moderate amount of corrosion.

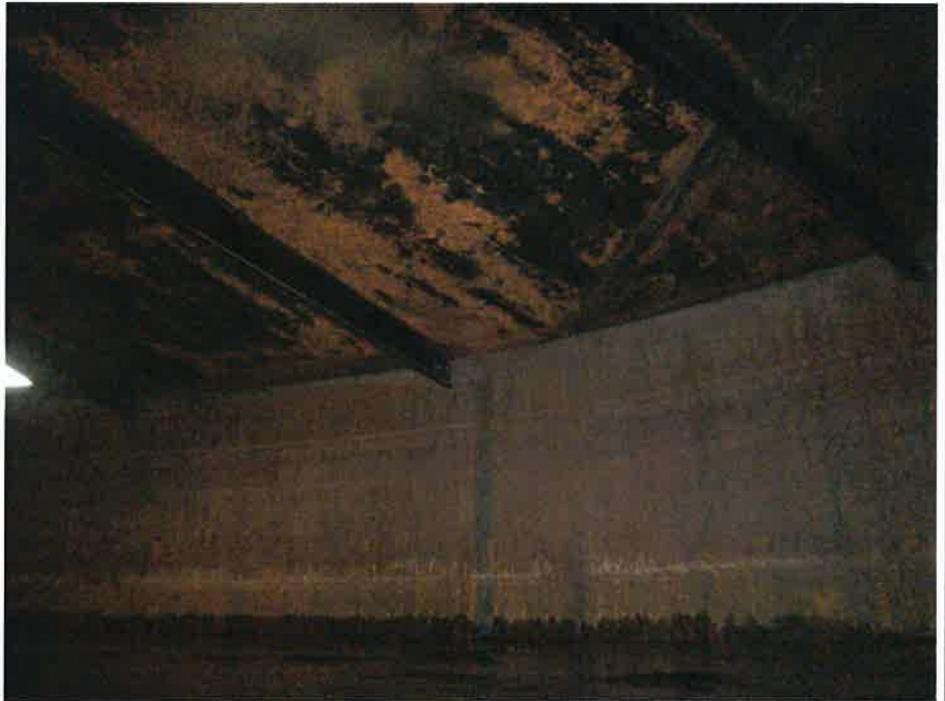
Image #45

Ceiling 3:00

Condition:
Rust Grade¹ 3.

Description:
Ceiling appeared to be in fair condition with a moderate amount of corrosion.

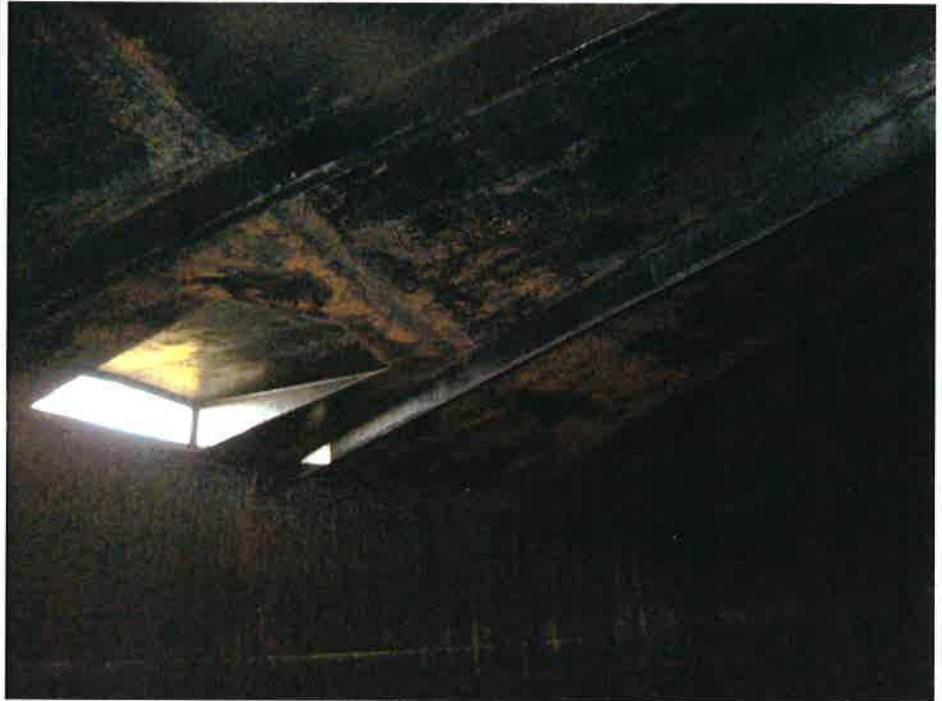
Image #46

Condition:
Rust Grade¹ 3.

Description:
Ceiling appeared to be in fair condition with a moderate amount of corrosion.

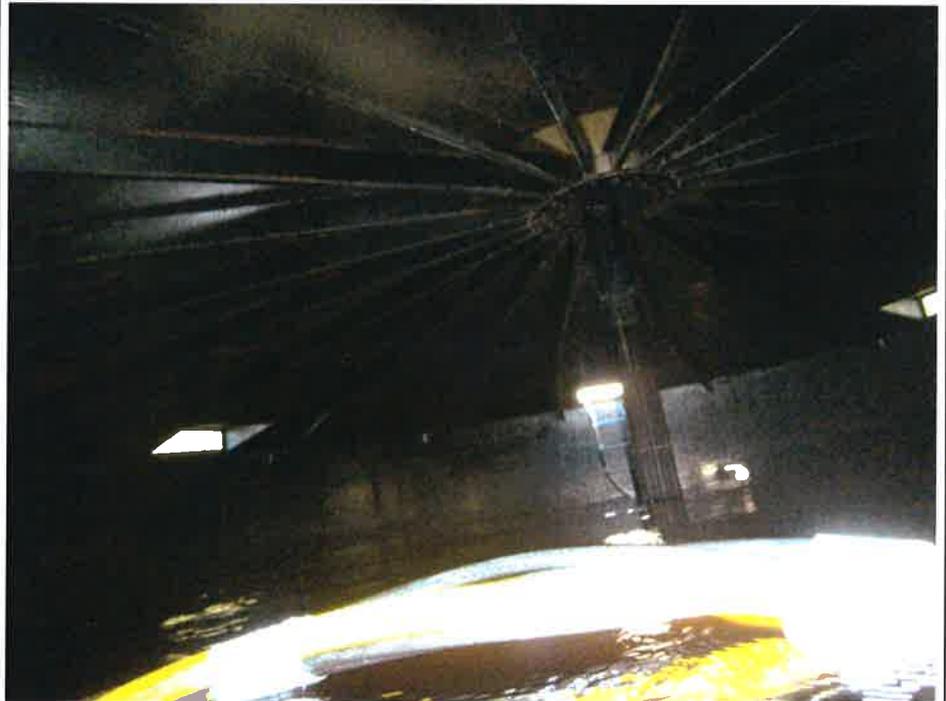
Image #47

Ceiling 9:00

Condition:
Rust Grade¹ 3.

Description:
Ceiling appeared to be in fair condition with a moderate amount of corrosion.
