CITY OF SHASTA LAKE

2016-2026 WATER MASTER PLAN

FINAL • OCTOBER 2016

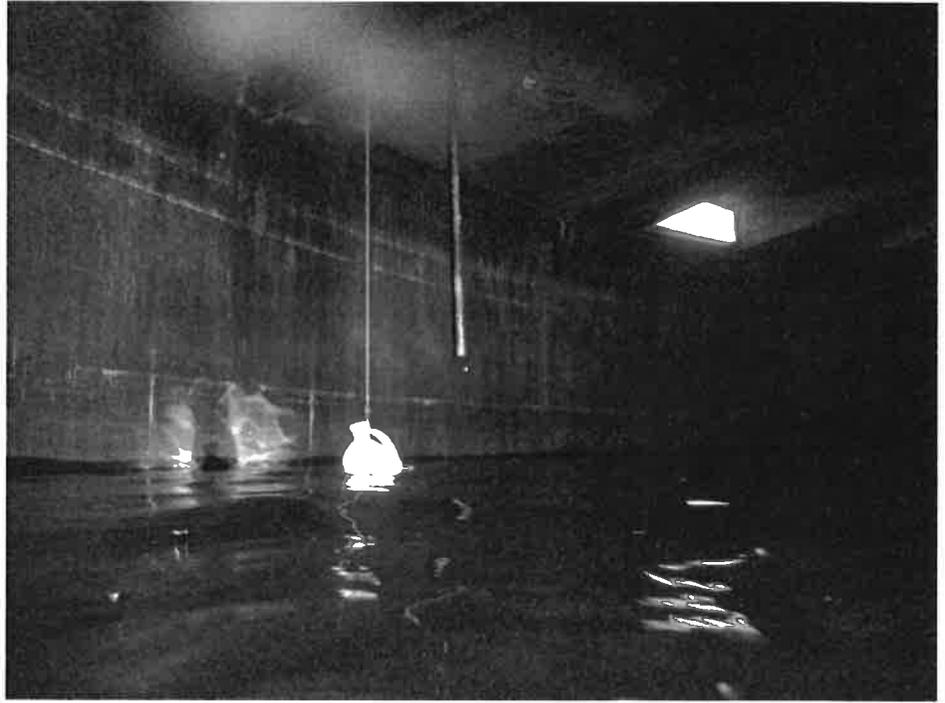
*Liquid Level Indicator
Float 12:05*

Condition:
Appeared to be
suspended functioning
properly.

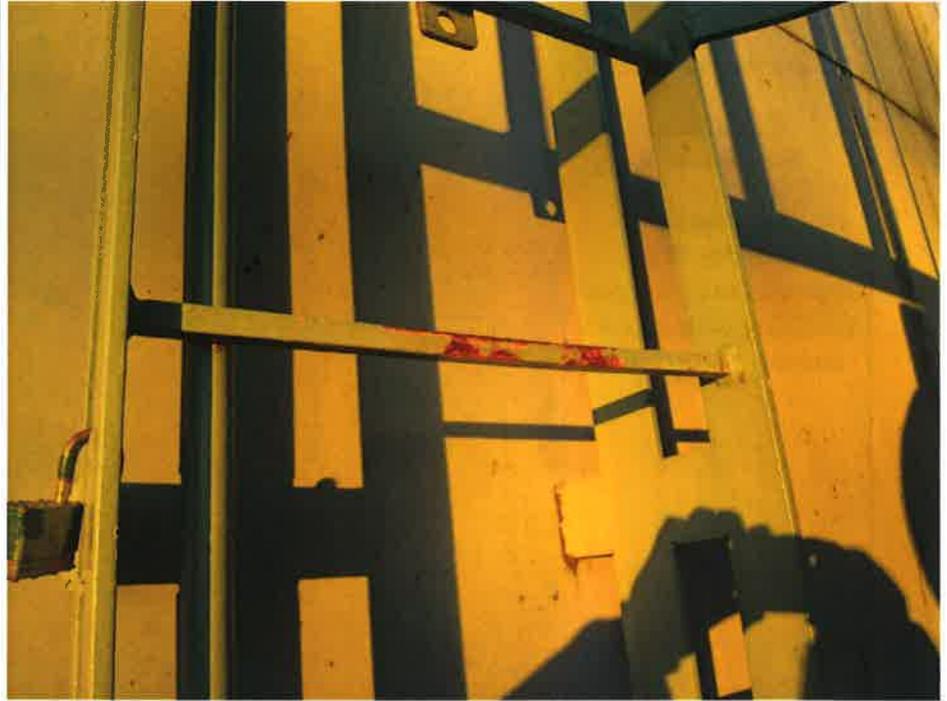
Image #2

Condition:
Rust Grade' 8.

Description:
Exterior Ladder appeared to be in good condition with a minor amount of corrosion.

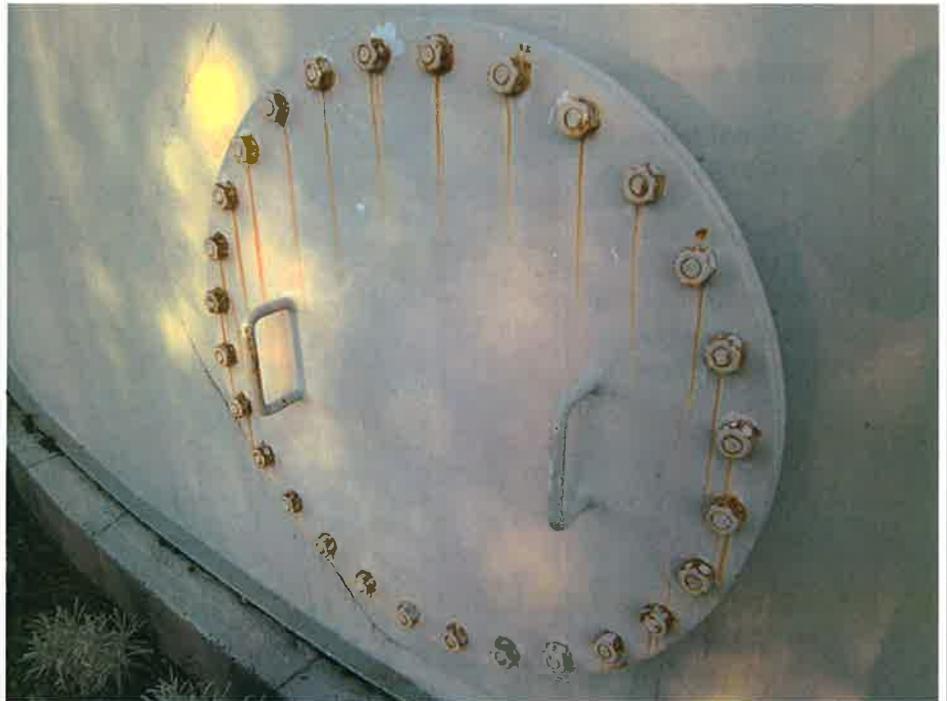
Image #3

Man Way 2:45

Condition:
Rust Grade' 7.

Description:
24" Man Way appeared to be in good condition with a minor amount of corrosion.

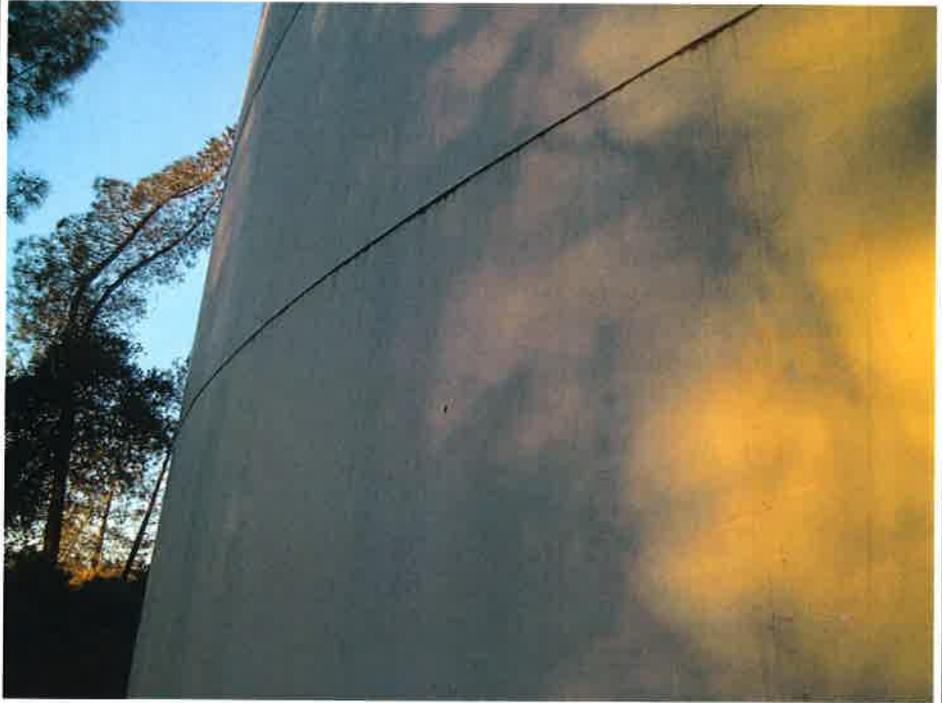
Image #4

Condition:
Rust Grade¹ 9.

Description:
Exterior Wall appeared to be in good condition with a minor amount of corrosion.

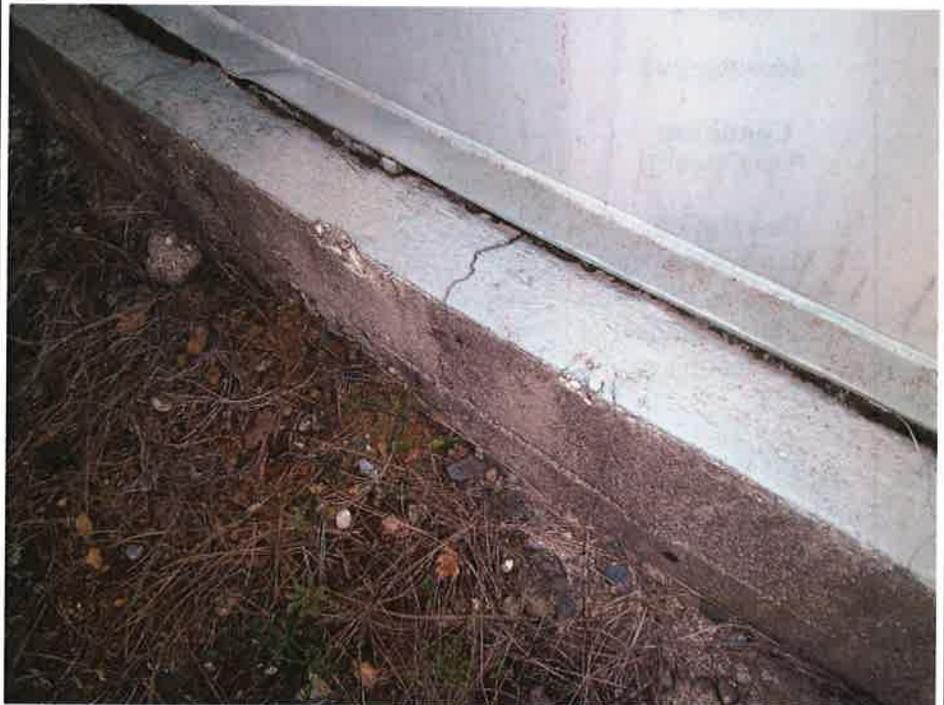
Image #5

Exterior Base 3:00

Condition:
Concrete Deform³ CK.

Description:
Exterior Base appeared to be in fair condition with a moderate amount of cracking.

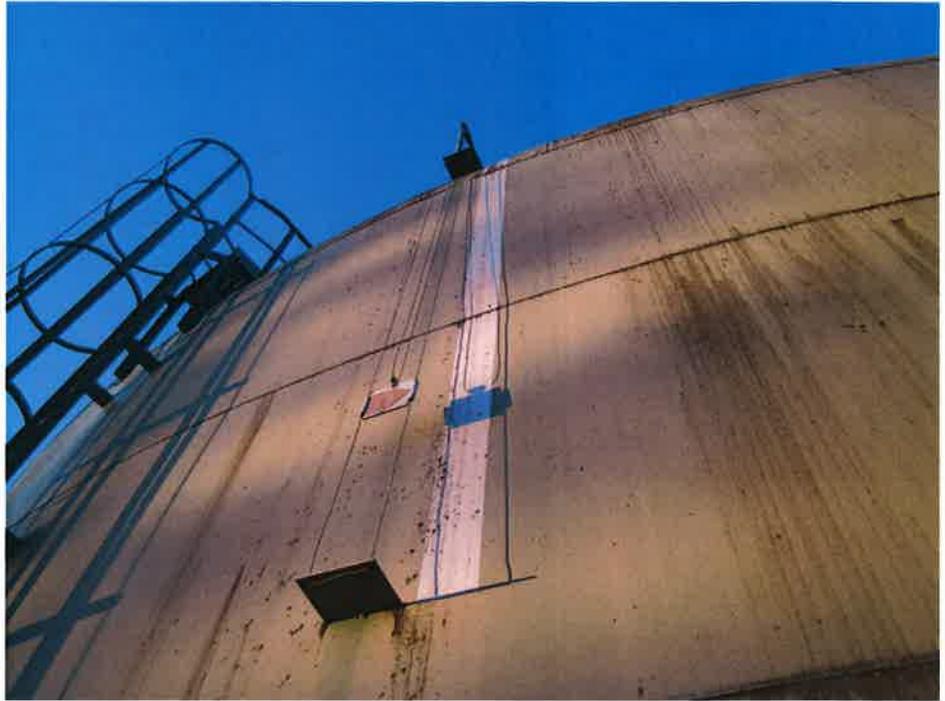
Image #6

Condition:
Rust Grade¹ 7.

Description:
Liquid Level Indicator
Reader Board appeared
to be in good condition
with a minor amount of
corrosion.

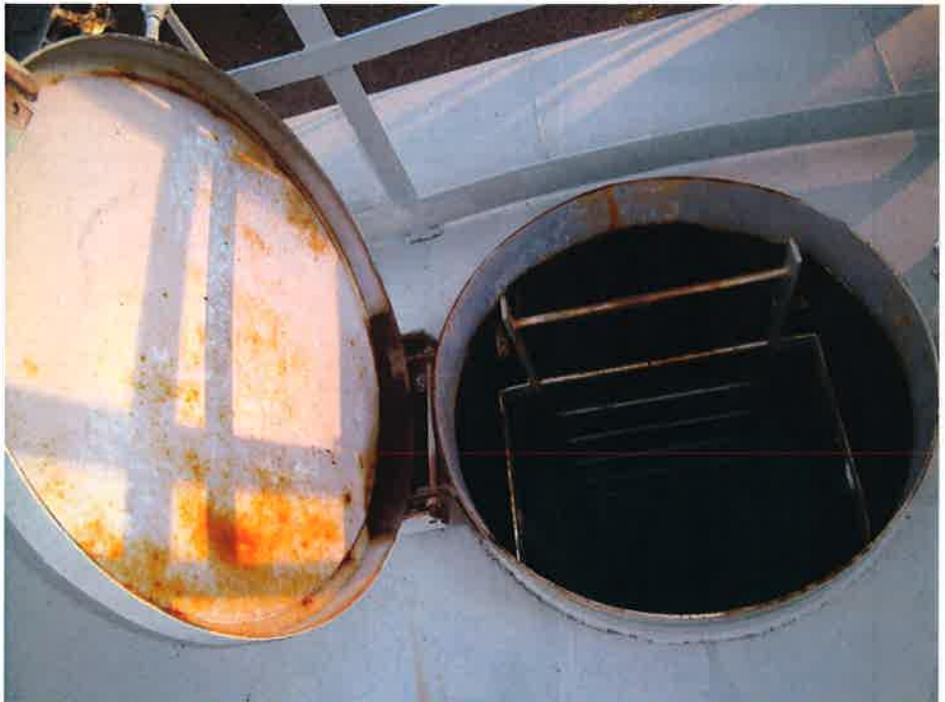
Image #7

Entry Hatch 12:00

Condition:
Rust Grade¹ 6.

Description:
24" Entry Hatch
appeared to be in good
condition with a
moderate amount of
corrosion.

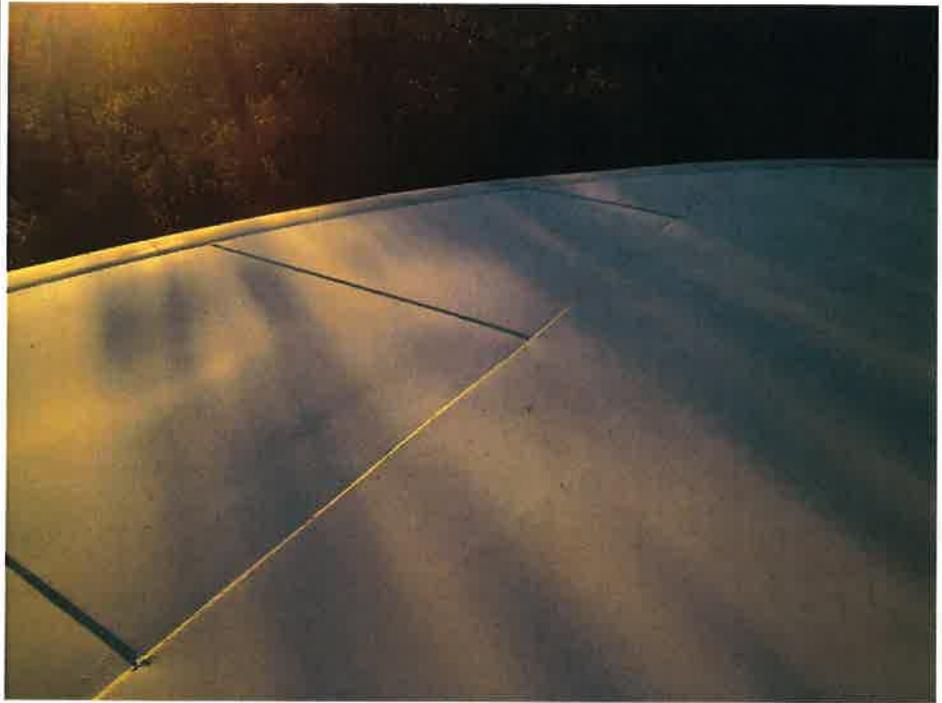
Image #8

Condition:
Rust Grade¹ 9.

Description:
Roof appeared to be in good condition with a minor amount of corrosion and chalking observed.

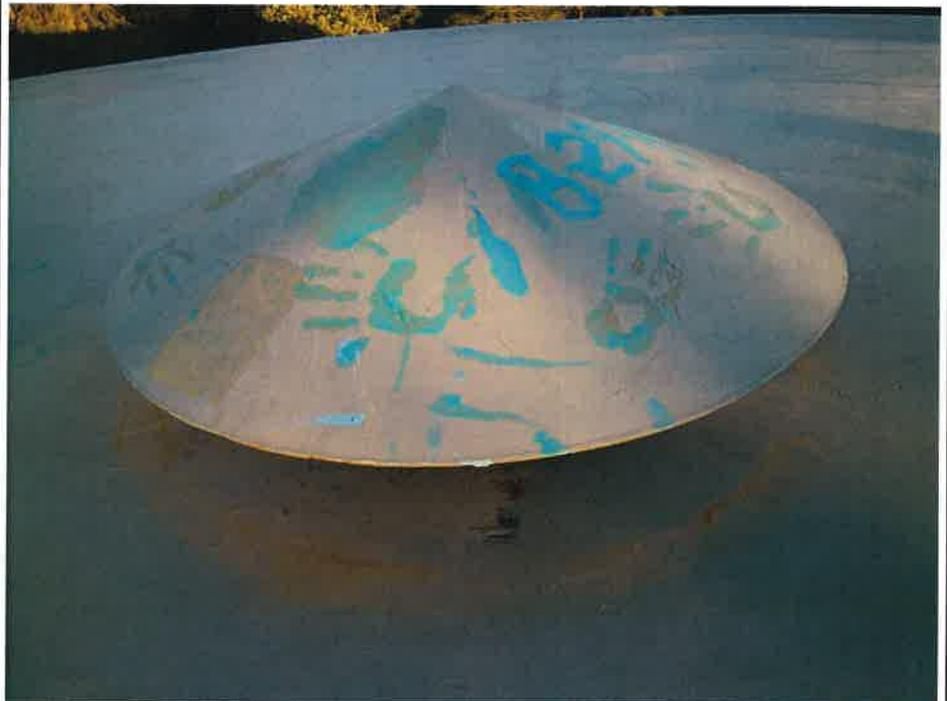
Image #9

Vent Center

Condition:
Rust Grade¹ 74

Description:
30" Vent appeared to be in good condition with a minor amount of corrosion. Most corrosion observed was on underside of lid.

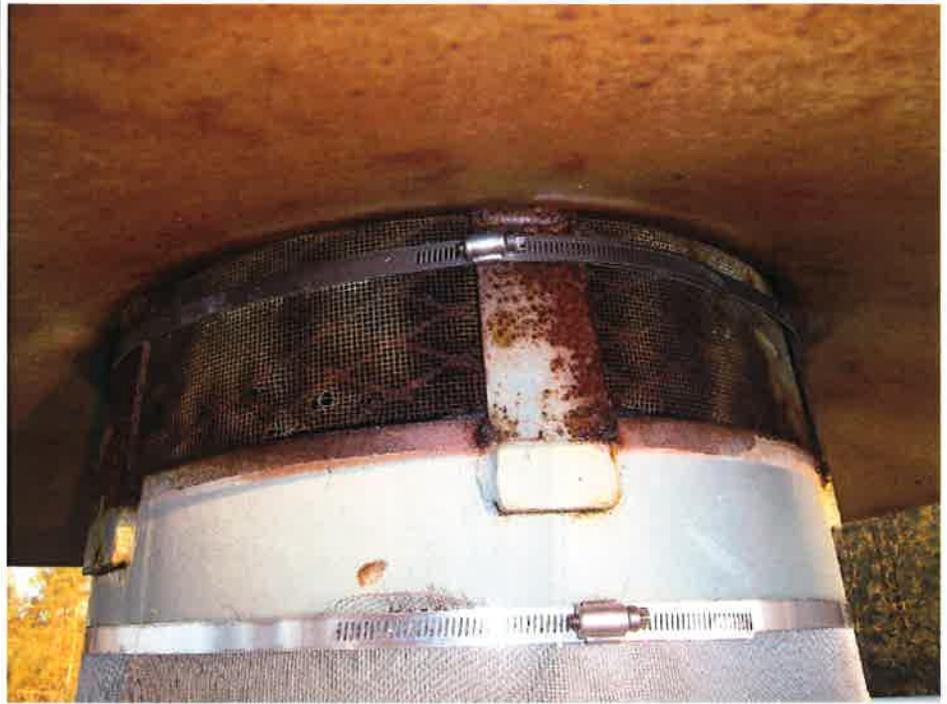
Image #10

Condition:
Rust Grade' 3.

Description:
Large and Fine Mesh Vent Screens appeared to be in fair condition with tears observed in Fine Mesh Screen and moderate corrosion observed on the Large Mesh Screen.

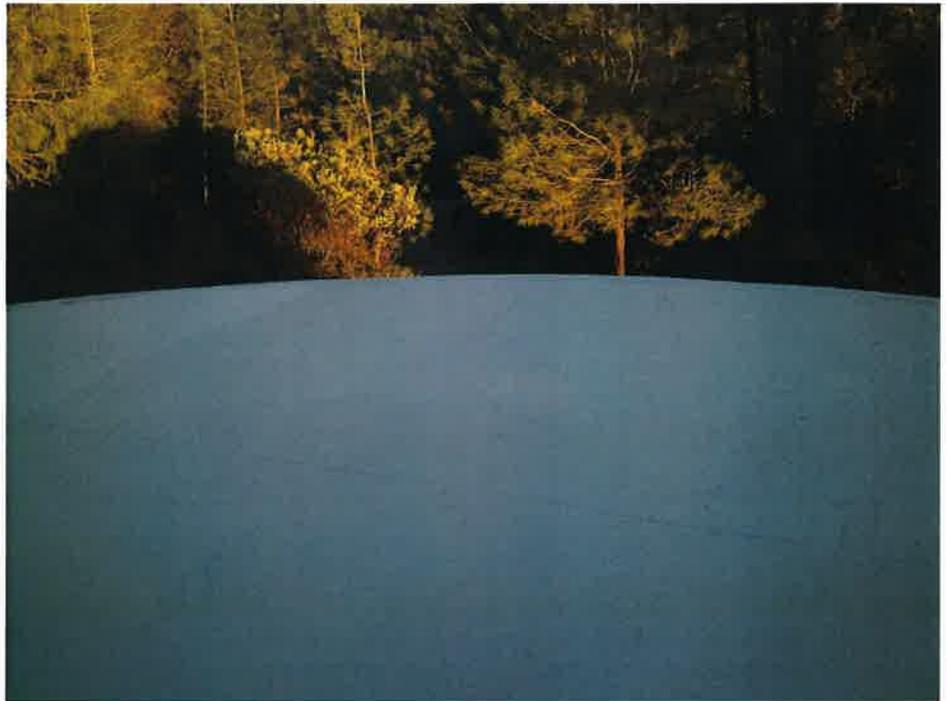
Image #11

Roof 9:00

Condition:
Rust Grade' 9.

Description:
Roof appeared to be in good condition with a minor amount of corrosion and chalking observed.

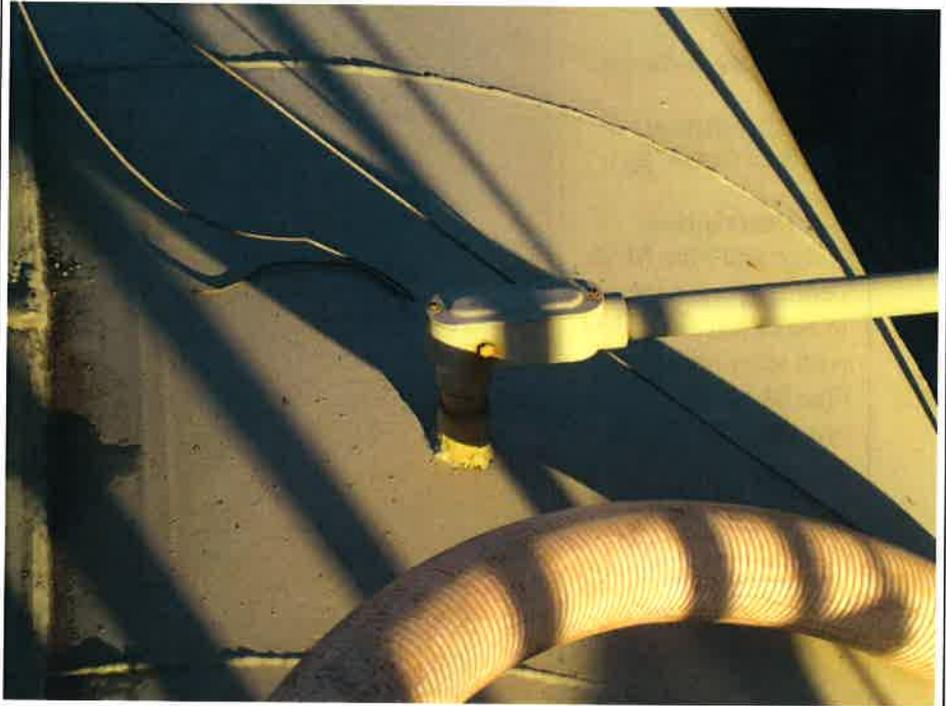
Image #12

Condition:
Rust Grade 7.

Description:
1" Liquid Level
Indicator Penetration
appeared to be in good
condition with a minor
amount of corrosion.

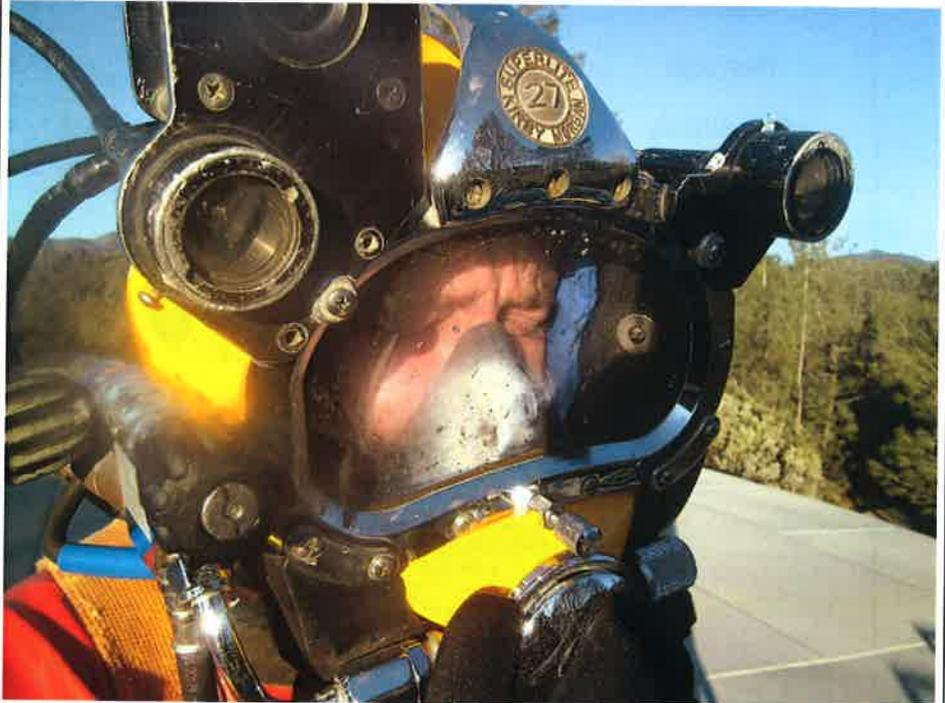
Diver

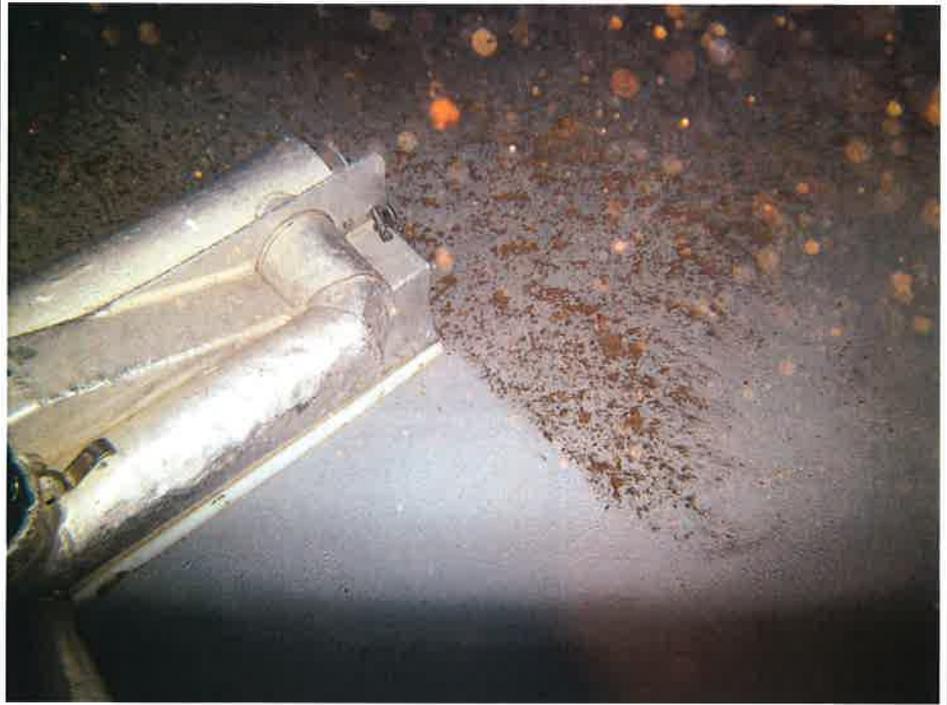
Image #13

Sediment

Description:
1/32" of sediment was removed from reservoir floor.

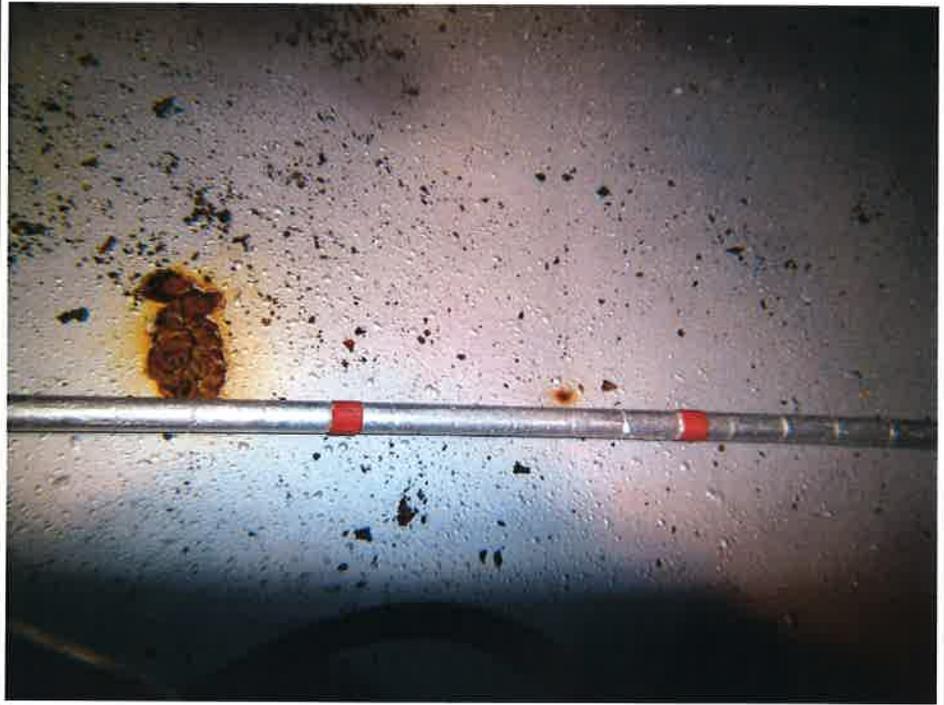
Condition:
Rust Grade' 3.

Description:
Floor appeared to be in poor condition with a heavy amount of corrosion and moderate blistering observed.

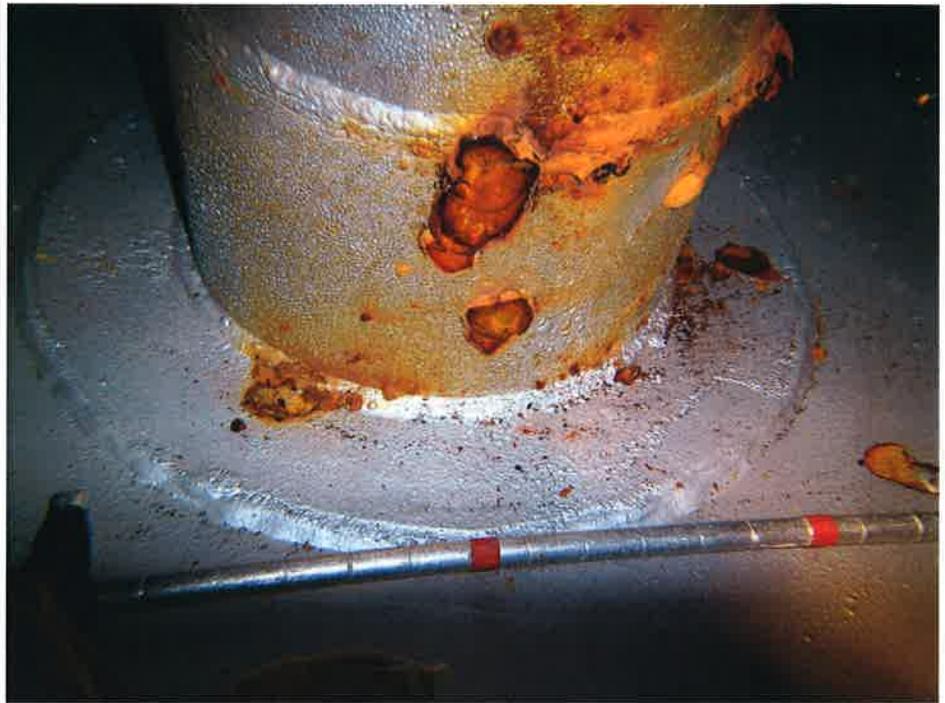
Condition:
Rust Grade' 6.

Description:
12" Overflow appeared to be in fair condition with a moderate amount of corrosion.

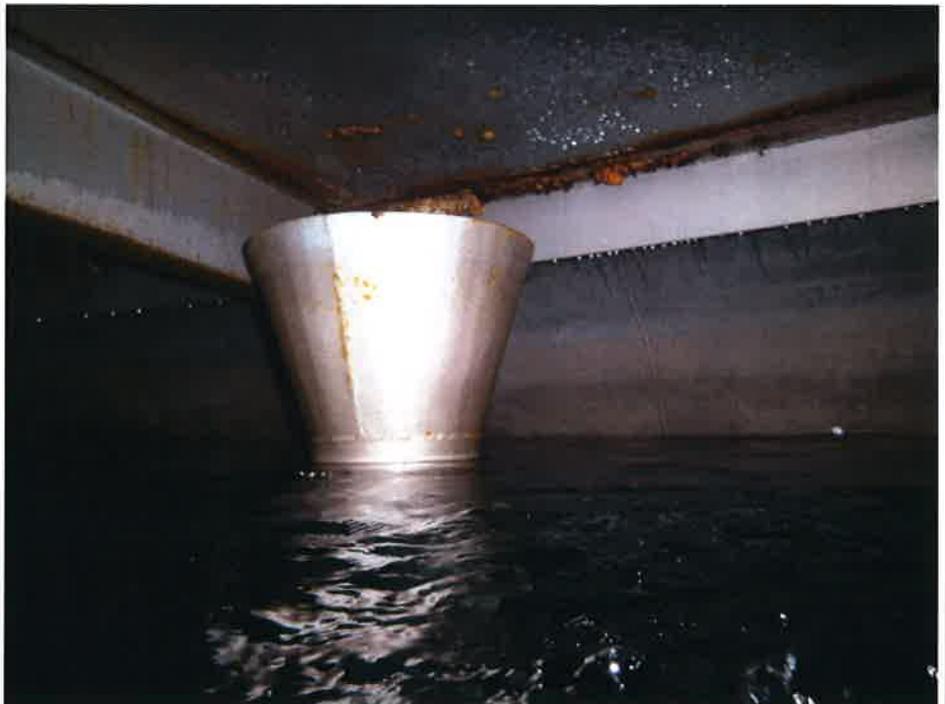
Image #18

Overflow Bell 1:00

Condition:
Rust Grade' 7.

Description:
16" Overflow Bell appeared to be in good condition with a minor amount of corrosion.

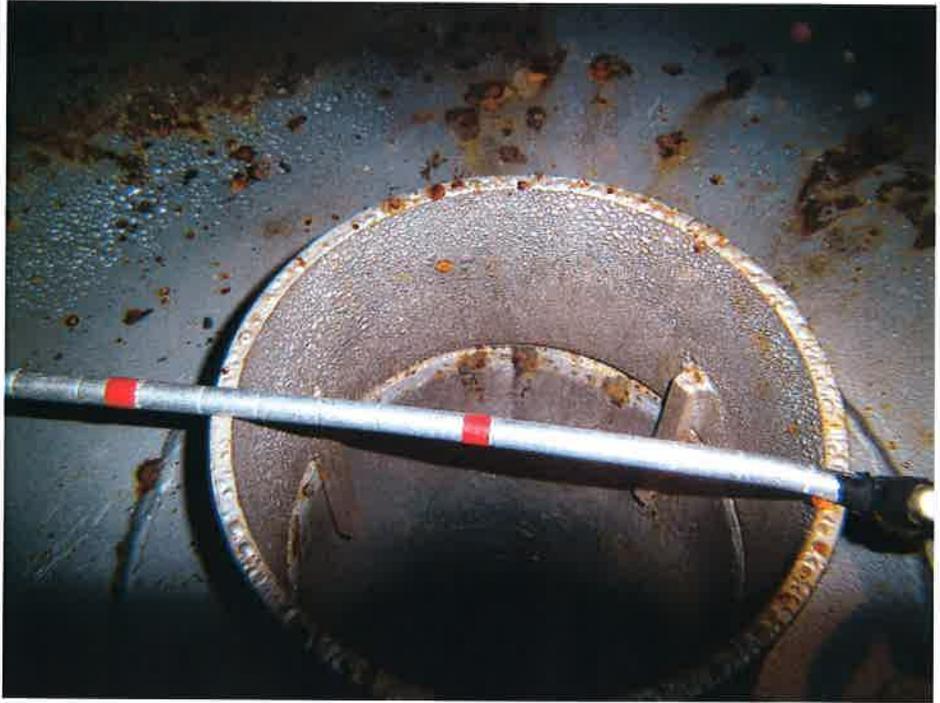
Image #19

Condition:
Rust Grade¹ 8.

Description:
10" Inlet / Outlet appeared to be in fair condition with a minor amount of corrosion and blistering observed.

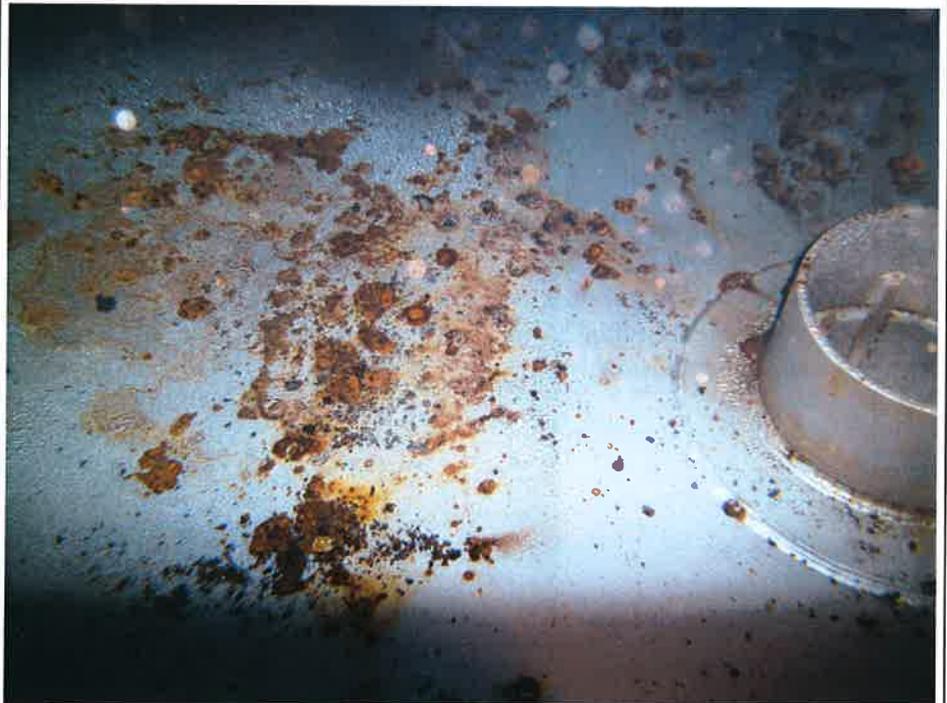
Image #20

Floor 2:00

Condition:
Rust Grade¹ 2.

Description:
Floor appeared to be in poor condition with a heavy amount of corrosion and moderate blistering observed.
Heavy surface corrosion on floor was observed near Inlet/Outlet from rust scale.

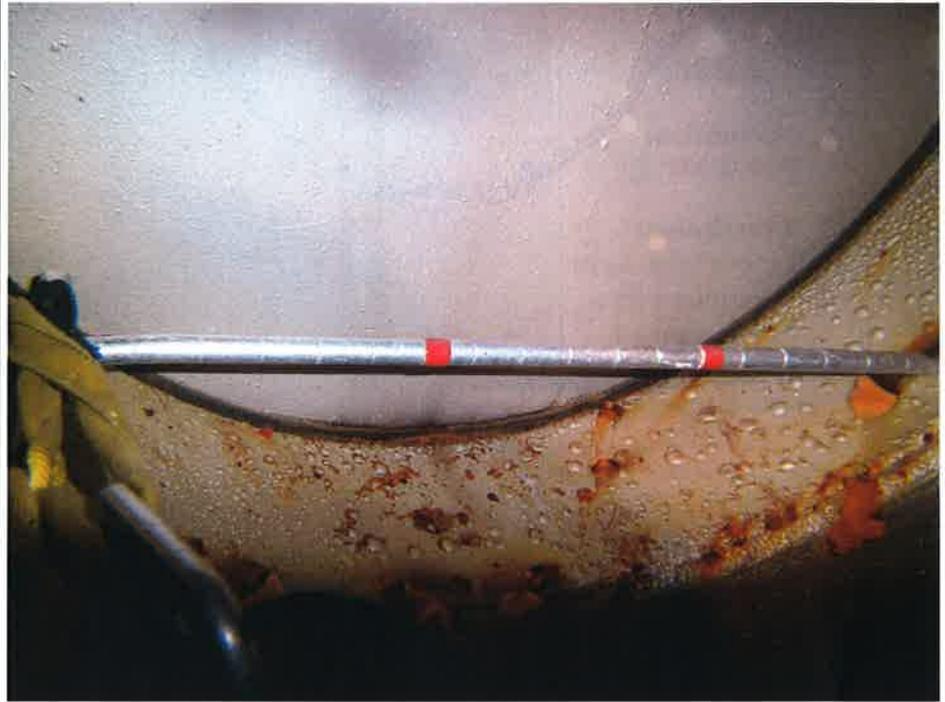
Image #21

Condition:
Rust Grade¹ 7.

Description:
24" Man Way appeared to be in fair condition with a minor amount of corrosion and moderate blistering observed.

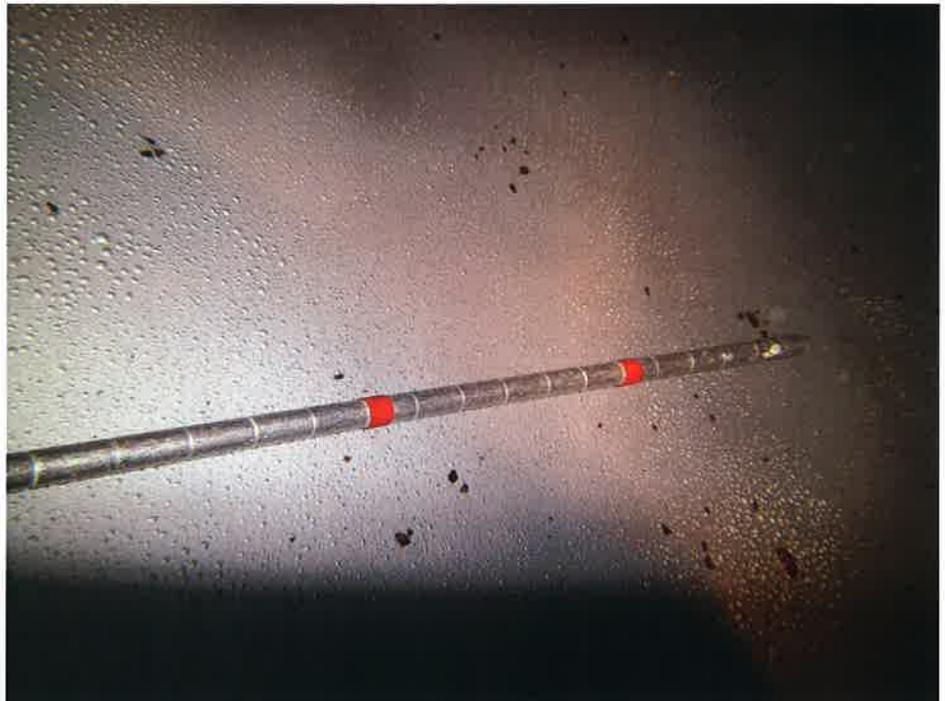
Image #22

Floor 3:00

Condition:
Rust Grade¹ 3.

Description:
Floor appeared to be in poor condition with a heavy amount of corrosion and moderate blistering observed.

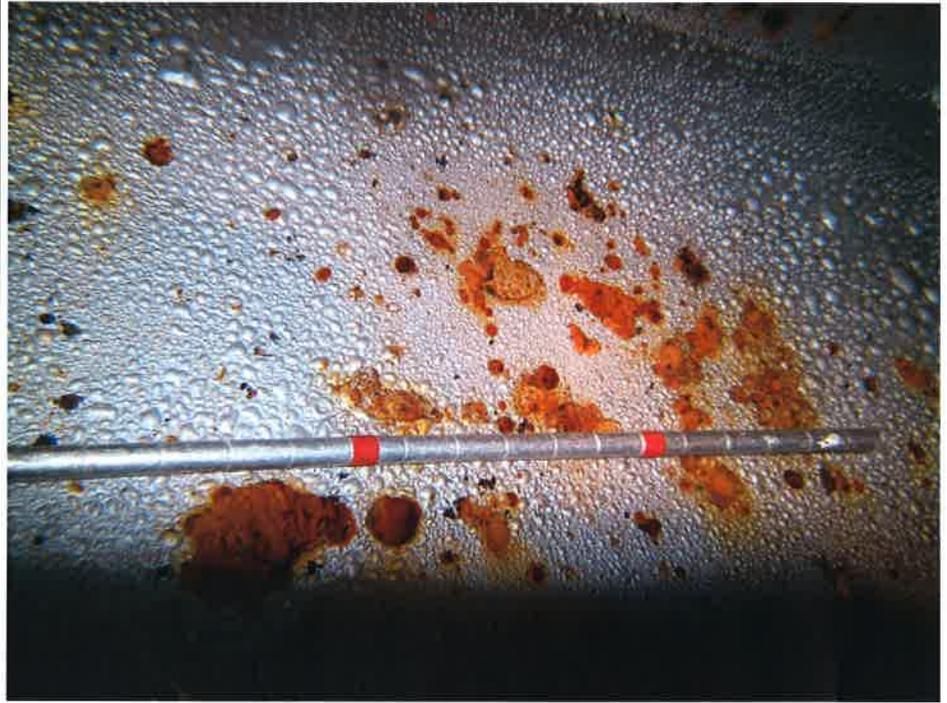
Condition:
Rust Grade 4.

Description:
Floor appeared to be in poor condition with a moderate amount of corrosion and heavy blistering observed.

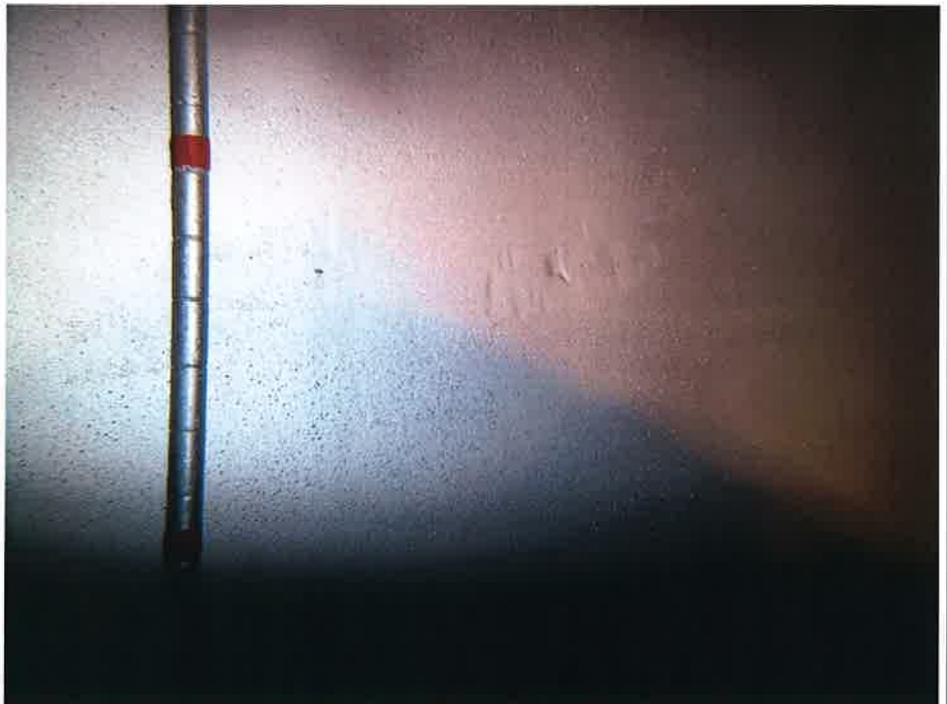
Image #26

Wall 6:00

Condition:
Rust Grade 8.

Description:
Wall appeared to be in fair condition with a minor amount of corrosion and blistering observed.

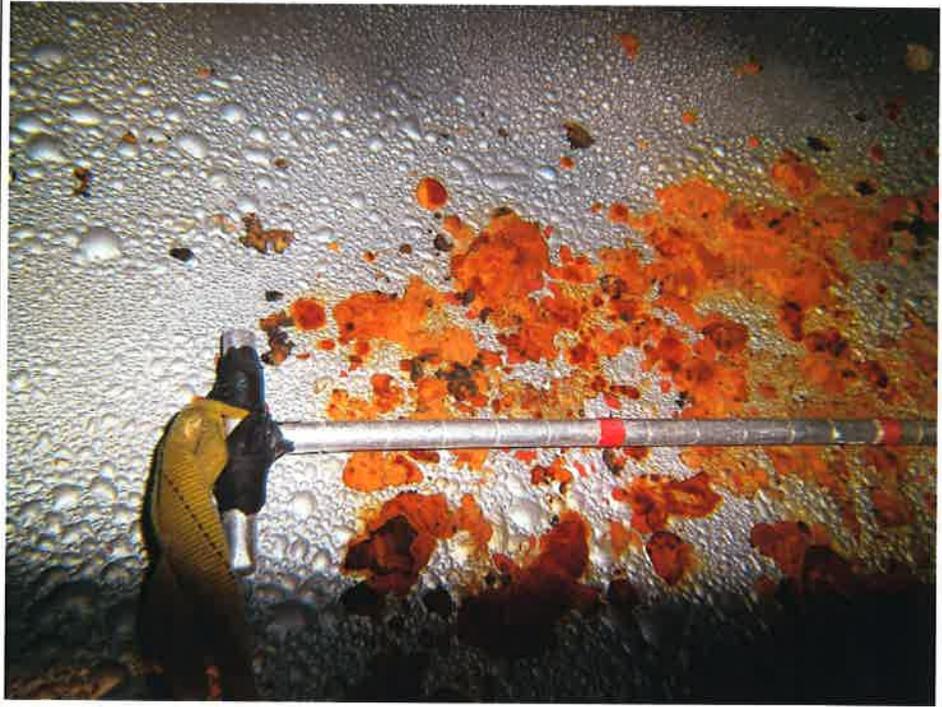
Image #27

Condition:
Rust Grade' 4.

Description:
Floor appeared to be in poor condition with a moderate amount of corrosion and heavy blistering observed.

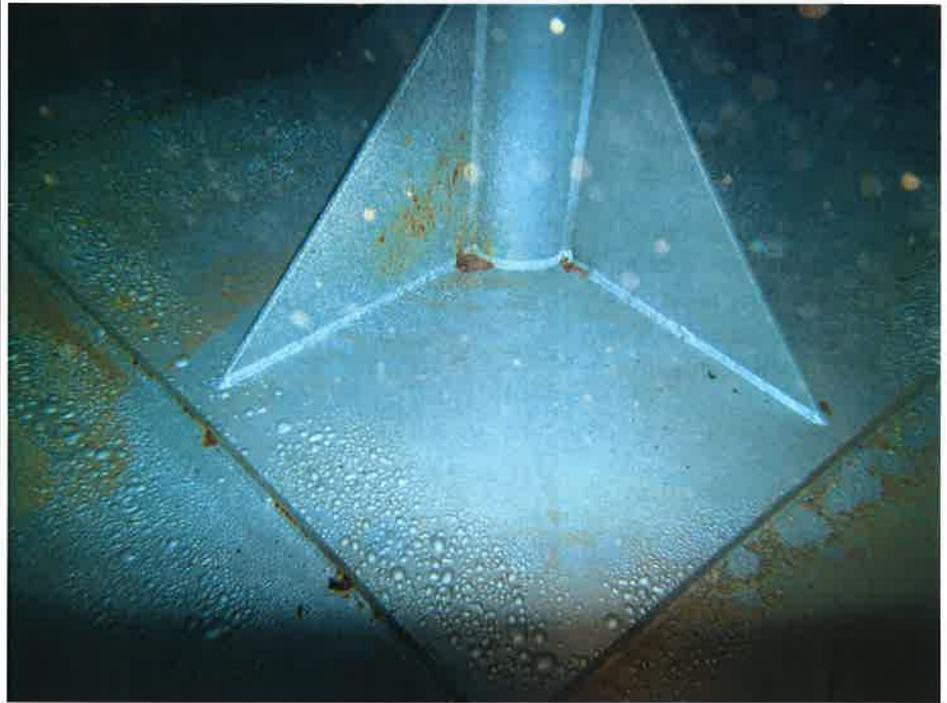
Condition:
Rust Grade¹ 8.

Description:
12" Column appeared to be in fair condition with a minor amount of corrosion and moderate blistering observed.

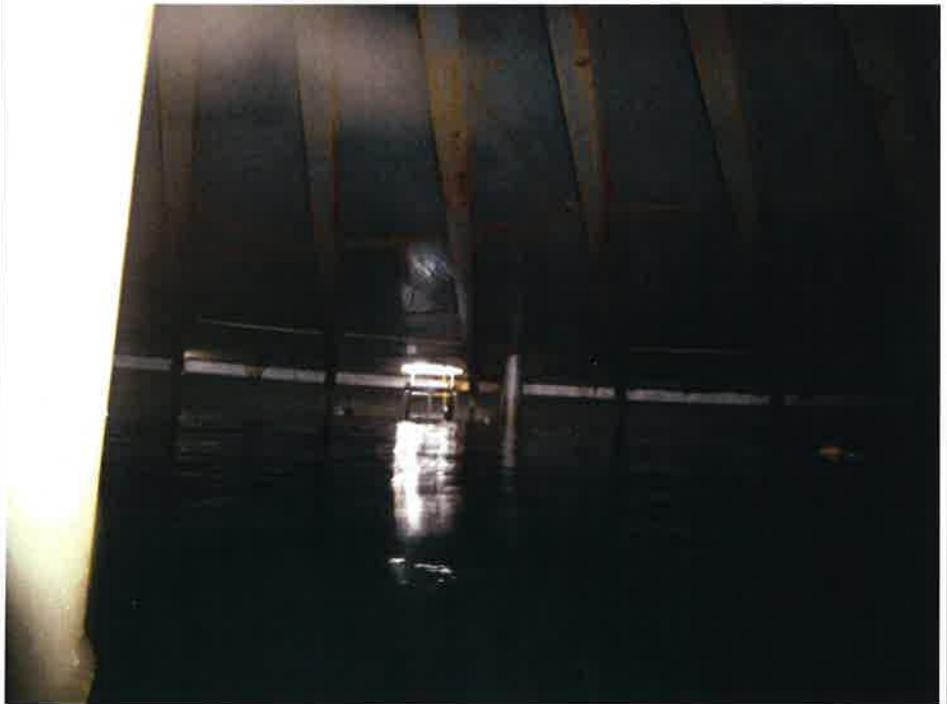
Image #30

Ceiling 12:00

Condition:
Rust Grade¹ 4.

Description:
Ceiling appeared to be in fair condition with a moderate amount of corrosion.

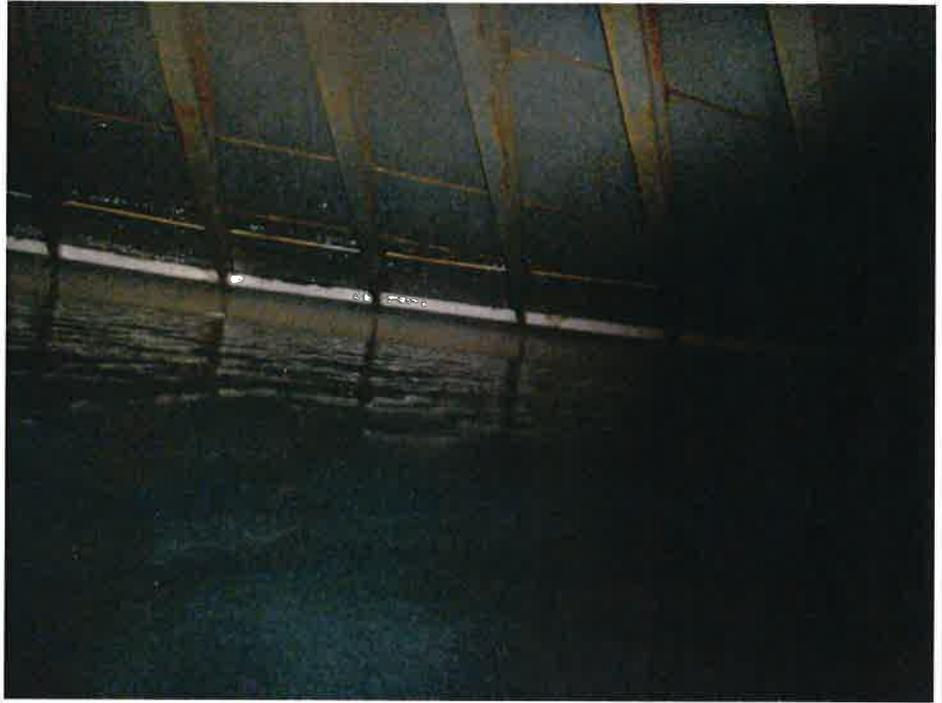
Image #31

Condition:
Rust Grade' 4.

Description:
Ceiling appeared to be in fair condition with a moderate amount of corrosion.

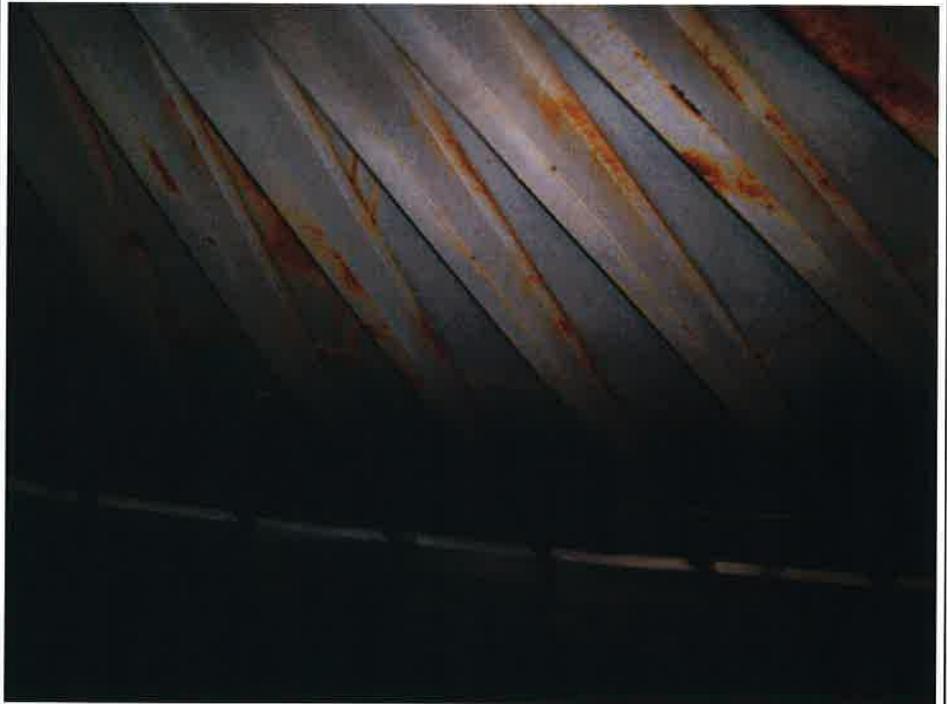
Image #32

Ceiling 6:00

Condition:
Rust Grade' 4.

Description:
Ceiling appeared to be in fair condition with a moderate amount of corrosion.

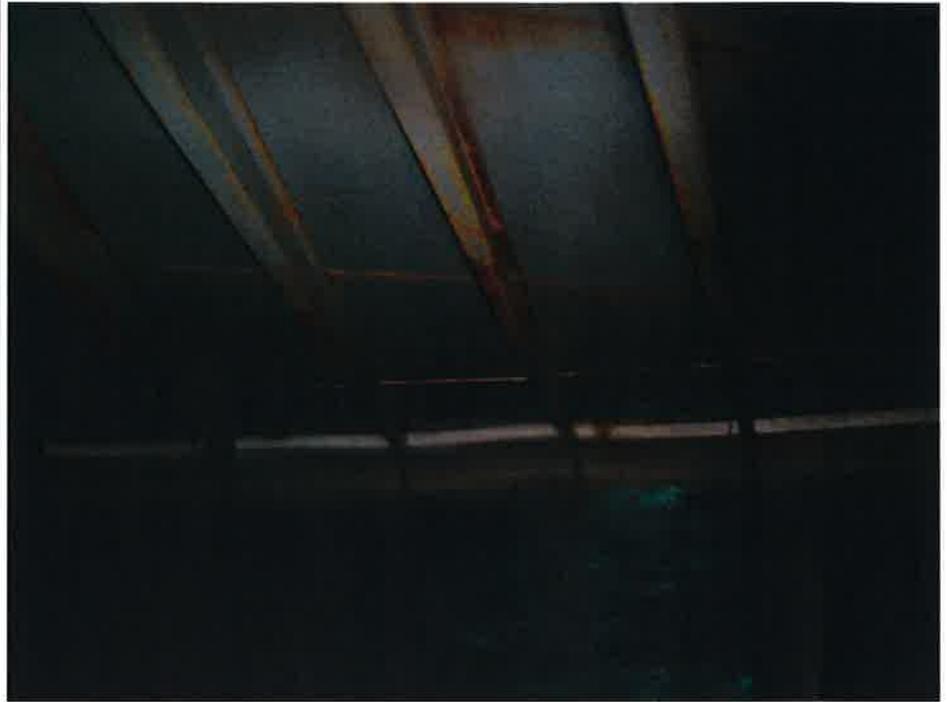
Image #33

Condition:
Rust Grade¹ 4.

Description:
Ceiling appeared to be in fair condition with a moderate amount of corrosion.

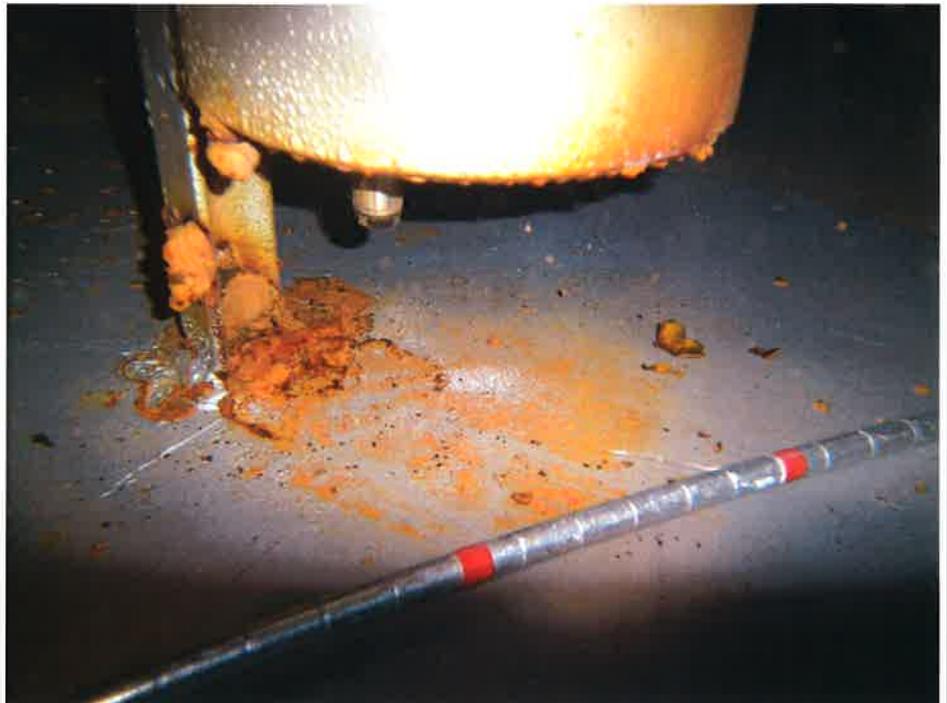
Image #34

Telemetry Stillwell 12:00

Condition:
Rust Grade¹ 8.

Description:
8" Telemetry Stillwell appeared to be in fair condition with a minor amount of corrosion and blistering observed. Sensor appeared to be properly suspended.

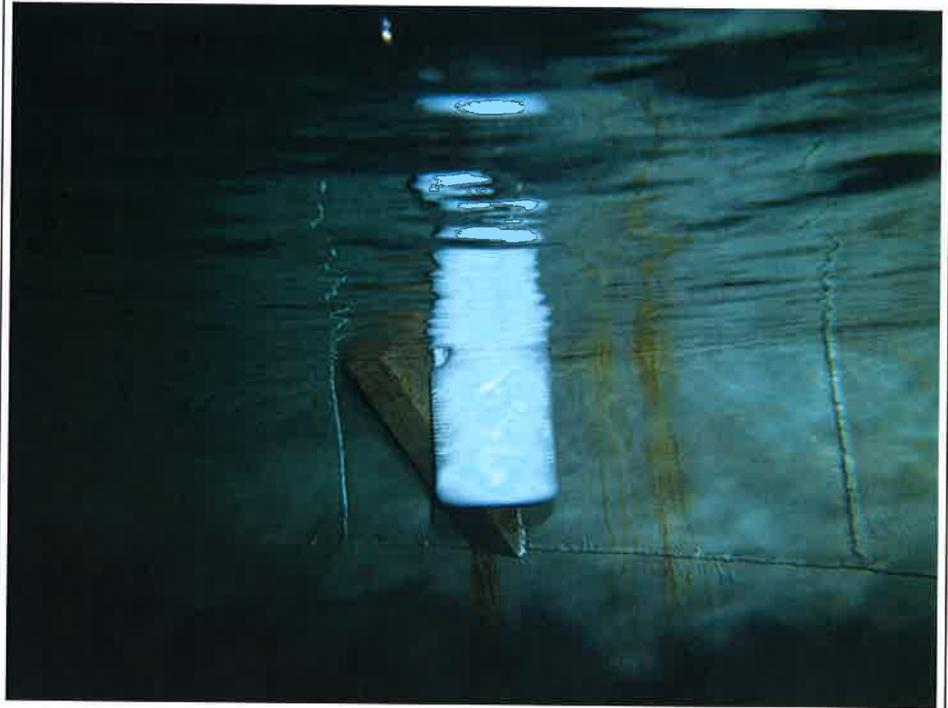
Image #35

*Liquid Level Indicator
Float 11:45*

Condition:
Float appeared to be in
good working
condition.
